Sweeper Crushed in Hay Press Bale Elevator

INCIDENT FACTS

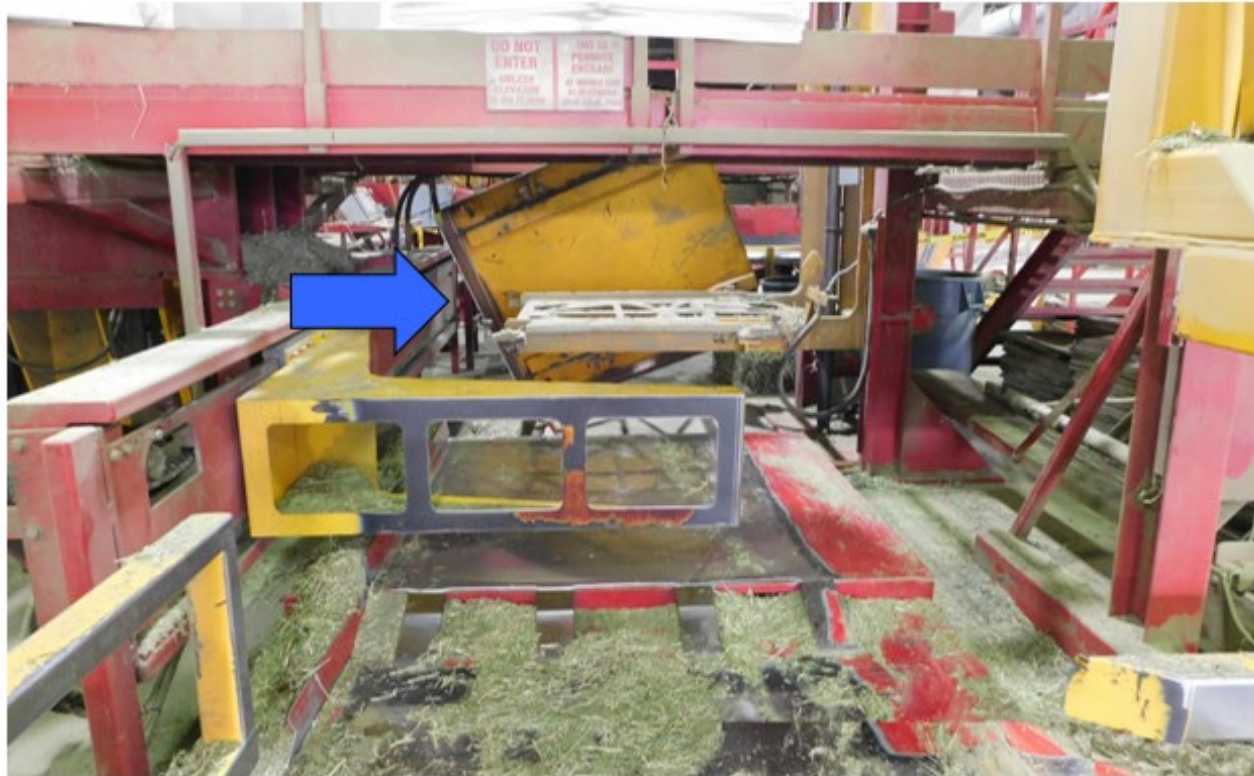
Photo 1. Hay press bale elevator with output platform and pusher in foreground. Arrow shows elevator and yellow table that came off it when the worker was crushed. Warning signs are on the machine frame above the elevator. The worker entered the area from the back.

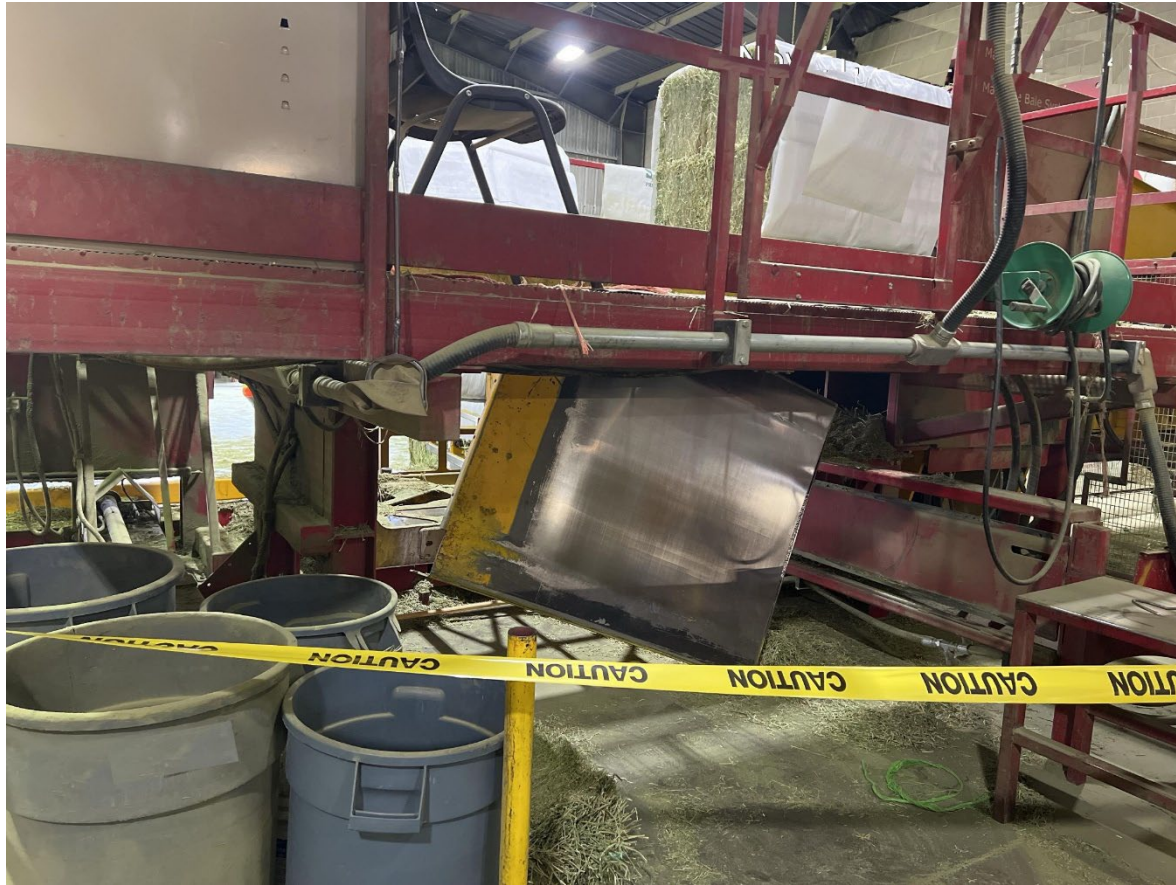
Photo 3. Unguarded area behind hay bale elevator where worker entered before being crushed. Note lack of hazard warning and LOTO procedure requirement signage.

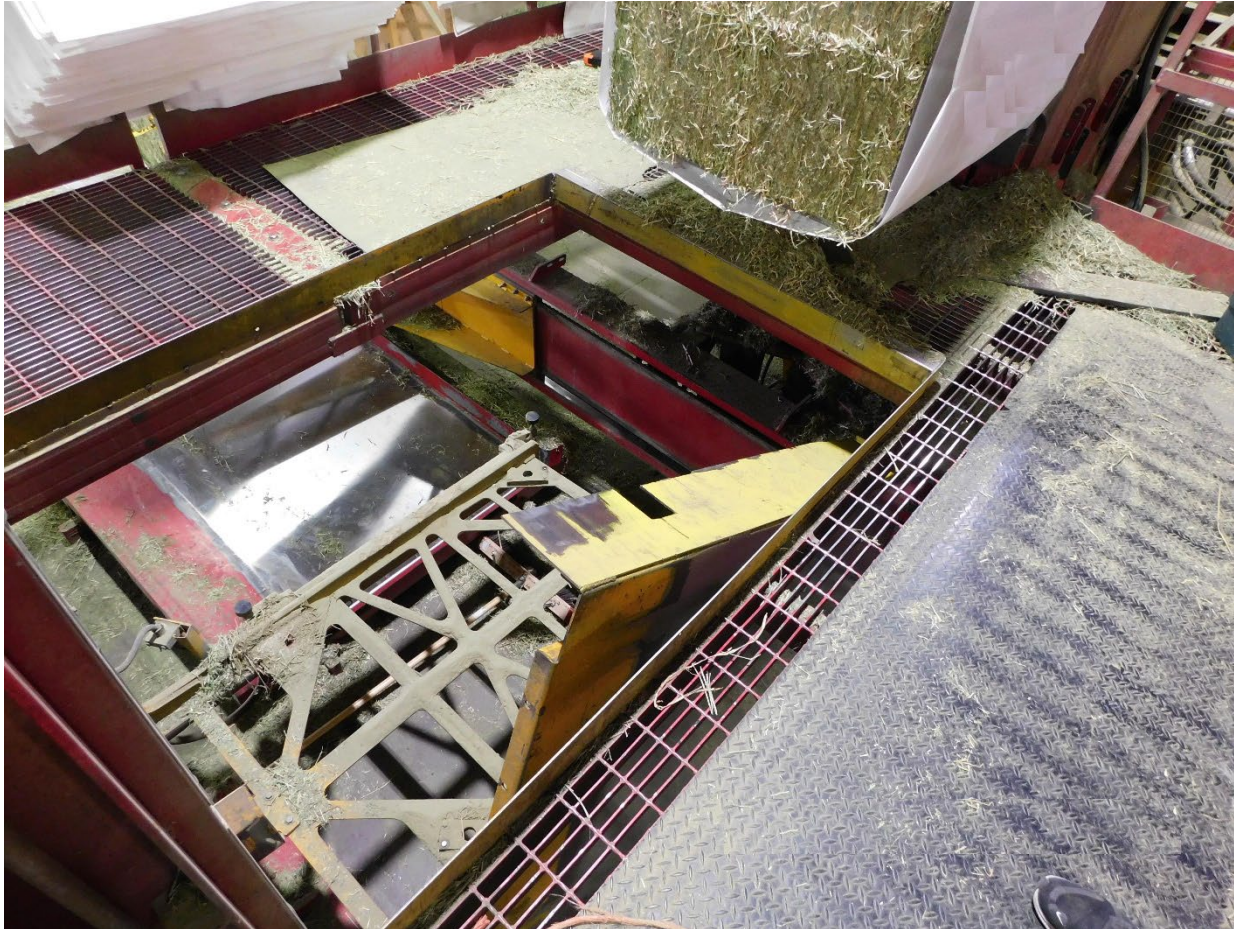
Photo 4. Overhead view of hay bale elevator and output platform from bale ejection and loading area.
