Laborer Severely Injured in 60-Foot Fall from Scissor Lift

INCIDENT FACTS

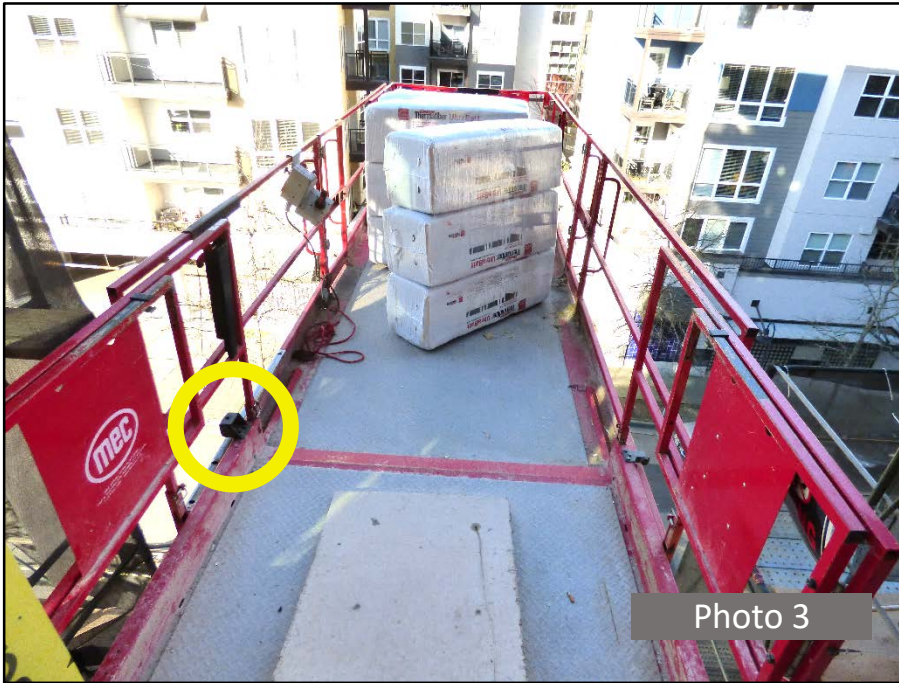
Photo 3. Scissor lift platform at the incident scene. The yellow circle shows the location of the broken deck extension locking pin.

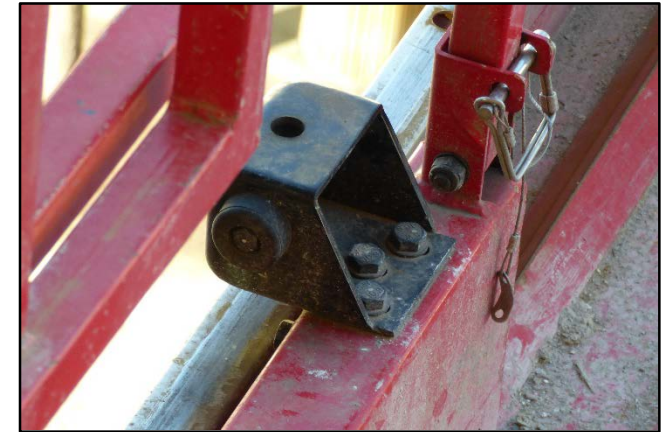
Photo 5. Locking pin broken into two pieces.
