Laborer Suffers Traumatic Brain Injury when Struck by Load Falling from Forklift

INCIDENT FACTS

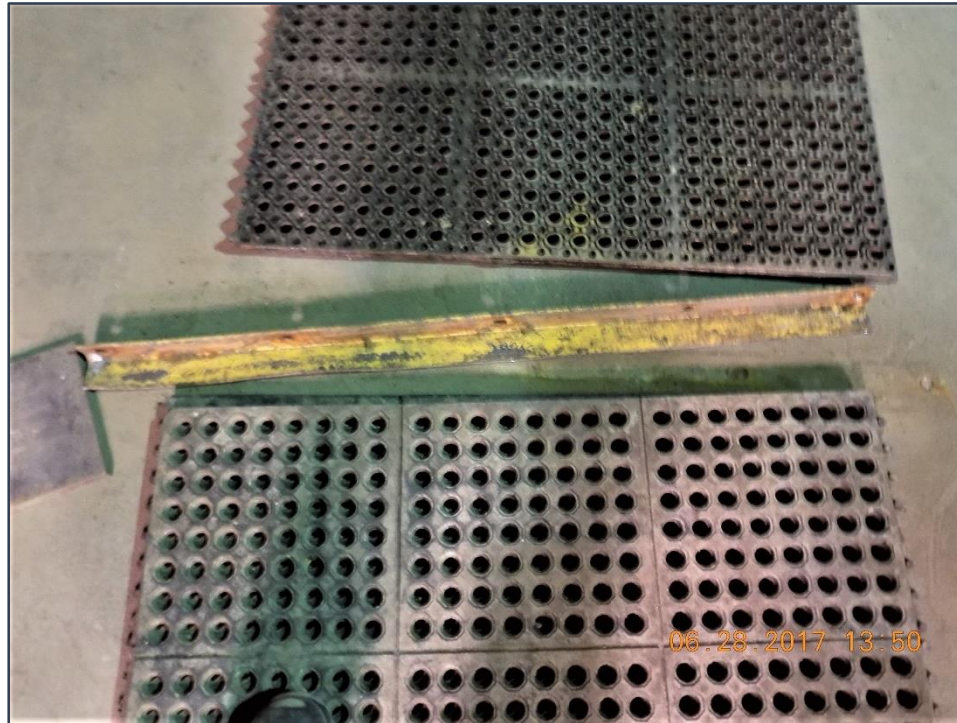
Photo 6. Piece of angle iron on the floor that caused the forklift to stop abruptly, destabilizing the forklift's load of the staircase platform, causing it to fall off the forks.
