Operator Dies after Excavator Tips Over the Side of a Bridge into River

Investigation: # 08WA00101
Release Date: August 7, 2014
SHARP Report: # 52-31-2014

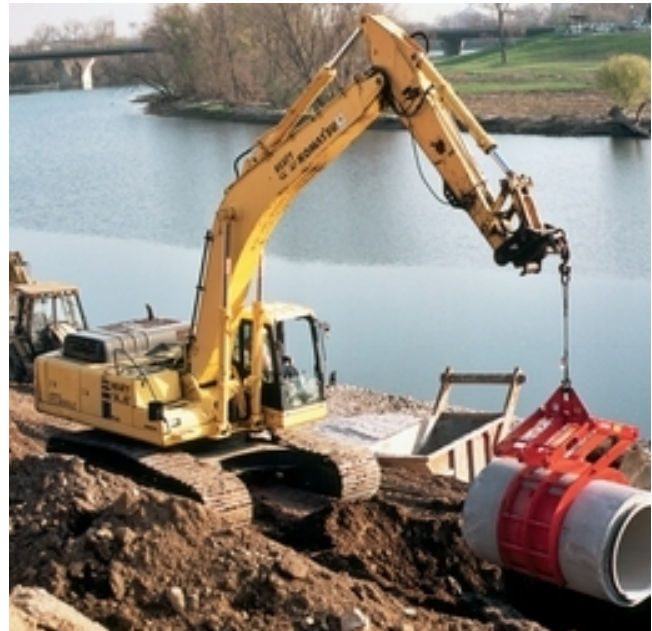
Photo 2: Photo of an excavator completing an over the front lift. Notice the cab and counterweight are in line with the tracks

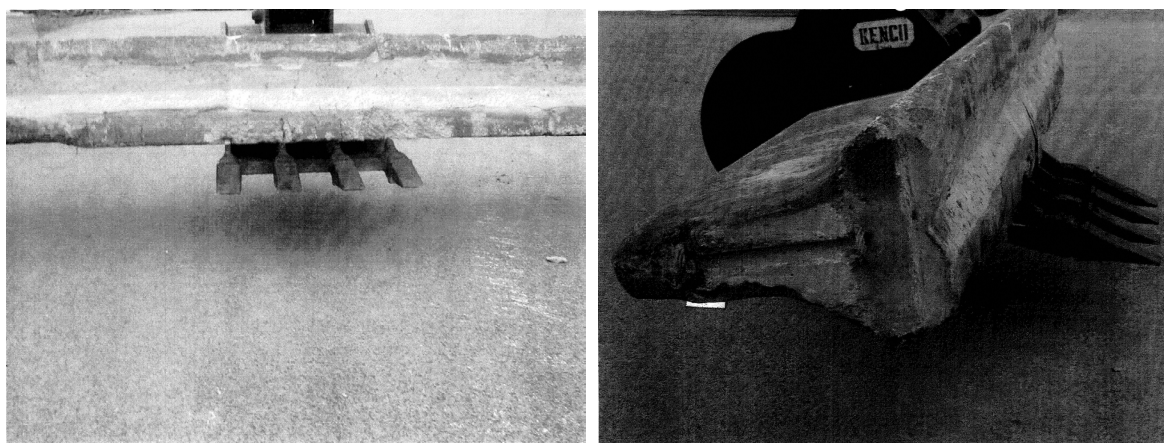
Photos 8&9: Front and side view of Slab Crab during load testing with a concrete Jersey barrier
