Communication Tower Worker Falls 260 Feet

INCIDENT FACTS

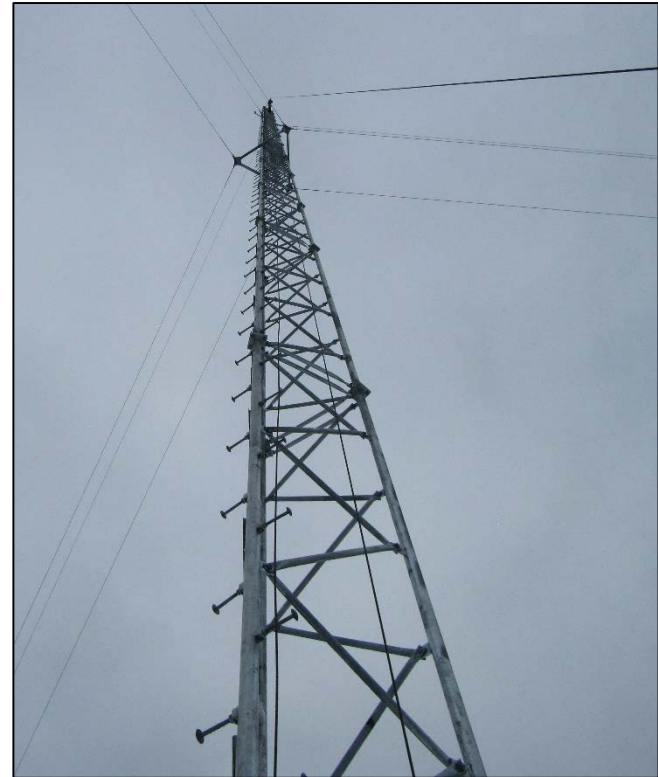
A 24-year-old tower climber fell 260 feet from a communication tower under construction.

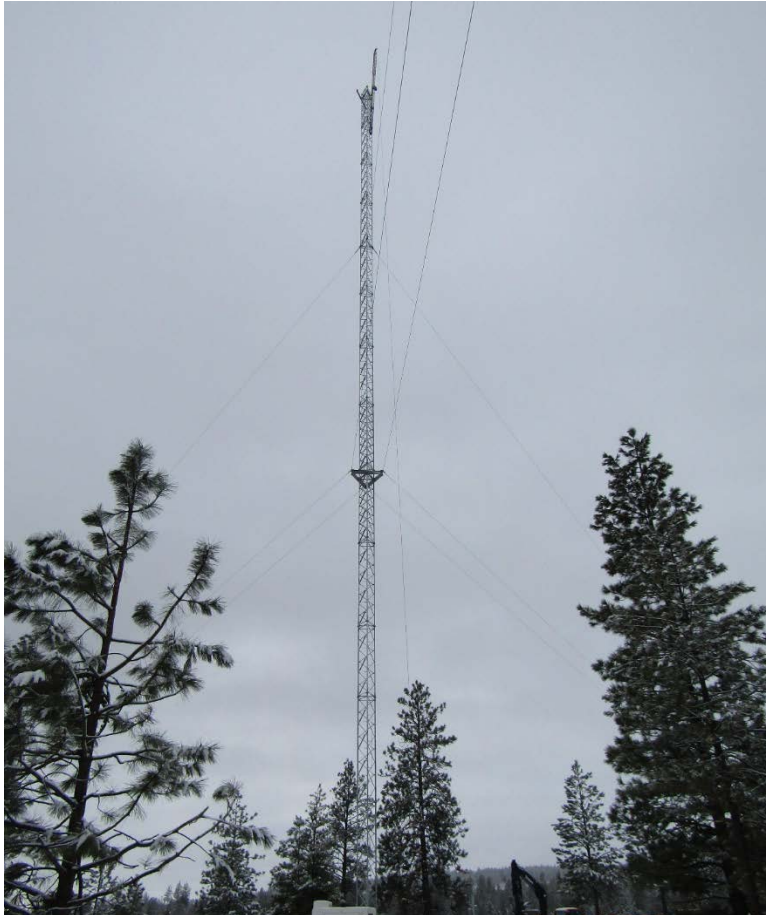
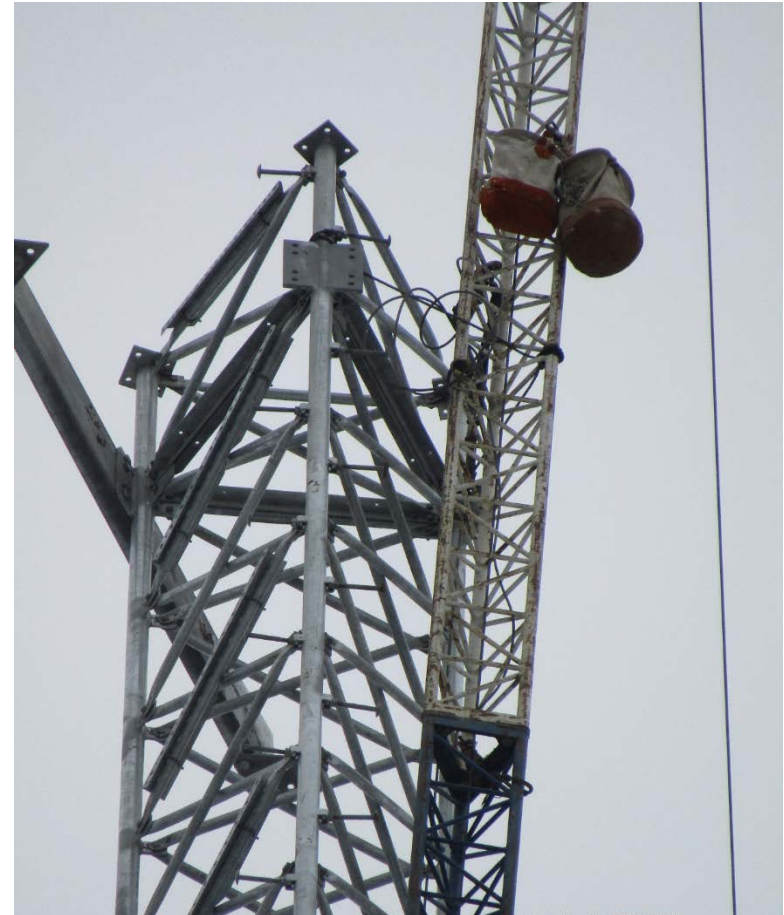
Photos 1 and 2. View of the 260-foot unfinished tower on the left. View of the top of the tower with gin pole in front on the right.
