CONSTRUCTION FATALITY NARRATIVE

REPORT #: 71-203-2021

Roofer Falls 30 Feet from Rain Slick Roof

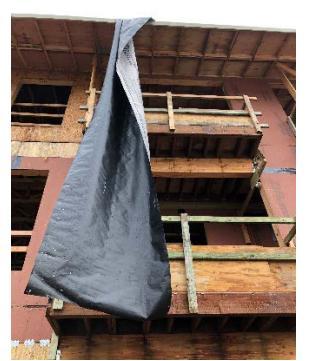
Roofing underlayment he attempted to grab on to as he was falling.

returned to the roof to install it on the roof ridge. While preparing to install his anchor, he fell and slid about 12 feet down the wet plywood roof deck. As he slid, he grabbed roofing underlayment in an attempt to stop his descent and then fell off the roof edge. As he fell, he struck a steel storage container and landed on the ground 30 feet below. His anchor and hammer were found near him. First responders took him to a hospital where he died of blunt force injuries.

Investigators found: 1) The roofer was wearing a fall protection harness, but a lanyard was not attached to it. 2) The plywood decking had been exposed to rain for several weeks and due to it being uncovered the plywood fibers absorbed water and expanded, making the decking slick. 3) The roofer was wearing plastic rain pants, which could have accelerated his slide off the roof. 4) A crew leader-crew safety meeting had not been held that week. 5) A walk-around safety inspection had not been held that week.

- Before beginning a job, focus on identifying fall protection needs and ensure systems are in place to protect workers. This could include installing multiple anchorages positioned so that workers can safely move about the roof.
- Always use fall protection during roofing operations.

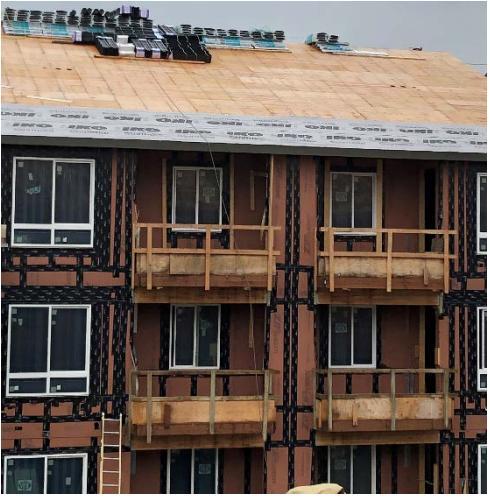
A 45-year-old roofer died when he fell 30 feet from a rain slick roof of an apartment building under construction.

Three-story apartment building from which the roofer fell 30 feet.
