INCIDENT FACTS

71-218-2022

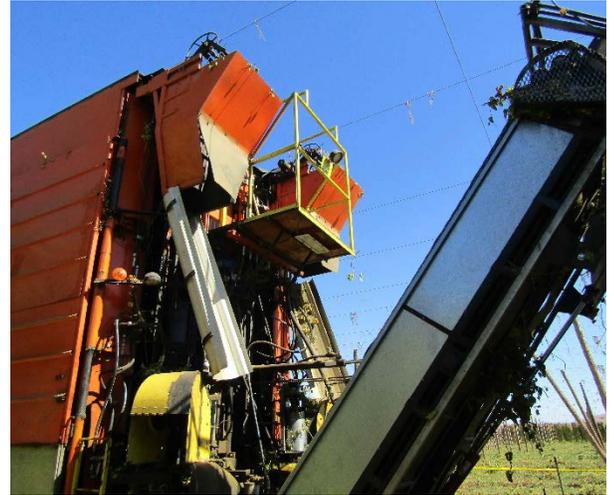
Rear of harvester with elevated platform where worker was located. Cross-cables are overhead and leaning poles are in the background.
