Hop Farm Harvester Operator Struck By Steel Cable

INCIDENT FACTS

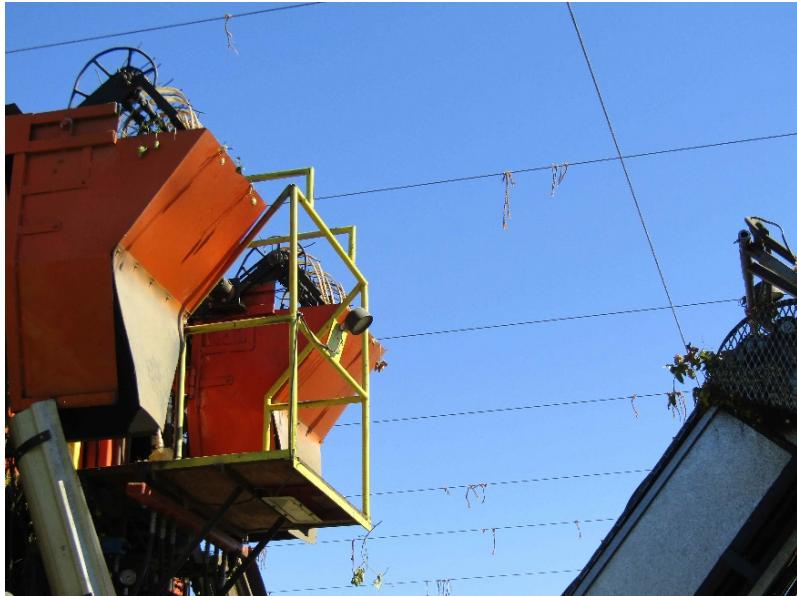
Photo 1. View of rear of harvester with elevated platform where operator was located. Platform had rear and side guard rails (in yellow) to prevent operators from falling.
