# CONSTRUCTION FATALITY NARRATIVE

**REPORT #:** 71-231-2022

## Site Superintendent Run Over by Backing Dump Truck

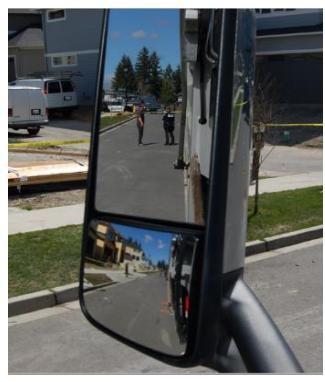
Truck side mirror shows workers are difficult to see if not wearing high-visibility vests.

- Continuously assess the hazards of vehicles to workers on foot and ensure hazards are corrected.
- Require workers to wear ANSI Class 2 high-visibility garments, such as vests, when exposed to vehicular traffic.

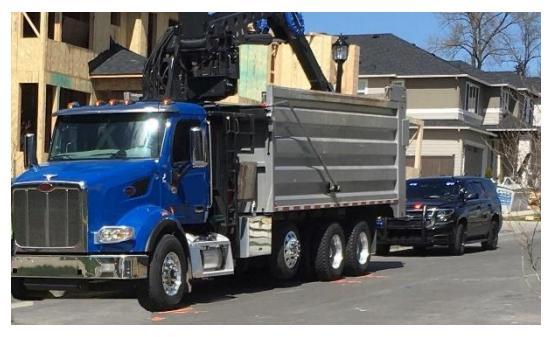
Dump truck that backed over the superintendent.

- The truck did not have a backup camera, nor was an observer signaling that it was safe to back up.
- The truck's backup alarm was working as it backed up.
- The truck drivers were not trained on procedures for backing up at construction sites.

- Consider installing pedestrian proximity detection systems on trucks to alert drivers of workers on foot.
- Train drivers that they must use a signaler or back up camera when backing near workers on foot.
- Create and enforce policies that:
  - Drivers maintain visual contact with workers on foot. When visual contact is lost, drivers should stop and not resume movement until visual contact is re-established.
  - $_{\odot}\,$  Workers on foot stay out of backing zones unless trained and acting as an observer signaling the driver.
