Tractor Overturn Kills 16-Year-Old Farm Worker in Washington State.

Investigation No.: 99WA05601

SHARP Report No.: 52-6-2001

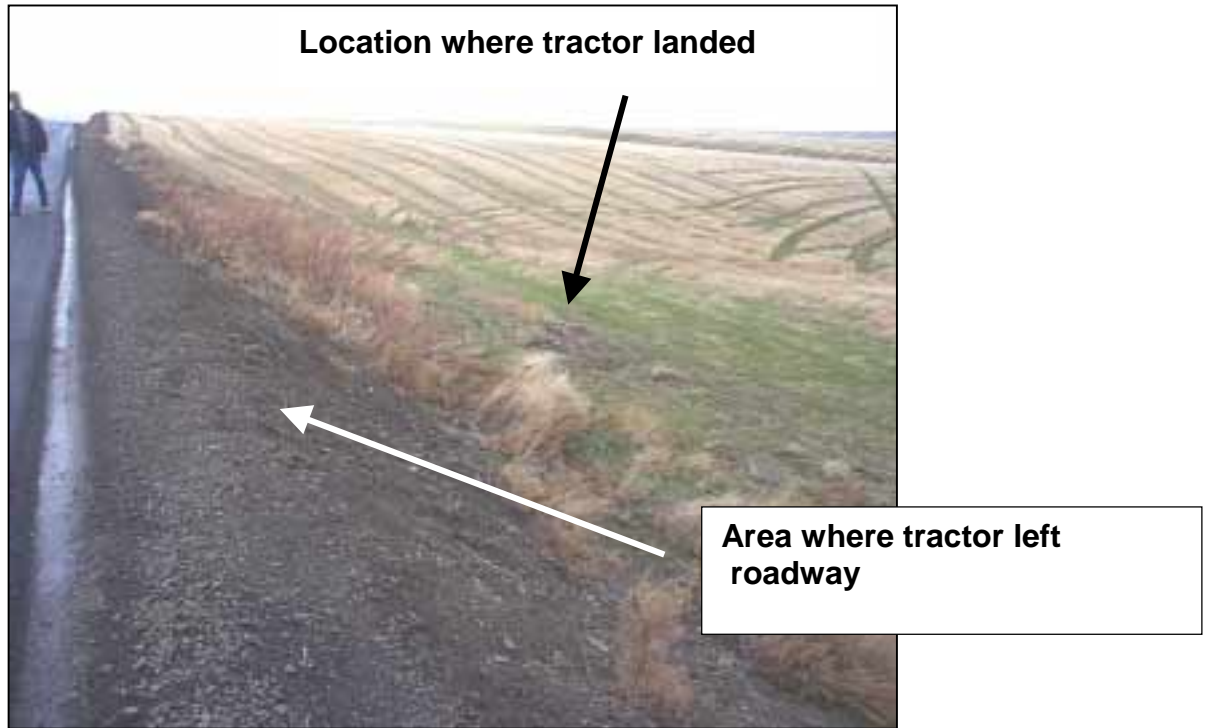
Photograph 1. The scene of the incident.

Both shoulders of the road were made of packed gravel and dirt. The right shoulder (as seen by the victim) measured 4 feet in width and the left shoulder measured 4 feet 1 inches in width (see Figure 1 and Photograph 1). At the point of the incident, the far right hand edge of the shoulder dropped steeply from road level to the field below. The drop to where the tractor was found was approximately 11 to 12 feet. The bank was covered with loose soil and light vegetation.
