## Framer Setting Roof Truss Falls 20 Feet

**REPORT #:** 71-186-2019s

**INDUSTRY:** New single-family housing  
construction

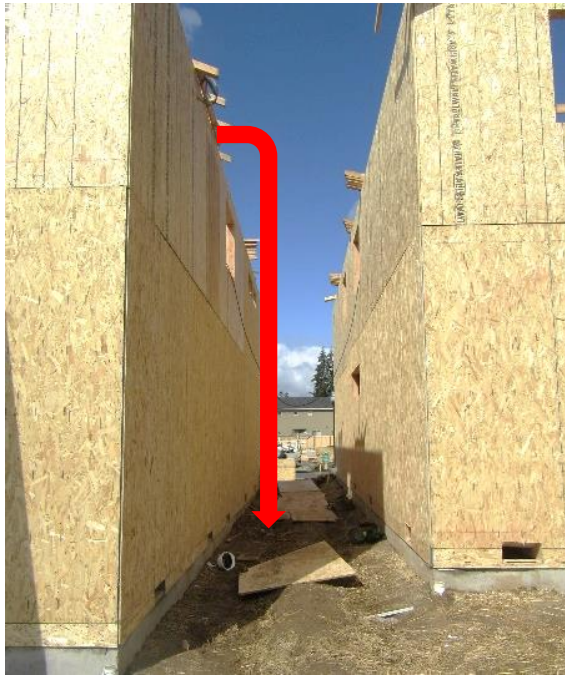
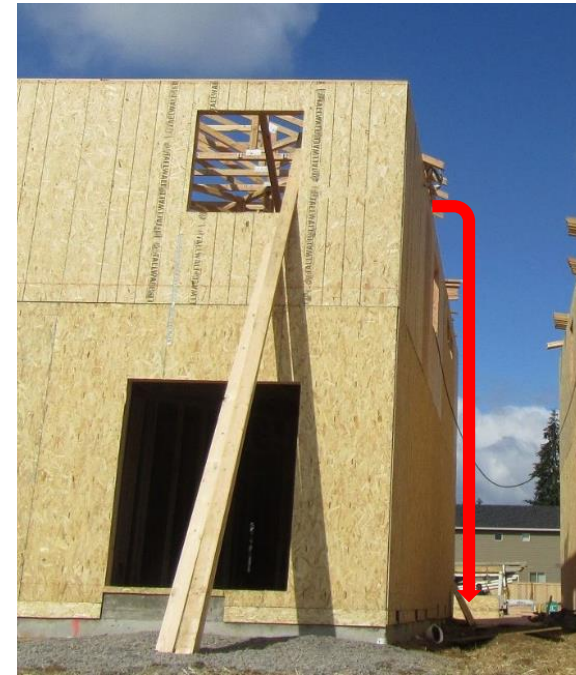
## Photos 1 & 2

State investigators found that the framer fell 20 feet from the house's six-inch-wide top plate.

He was not using fall protection.

Two views of the two-story house under construction and the location where the framer fell 20 feet from the top plate while preparing to install roof trusses.

- Do not perform work while standing on top plates.
- Use interior or exterior mounted bracket scaffolds, boom or scissor lifts, and platform ladders or stepladders.

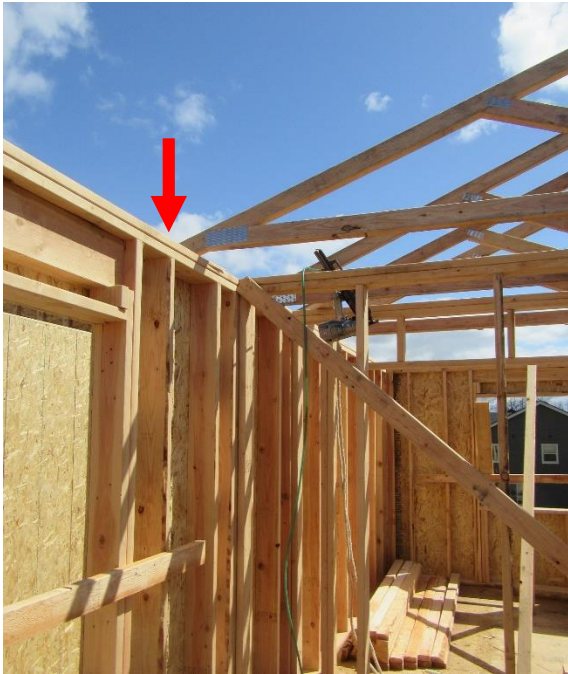
**Photo 3**

Interior view of house. The arrow points to the approximate position of where the framer was standing on the top plate when he fell.

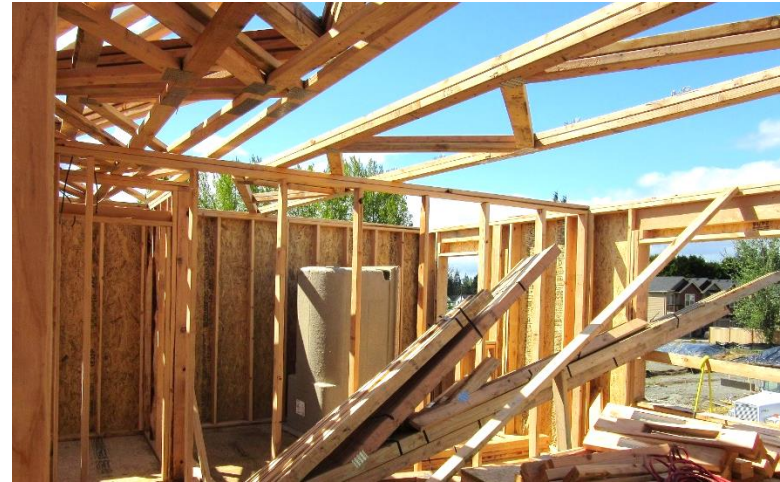
**Photo 4**

Interior view of roof trusses staged on house top plate.
