# Orchard Manager Dies When ATV Crashes into Apple Bin

**REPORT #:** 71-180-2019s

**INDUSTRY:** Apple orchard

**EVENT TYPE:** Machine/ATV

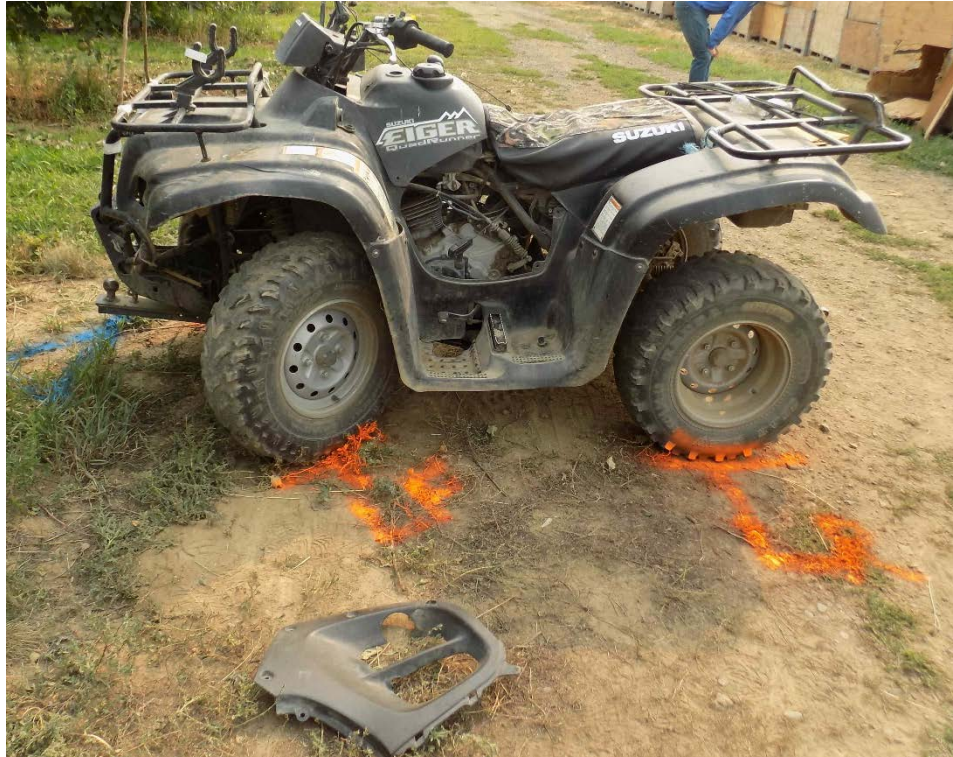
They found that the manager was operating the ATV along an orchard gravel and dirt road at a high rate of speed when the ATV went into a 58-foot straight skid and struck an apple bin. The ATV then rolled over and came to rest 20 feet from the point of impact. The manager was found on the road 12 feet from the ATV. He was not wearing a helmet. He died of massive head injuries. The employer did not ensure that his employees wore DOT approved helmets while operating ATVs. Investigators noted the operation of the ATV at an excessive speed as a primary cause of this incident.

**Photo 1.** ATV at the incident scene.

- Operate ATVs at speeds safe for conditions and terrain.
- Employers should create and enforce a policy to ensure that employees use helmets when operating ATVs.
- Employers should consider providing and requiring employees to use company ATVs.
- Employers should consider installing governors on ATVs to prevent high-speed operation.
- Always wear a DOT approved helmet while operating ATVs.
- Take a hands-on ATV safety training course.
- Follow manufacturer's instructions and warnings for safe operation of ATVs.

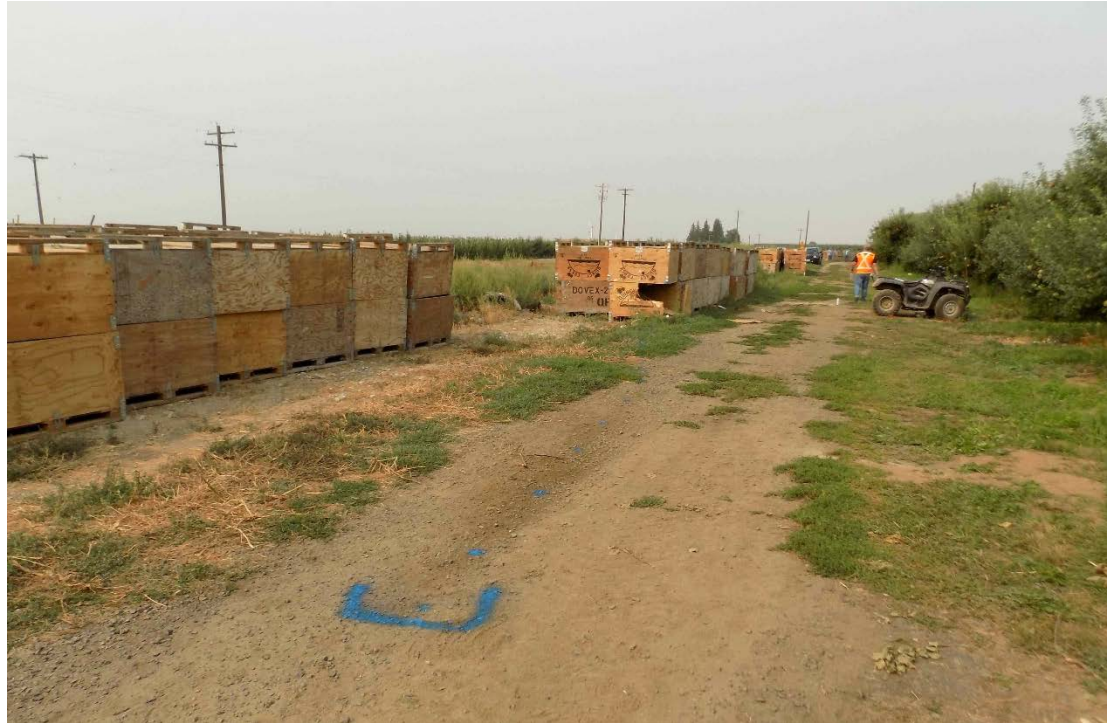
**Photo 2.** Orchard road along which the manager was operating the ATV. The painted blue “U” on the road indicates where the ATV went into a skid for 58 feet before striking the bin.

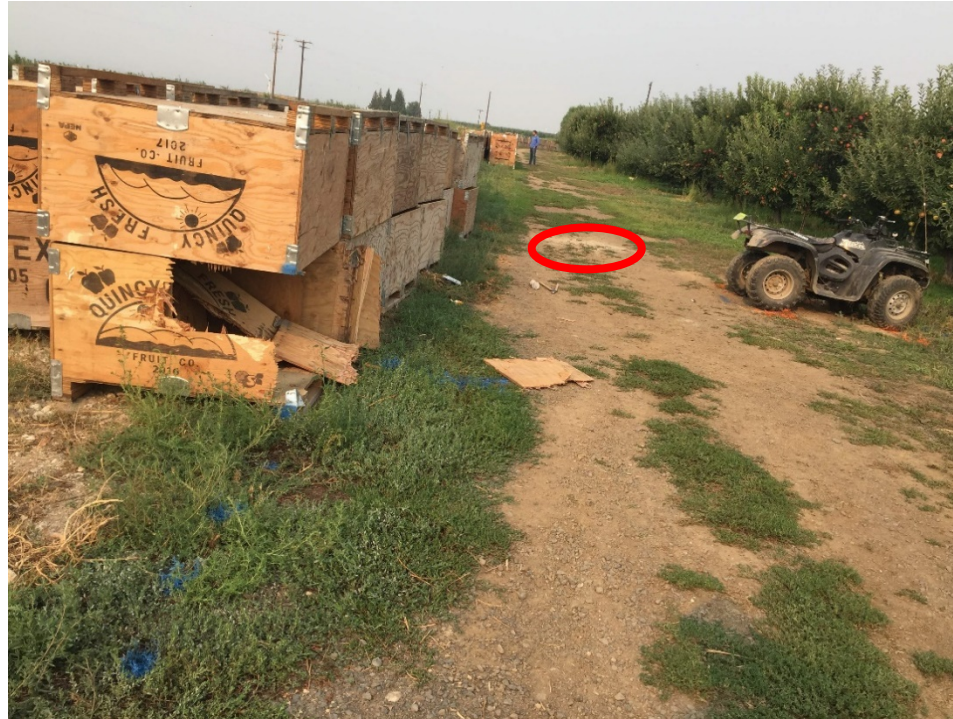
**Photo 3.** The incident scene showing the damaged apple bin after being struck by the ATV, where the ATV came to rest, and the location (indicated by the red circle) of the manager after being thrown from the ATV.

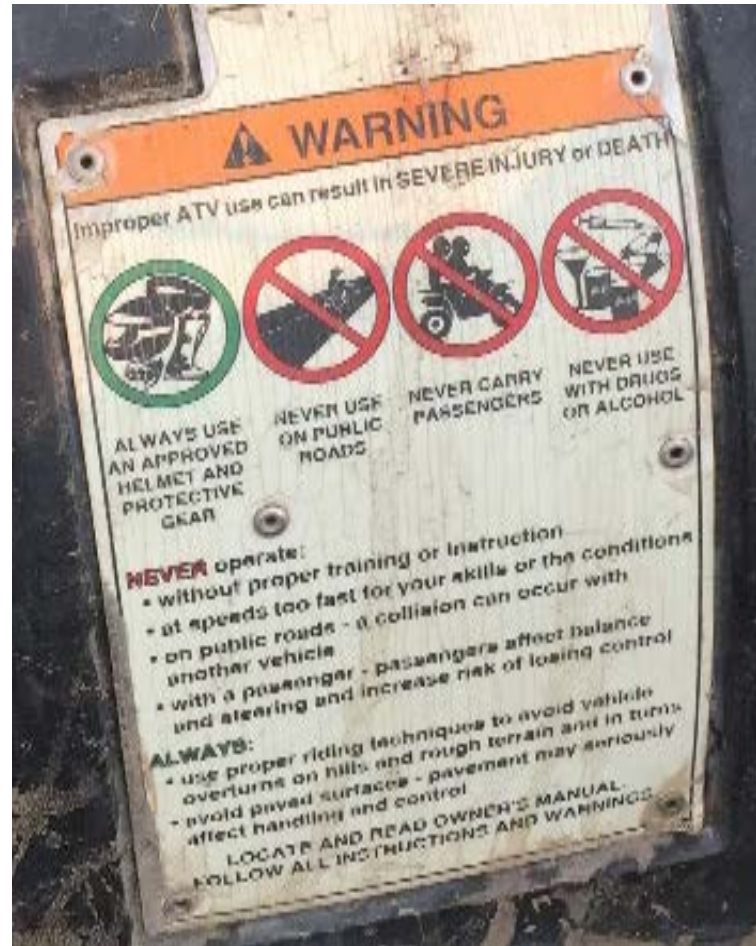
**Photo 4.** The manufacturer's decal on the ATV showing that DOT approved helmets are required when operating the ATV.

Employers must provide personal protective equipment (PPE) to ensure that employees are protected from injury. Wherever appropriate, employers must ensure that employees use PPE.
