## CONSTRUCTION FATALITY NARRATIVE

#### Roofer Falls 18 Feet from Wet Roof

**REPORT #: 71-178-2019s**

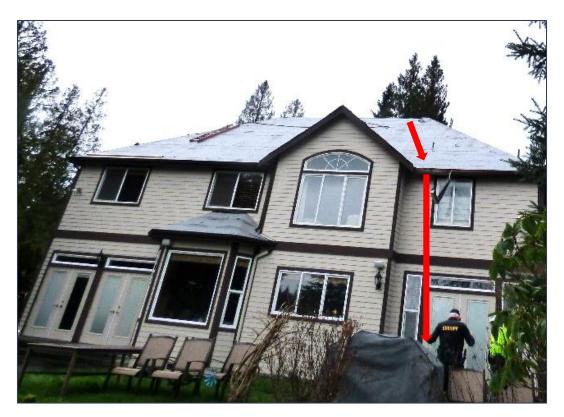
The state investigator found that the victim's rope grab lifeline was attached to a roof anchor, but he was not tied off to it when he slid on the wet roof underlayment and fell off the roof edge.

**Photo 1.** Incident scene showing where the roofer slipped and fell.

Regardless of work activity, employers must ensure that employees exposed to fall hazards of four feet or more while working on a roof with a pitch greater than 4/12 use one of the following systems: fall restraint, fall arrest, or positioning device.

Always use fall protection during roofing operations.

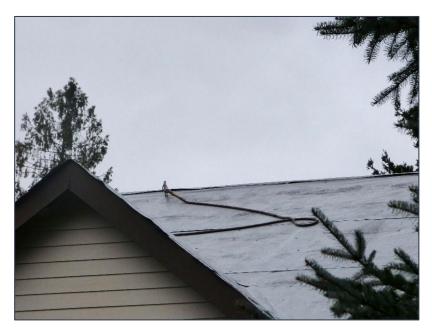
Photo 2. Roof of the house showing the location of the lifeline for rope grab attachment.

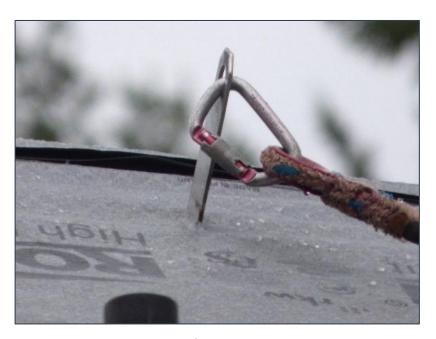
**Photo 3.** Close-up of the anchor.
