## Roofer Falls 30 Feet through Skylight

### INCIDENT FACTS

**REPORT #:** 71-188-2019s

**REPORT DATE:** November 22, 2019

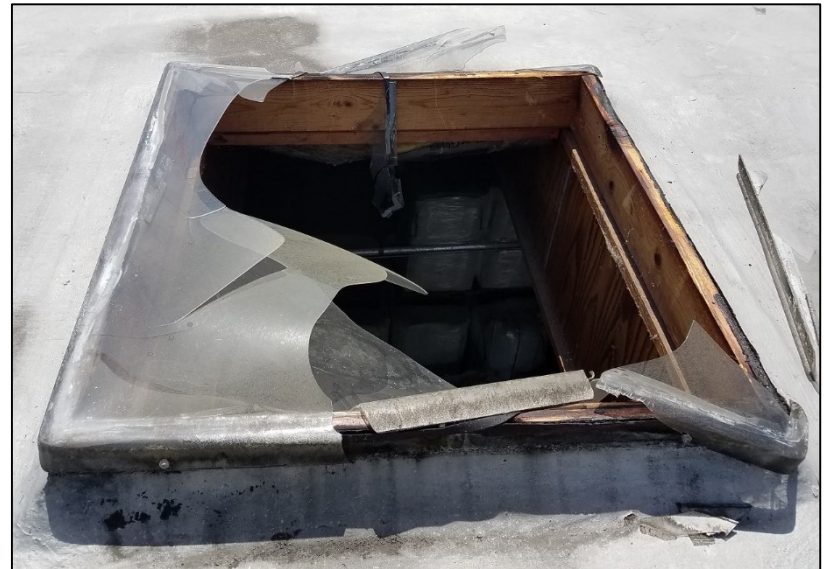
A 47-year-old roofer was cleaning the roof of a commercial warehouse when he fell through a skylight.

The victim fell onto the unprotected plastic dome skylight cover, which broke, and he fell through the skylight. He landed 30 feet below on a concrete floor.

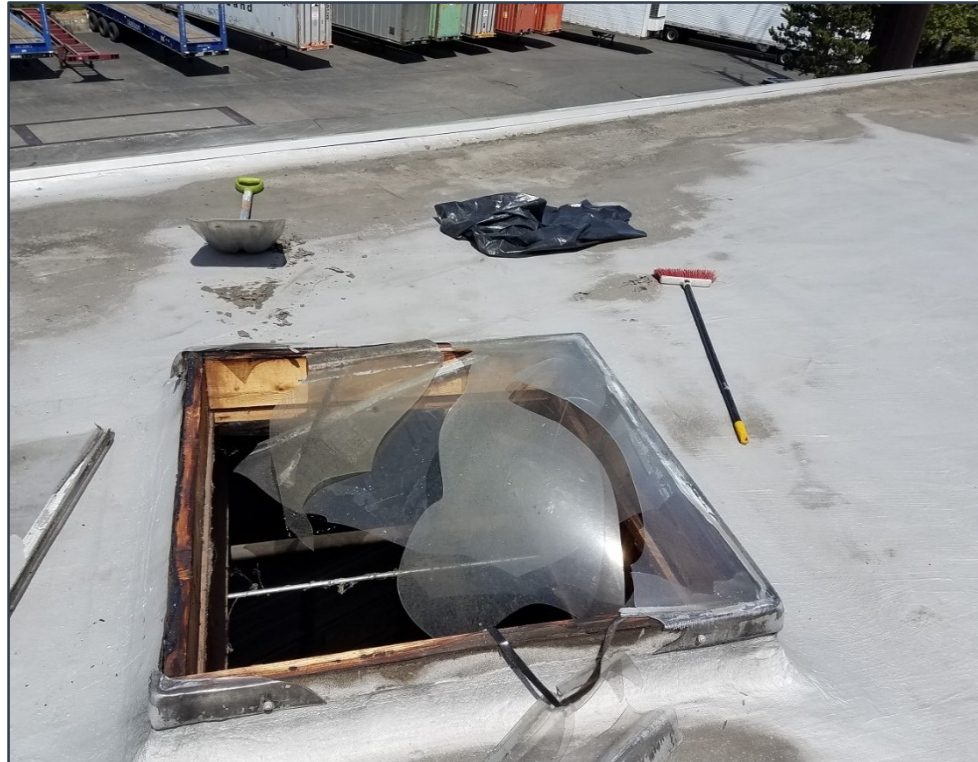
Skylight through which the roofer fell 30 feet.

Whenever there is a danger of falling through an unprotected skylight opening, or the skylight has been installed and is not capable of sustaining the weight of a 200 pound person with a safety factor of 4, employers must provide standard guardrails on all exposed sides in accordance with [WAC 296-155-24615\(2\)](#) or the skylight must be covered in accordance with [WAC 296-155-24615\(3\)](#).

- Building owners should install protective guards or screens over skylights or install guardrails to prevent falls through skylights by maintenance or other personnel who may enter the roof.
- Employers should provide skylight safety nets and train employees to properly use them.
- State building code officials should consider including a provision in the building code which would require all skylights in new or renovated buildings to either have a protective cover or be of sufficient strength to prevent a worker from falling through.

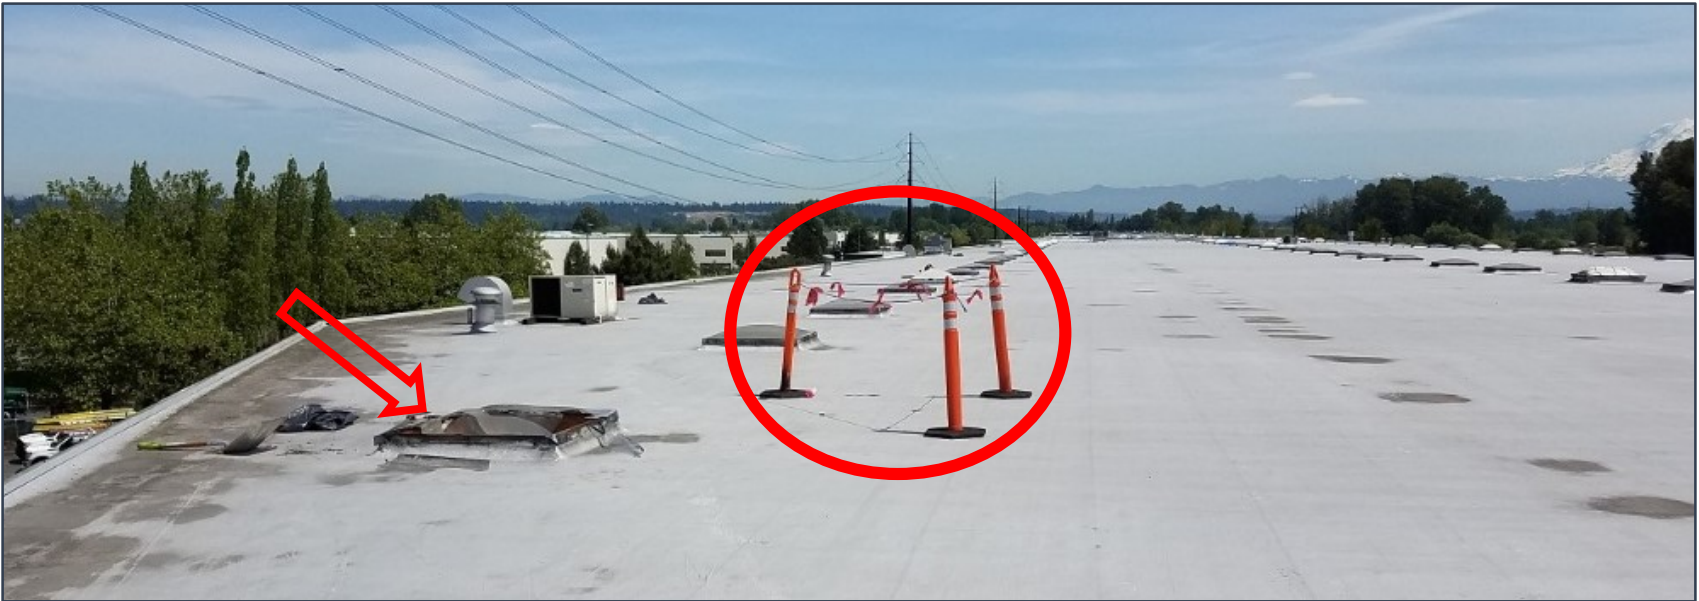
- 1) Inappropriate fall protection was used. Safety monitor and warning line systems should not be used when unprotected skylights are present. Though warning lines must be used around unprotected sides and edges of a low pitch roof work area.
- 2) The employer did not protect skylights.
- 3) The building owner did not protect skylights.

Incident scene showing the roof of the commercial warehouse. The arrow shows the skylight the roofer fell through. The circle shows the warning line system that was used. The warehouse roof had 97 skylights. All were unprotected.

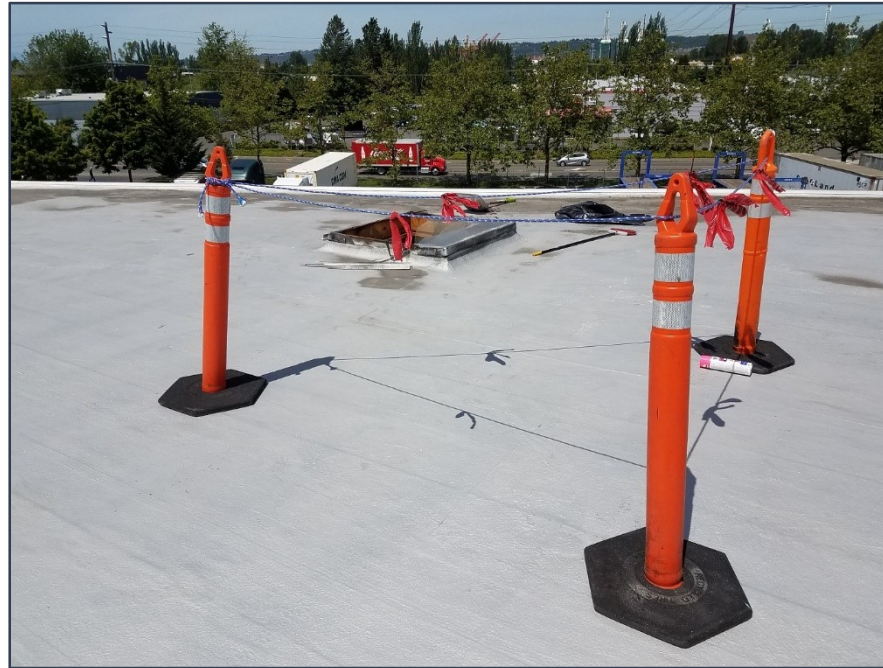
Position of the warning line system used. Due to the employer's misunderstanding of safety requirements, the warning line system was incorrectly setup around the safety monitor. When they needed to move to a different area, three workers each picked up a stanchion and walked the system with the safety monitor inside to the new location. In the background is the skylight the victim fell through.

Employers must ensure that employees exposed to fall hazards of 4 feet or more while engaged in work, other than roofing or leading edge work, on low pitched roofs use one of the following: fall restraint system; fall arrest system; positioning device system; safety monitor and warning line system; or safety watch system.

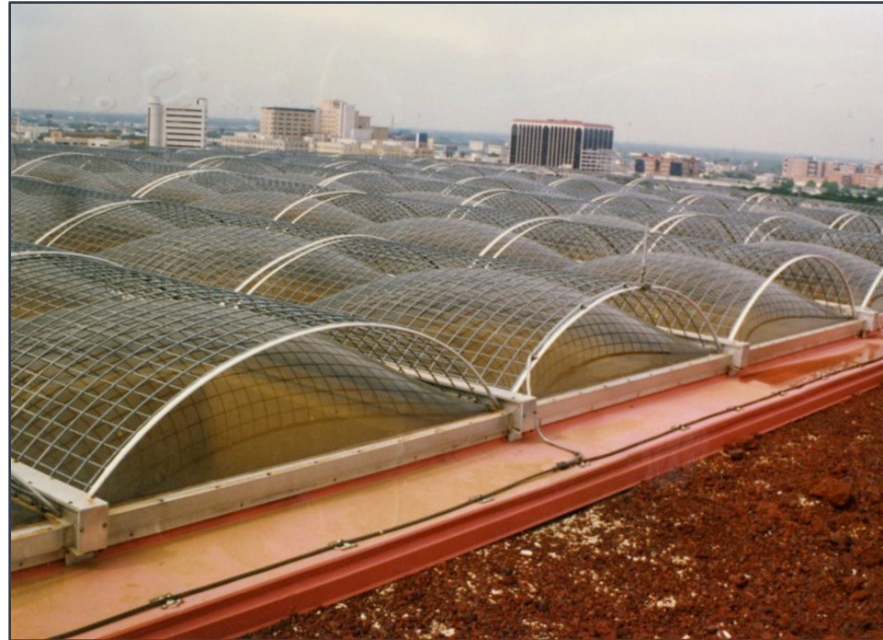
Example of skylights guarded with screens.
