## Truck Driver Crushed by Hay Bales

**REPORT #:** 71-197-2020s

**REPORT DATE:** July 6, 2020

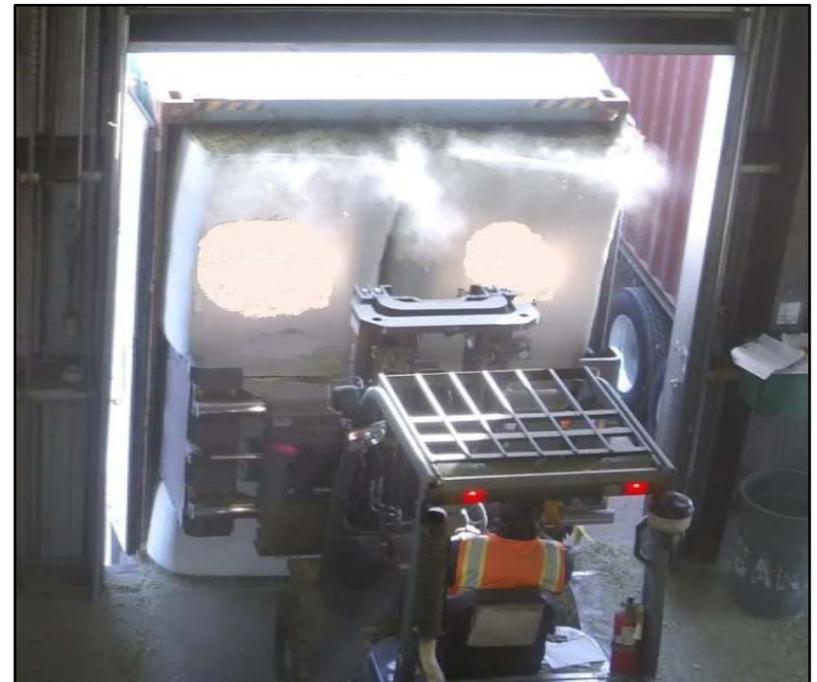
A 61-year-old truck driver working inside a semi-truck's freight container was crushed when a forklift operator loaded hay bales into the container.

Shortly after she went into the 40-foot container, a forklift operator entered the container with a load of hay bales.

The forklift's hay clamp attachment held four double-compressed alfalfa sleeve bales stacked two high, each weighing nearly 1,100 lbs. Due to the size and height of the bales, the forklift operator could not see over or around them. The driver was in the far end of the container, and was unable to alert the operator due to forklift noise. The bales were stacked so that there was no room for the driver to escape.

The driver's body was found at the far end. She had been crushed against the container's front wall by hay bales.

Employers should conduct a job hazard analysis with the participation of workers to assess the hazards to all workers associated with truck freight loading and unloading operations at loading docks. Based on this assessment, employers should establish and enforce safety policies, hazard control procedures, and training for truck drivers and loading dock workers.

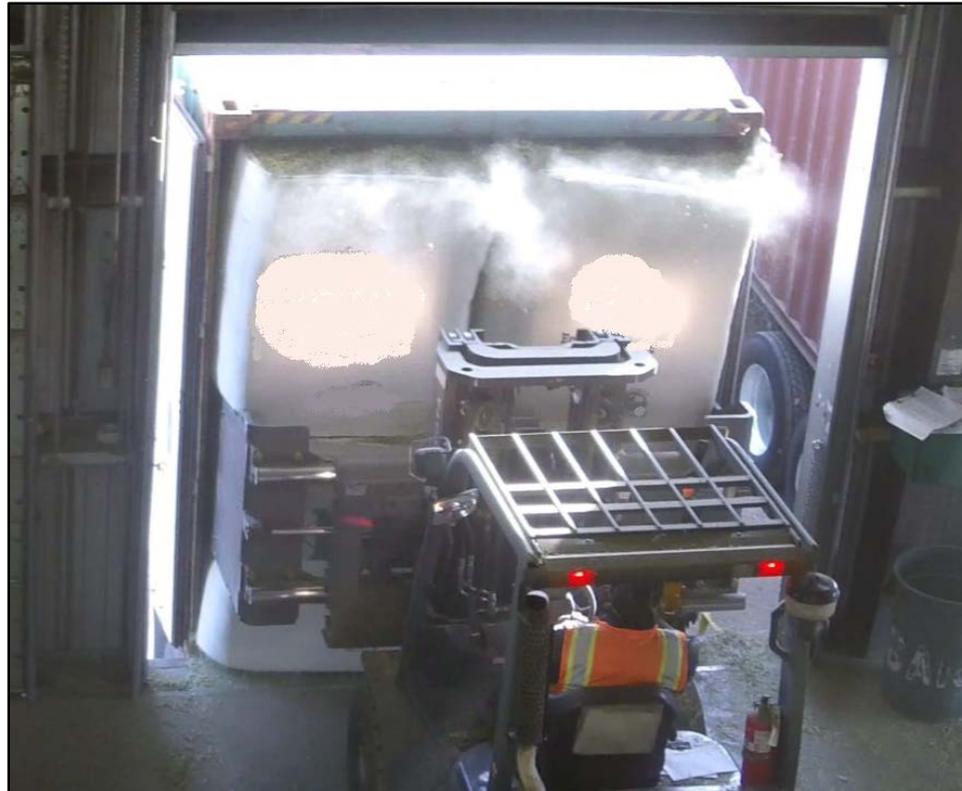
**Photo 1.** Screenshot from video of incident scene at loading dock showing the forklift entering the freight container. The four bales held by the forklift's hay clamp are stacked so that the operator cannot see over or around them as he enters the container.

After the incident, the employer required that drivers not be allowed on the loading dock; installed lighting on the dock that shines into the container; and instructed forklift drivers to no longer stack bales two high while in transit, allowing them to see in front of their load.

Employers must make sure that forklift operators look in the direction they are going and keep a clear view of the path of travel.

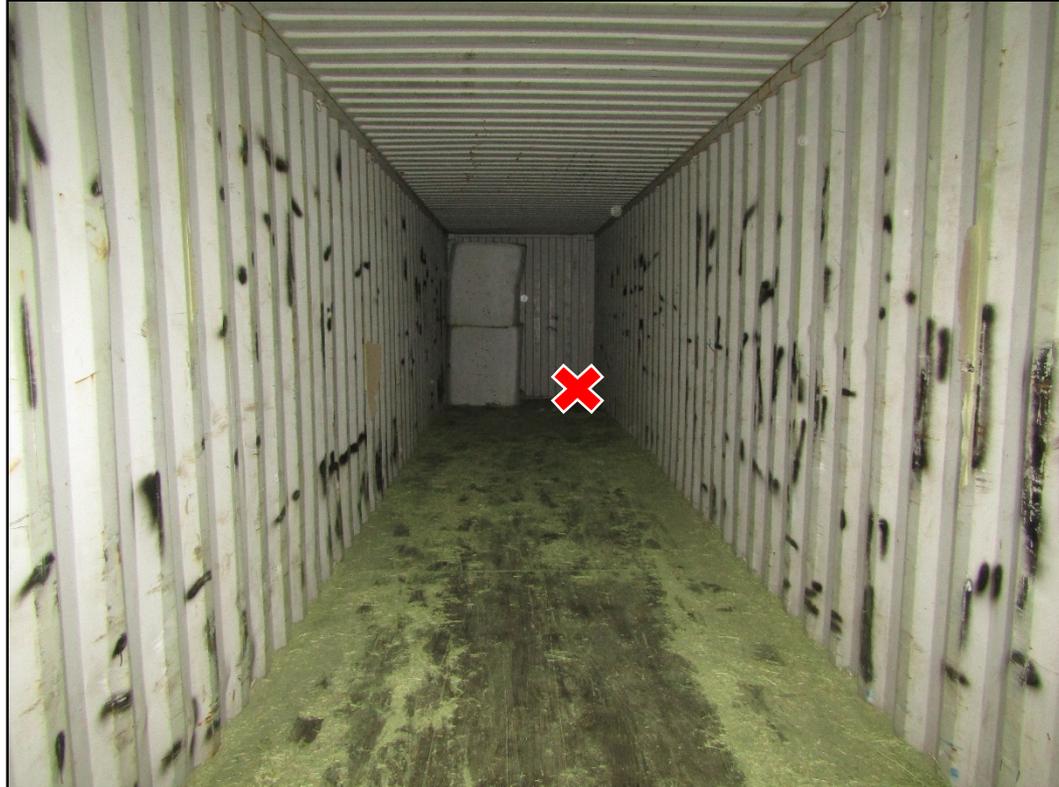
**Photo 2.** The truck driver was cleaning up debris on the floor at the far end of the freight container when a forklift operator deposited hay bales, crushing her against the back wall. The “x” indicates the location of the truck driver.

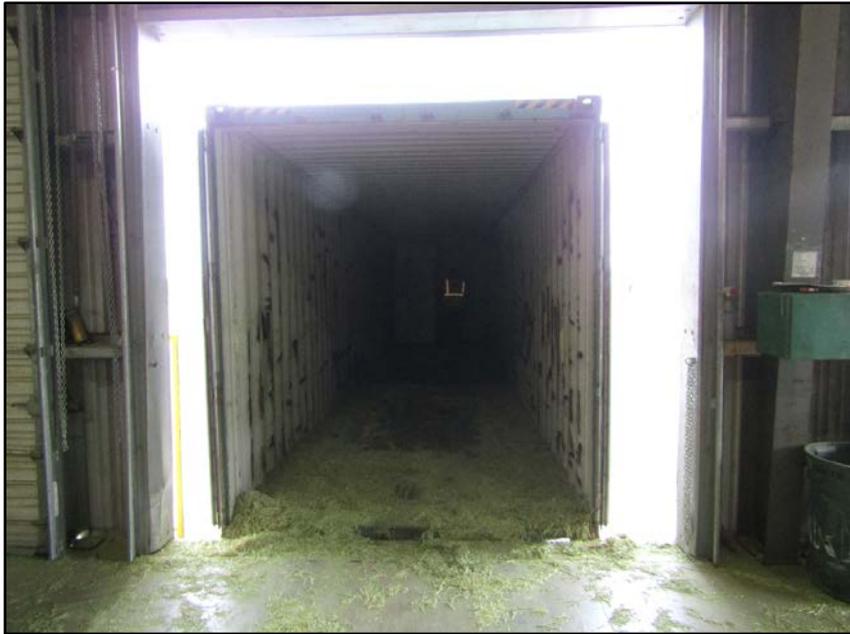
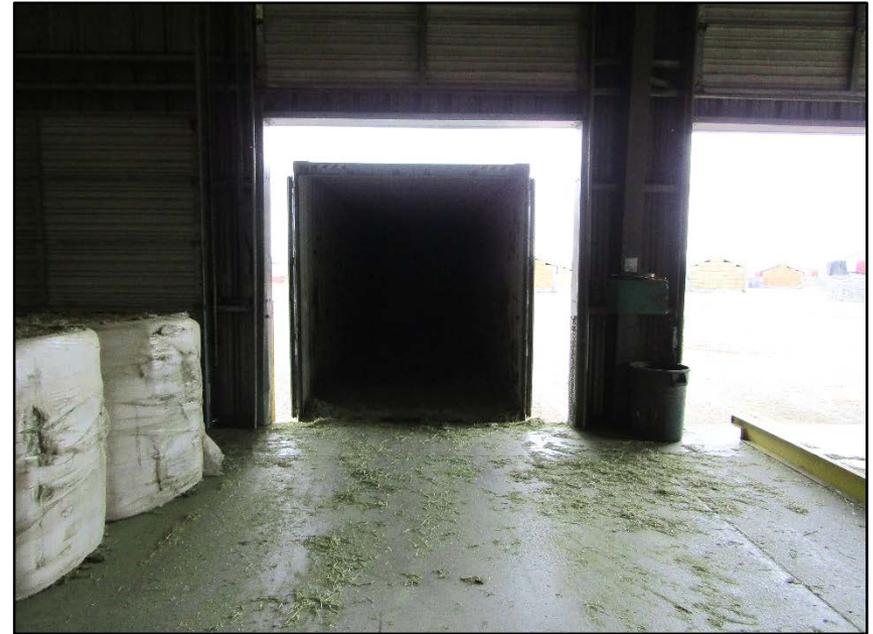
**Photo 3 and 4.** Two views of the freight container at the hay barn loading dock.
