# CONSTRUCTION FATALITY NARRATIVE

#### Roofer Falls 30 Feet from Rain Slick Roof

**REPORT #: 71-203-2021s**

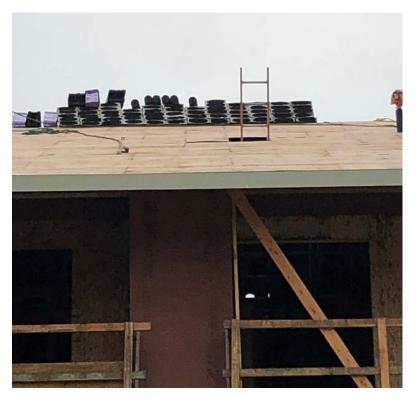
While preparing to install his anchor, he fell and slid about 12 feet down the wet plywood roof deck. As he slid, he grabbed roofing underlayment in an attempt to stop his descent and then fell off the roof edge. As he fell, he struck a steel storage container and landed on the ground 30 feet below. His anchor and hammer were found near him.

**Photo 1.** Roof location from where the roofer fell. He accessed the roof's deck by a ladder from the building's third story. Roofing material is shown near the roof's ridge.

- Before beginning a job, focus on identifying fall protection needs and ensure systems are in place to protect workers. This could include installing multiple anchorages positioned so that workers can safely move about the roof.
- Always use fall protection during roofing operations.

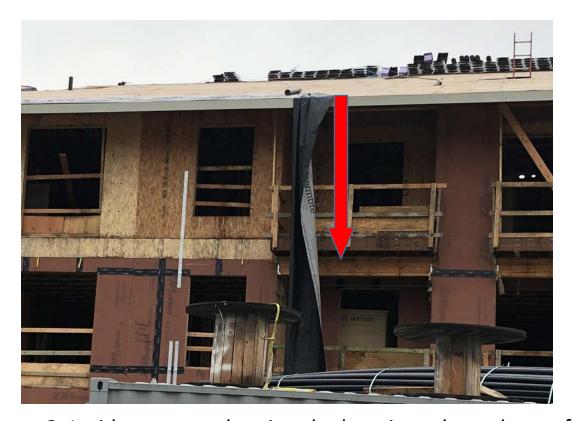
**Photo 2.** Incident scene showing the location where the roofer fell 30 feet from the roof.

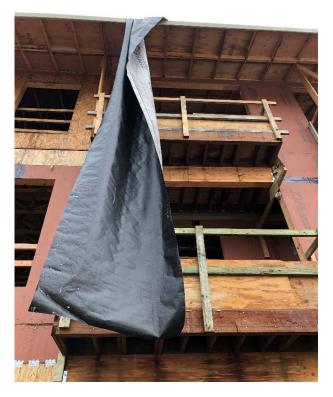
**Photo 3.** Roofing underlayment he attempted to grab on to as he was falling.
