REPORT #:

71-216-2022

Driver Struck by Semi-Truck in Shipper's Parking Lot

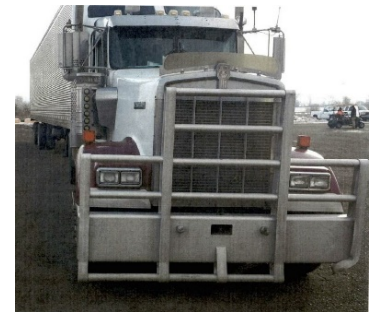
Meanwhile, another truck pulled into the lot's east entrance and turned right toward a row of parking spaces. The second driver was checking his mirrors while aligning his truck with the space he was going to back into and park. As he focused on his parking space, the first driver walked into the path of the moving truck and was struck by its front passenger side bumper area. The truck then backed up, running over the driver again.

Investigators believe that when the second driver turned right toward his parking space, he was looking over his left shoulder, away from where the first driver was walking. He stated that he never saw the injured driver but felt a bump as if he ran over something on the road. The fatally injured driver's employer did not have a formal, written Accident Prevention Program (APP).

Semi-truck that struck driver walking in the shipper's parking lot.

- Consider equipping trucks with tripod fender mirrors and commercially available radar-based turn assist systems that monitor a truck's blind spots and activate audible and visual alerts to warn drivers when pedestrians and other road users are detected inside them during right turns.
- Request shippers and customers to perform site surveys of their parking lots to identify and prevent vehicle struck by hazards. Surveys should assess lot area layout and internal truck routes to provide adequate maneuvering space for trucks to load, unload, and park, and safe passage for pedestrians, including designated crosswalks, visible signage, ample lighting, and safe walkway surfaces.
