## TRUCKING FATALITY NARRATIVE

# Driver Struck by Semi-Truck in Shipper's Parking Lot

**REPORT #: 71-216-2022s**

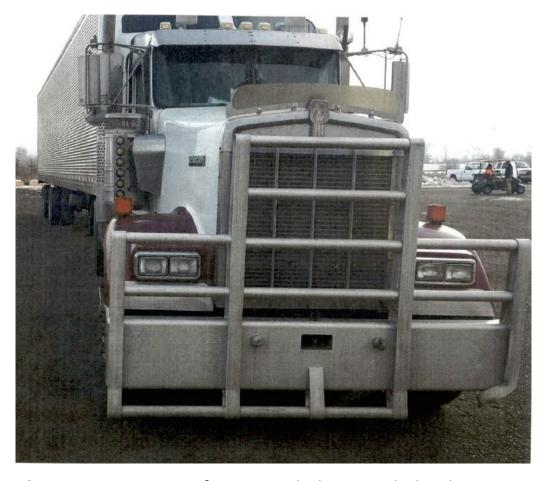
Meanwhile, another truck pulled into the lot's east entrance and turned right toward a row of parking spaces. The second driver was checking his mirrors while aligning his truck with the space he was going to back into and park. As he focused on his parking space, the first driver walked into the path of the moving truck and was struck by its front passenger side bumper area. The truck then backed up, running over the driver again.

**Photo 1**. Front view of semi-truck that struck the driver who was walking in the shipper's parking lot.

Consider equipping trucks with tripod fender mirrors and commercially available radar-based turn assist systems that monitor a truck's blind spots and activate audible and visual alerts to warn drivers when pedestrians and other road users are detected inside them during right turns.

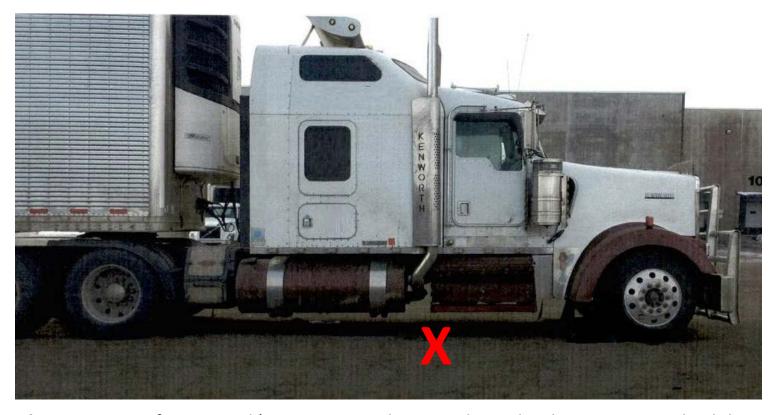
- 1) When the second driver turned right toward his parking space, he was looking over his left shoulder, away from where the first driver was walking. He stated that he never saw the injured driver but felt a bump as if he ran over something on the road.
- The fatally injured driver's employer did not have a formal, written Accident Prevention Program (APP).

**Photo 2**. View of semi-truck's passenger side area where the driver was struck while walking in the shipper's parking lot. Red X shows where the driver was found lying on the ground.

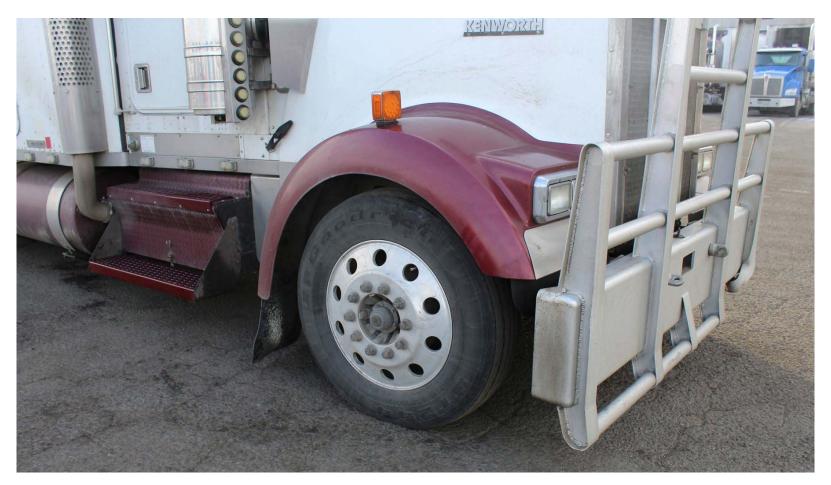
**Photo 3**. View of semi-truck's lower front passenger side area where the driver was struck while walking in the shipper's parking lot.
