Orchard Worker Driving UTV Struck By Car

INCIDENT FACTS

REPORT #: 71-222-2022s

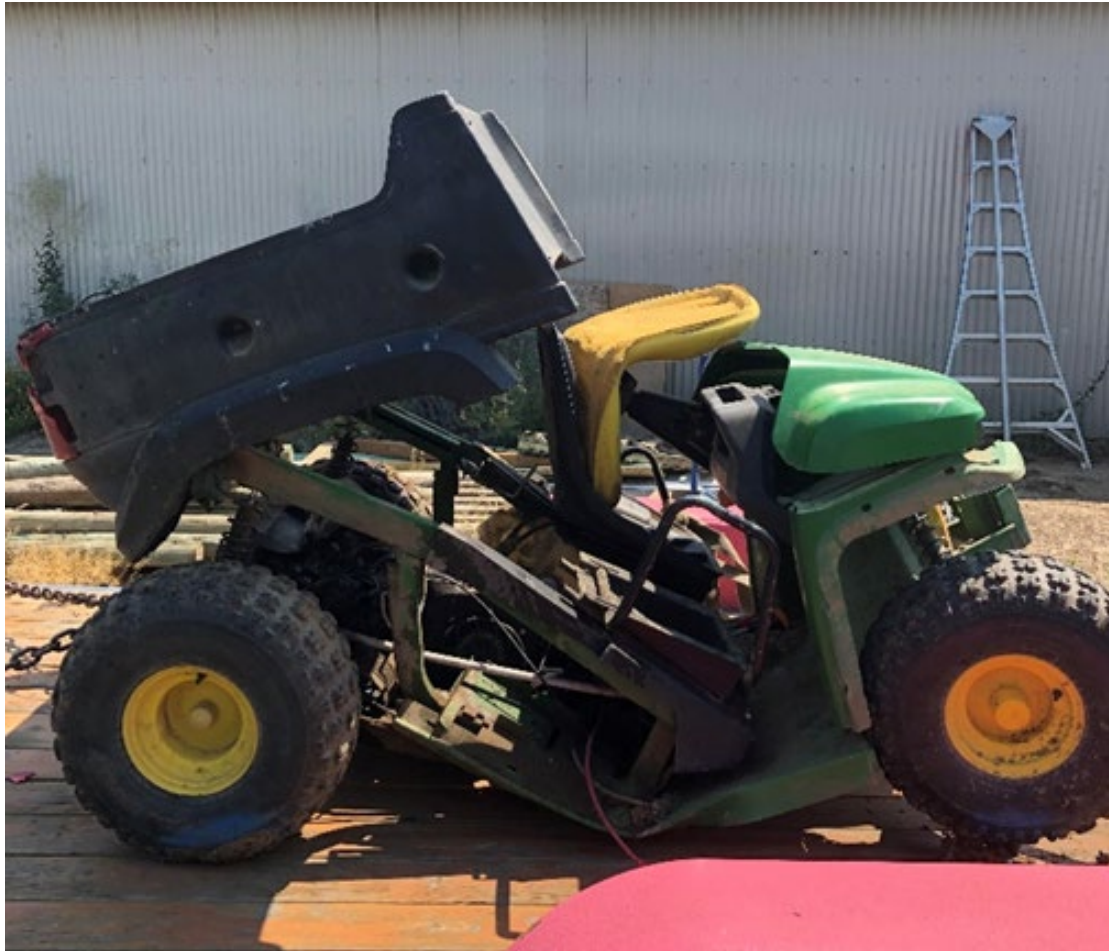
The speed limit was 55 mph, but there were no traffic signs or street lights in the area. It is unknown if the vehicles had their lights on. As the car caught up to the UTV, it struck it from the rear and pushed it 310 feet, nearly the length of a football field, before coming to a stop in an orchard adjacent to the road. First responders pronounced the worker dead at the scene.

Photo 1. Utility Task Vehicle (UTV) with collision damage caused by passenger car.

- Use a utility trailer or road safe/legal vehicle to transport UTV, ATV, and other off-road vehicles to worksites to avoid using public roads when such use is deemed unsafe by vehicle manufacturers and/or restricted by local ordinances.
- As part of their APP, employers should do a job hazard analysis (JHA) of tasks involving farm vehicles and equipment that may pose risks. Workers should be involved in creating the JHA.

- Make sure APP policies and safety training instruct UTV, ATV, and other off-road vehicle operators to follow manufacturer's safety guidelines and local vehicle and traffic rules.
- Develop APP policies that require UTV, ATV, and other off-road vehicle operators to turn on lights and wear DOT-compliant helmets and reflective, high visibility clothing in poor visibility conditions.

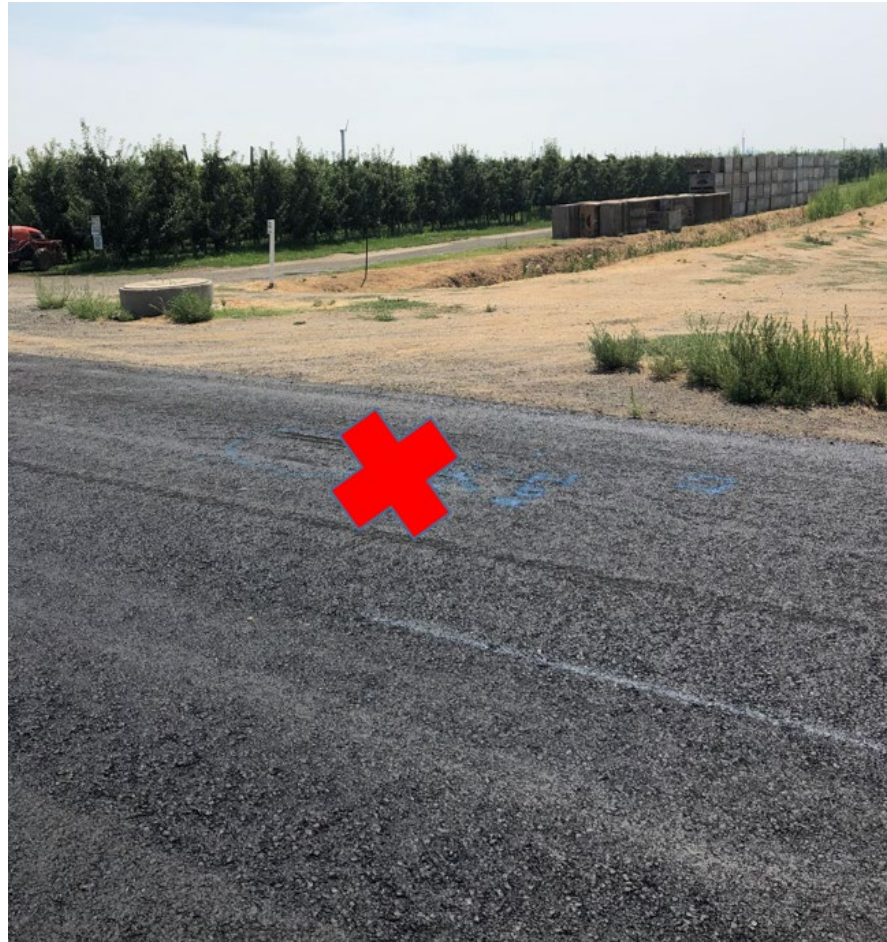
Photo 2. Red X shows where passenger car struck worker's UTV on paved county road.

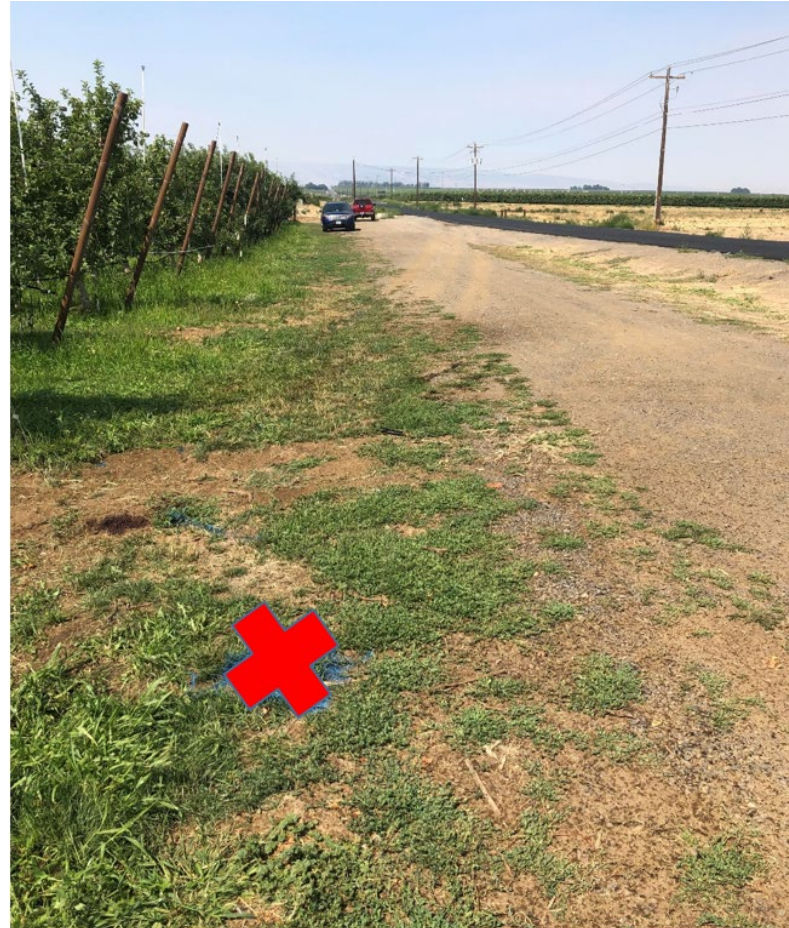
Photo 3. Red x shows where UTV came to a stop after being struck and pushed 310 feet by car.
