71-224-2022

Fall from roof

# Framer Falls 25 Feet from House Roof

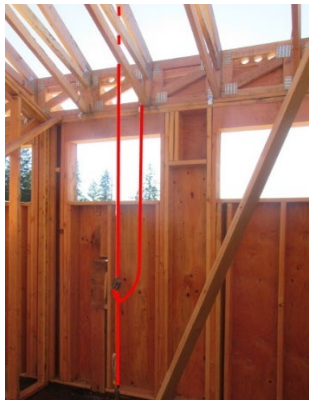
Lifeline that was available to the framer. The roof he fell from is located on the other side of the wall.

- Employers should
  - Conduct pre-shift safety meetings to determine if workers will be doing tasks that put them at risk of falls and reinforce the need for fall protection.
  - Perform unannounced fall protection spot checks to ensure workers maintain 100% tie-off.
  - Effectively enforce their written safety program.
- Workers should use employer provided fall protection.

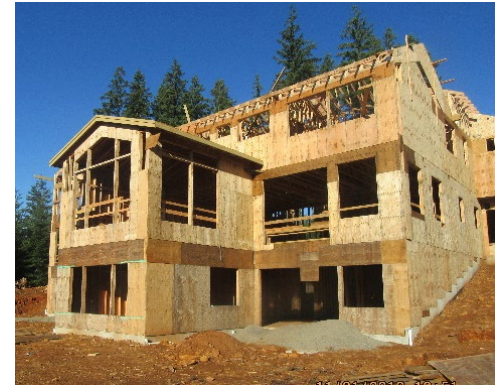
A framer was seriously injured after falling 25 feet from a sheathed low-pitched roof of a house being constructed.

House where framer fell 25 feet from the lower back sheathed roof. He was not using fall protection.
