## Laborer Climbing Scaffold Cross Braces Falls 25 Feet

**REPORT #:** 71-226-2022s

**SCENE:** Worksite of remodeling of a condominium complex

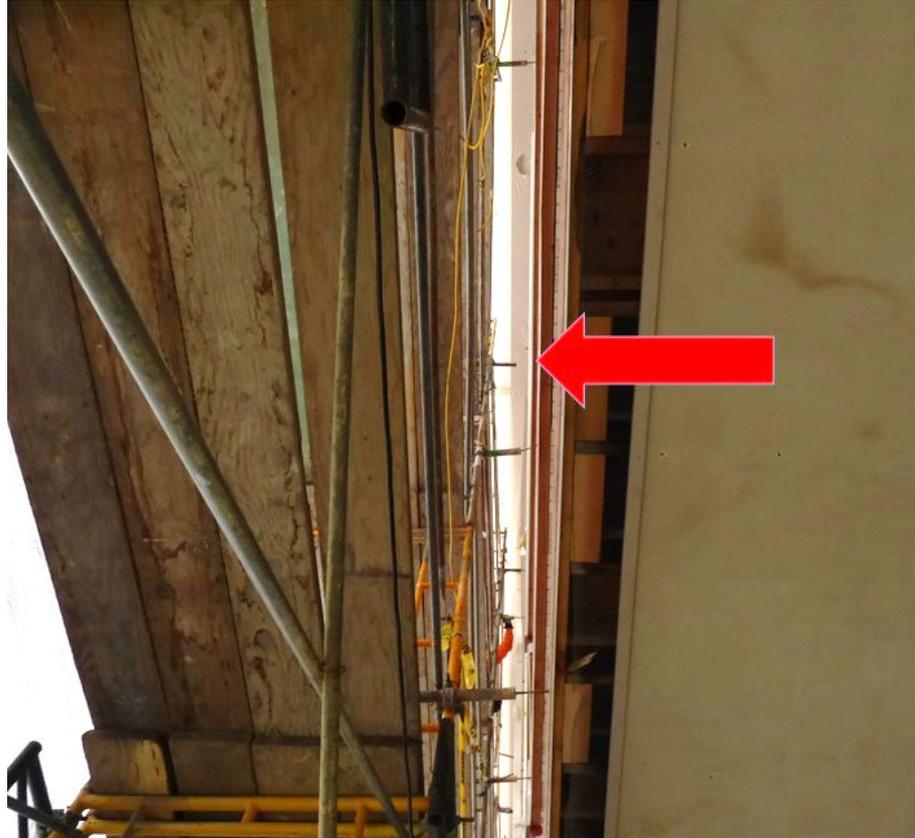
**Photo 2.** View from below the 12 ½-inch gap between the building and the scaffold (indicated by arrow) where the laborer fell through.

- Train workers to never climb on or use scaffold cross braces as a means of access.
- Assess fall hazards and the need for personal fall protection, even when it is not required.
- Add scaffold side brackets and planks just below each level of decks to prevent workers from accessing or falling through the gap between building and scaffold.
- Provide one dedicated access point to each deck from the scaffold.

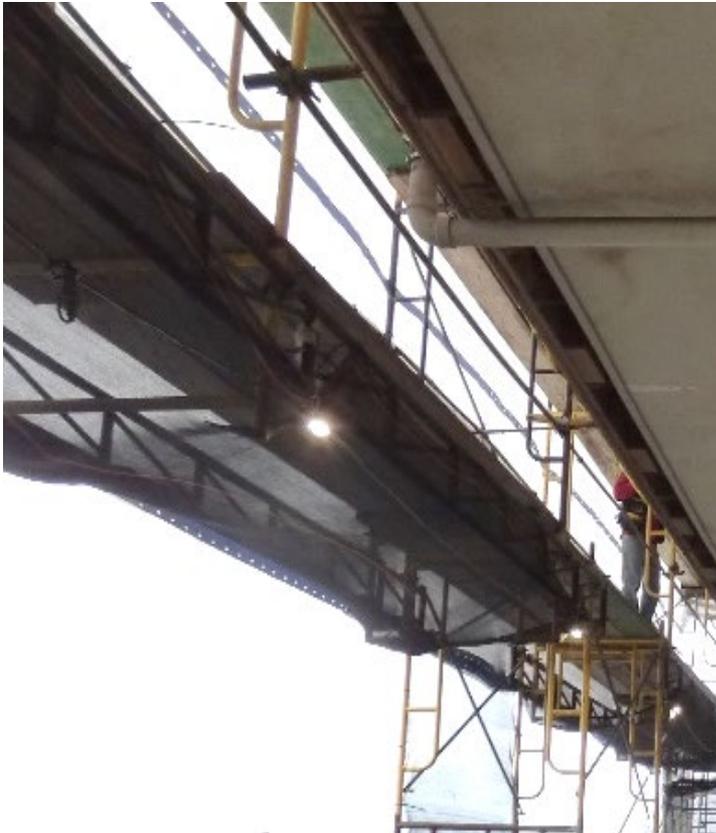
**Photo 3.** View from ground level showing cross braces and position in relation to the building.

- Make sure cross braces are not used as a means of access.  
See [WAC 296-874-20020\(2\)](#)
- Enforce the fall protection requirements for scaffolds.  
See [WAC 296-880-30030](#)
- Develop a formal accident-prevention program tailored to the needs of the particular plant or operation and to the type of hazard involved. See [WAC 296-155-110\(2\)](#)
- Train employees who work on a scaffold.  
See [WAC 296-874-20072](#)

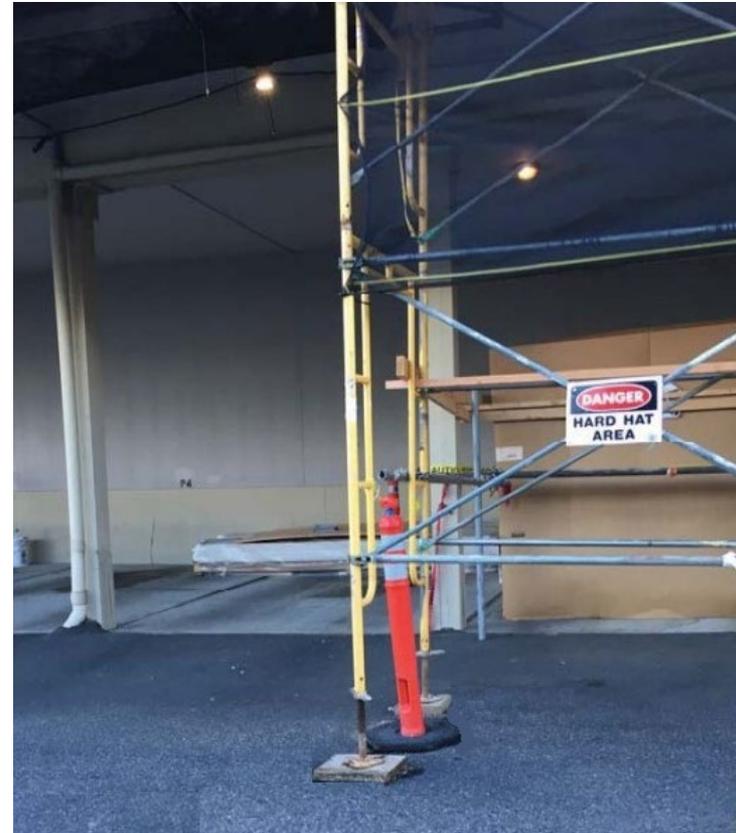
**Photo 4.** Location where the laborer landed after falling 25 feet from the scaffold cross braces.

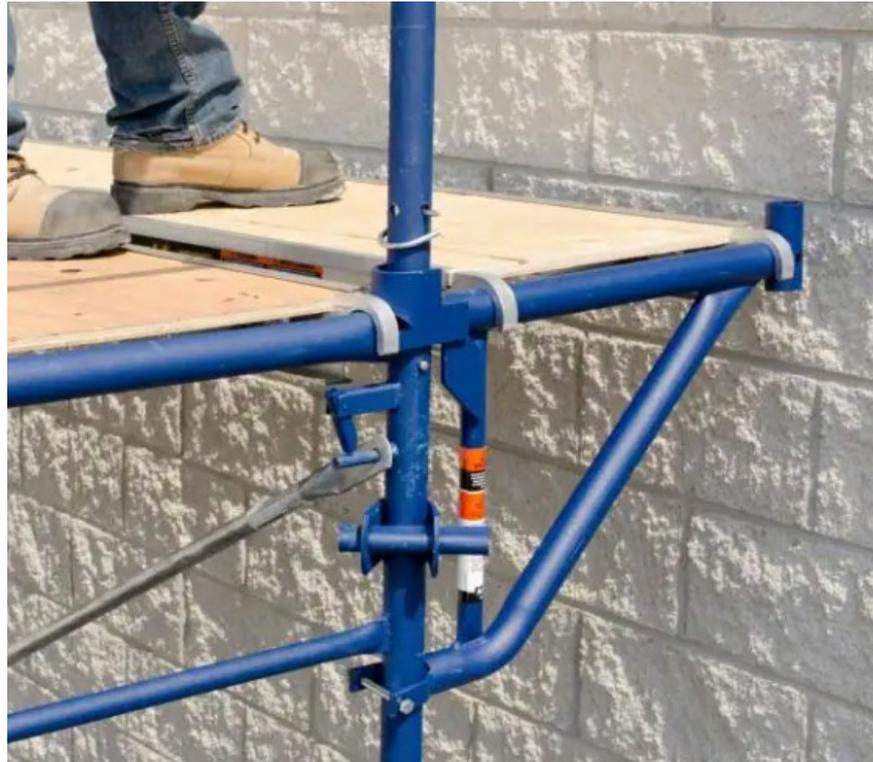
**Photo 5.** Scaffold side bracket with 19-inch wide scaffold platform (walk board). Photo courtesy of Metaltech.
