Maintenance Coordinator Dies After Falling from Ladder

REPORT #: 71-239-2023s

REPORT DATE: May 22, 2023

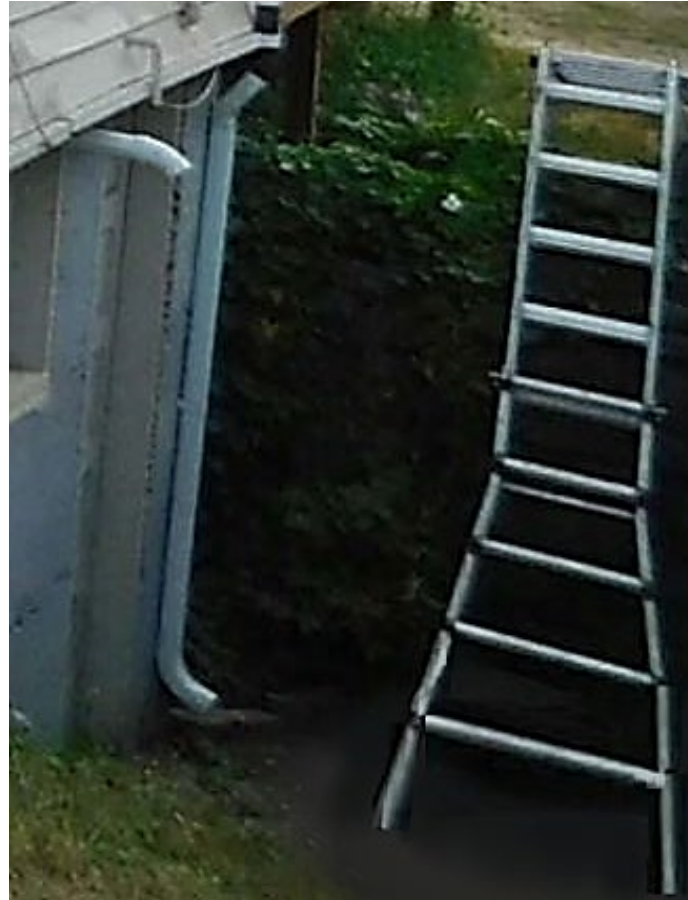
The homeowner had arrived around 1 p.m., talked briefly with the worker, and went inside to sleep. No one else saw the worker until 7 p.m., when a home appraiser found him badly injured lying on his back. He fell onto rocks and concrete at the base of an 18-foot fully extended, portable, metal articulated or multi-positional ladder. The ladder's bottom half was leaning on a 6-foot below-grade rock retaining wall near the basement entrance. The top half was resting horizontally on the ground level grass surface.

Photo 1: Bottom half of ladder against retaining wall. The worker was found on his back at the base after falling from the ladder.

- Place the ladder either: (a) With a secure footing on a firm, level support surface; or (b) Secure the ladder to prevent accidental displacement. [WAC 296-876-40015\(1\)](#)
- Train employees to recognize ladder hazards and the procedures to minimize these hazards. [WAC 26-876-15005\(1\)](#)
- Develop and implement a formal, written accident prevention program (APP) with a safety orientation that includes: (g) An on-the-job review of the practices necessary to perform the initial job assignments in a safe manner. [WAC 296-155-110\(3\)\(g\)](#)

- Ensure workers use ladders according to manufacturer's safety guidelines and warnings and maintain a 3-point contact, staying near the middle of the ladder, and facing it when climbing.
- Provide training to workers in each type of ladder they will use, including how to properly inspect, set up, secure, climb, relocate, transport, maintain, and store the ladder.
- Supervise lone workers to ensure safety by visiting work sites and requiring phone check-ins.

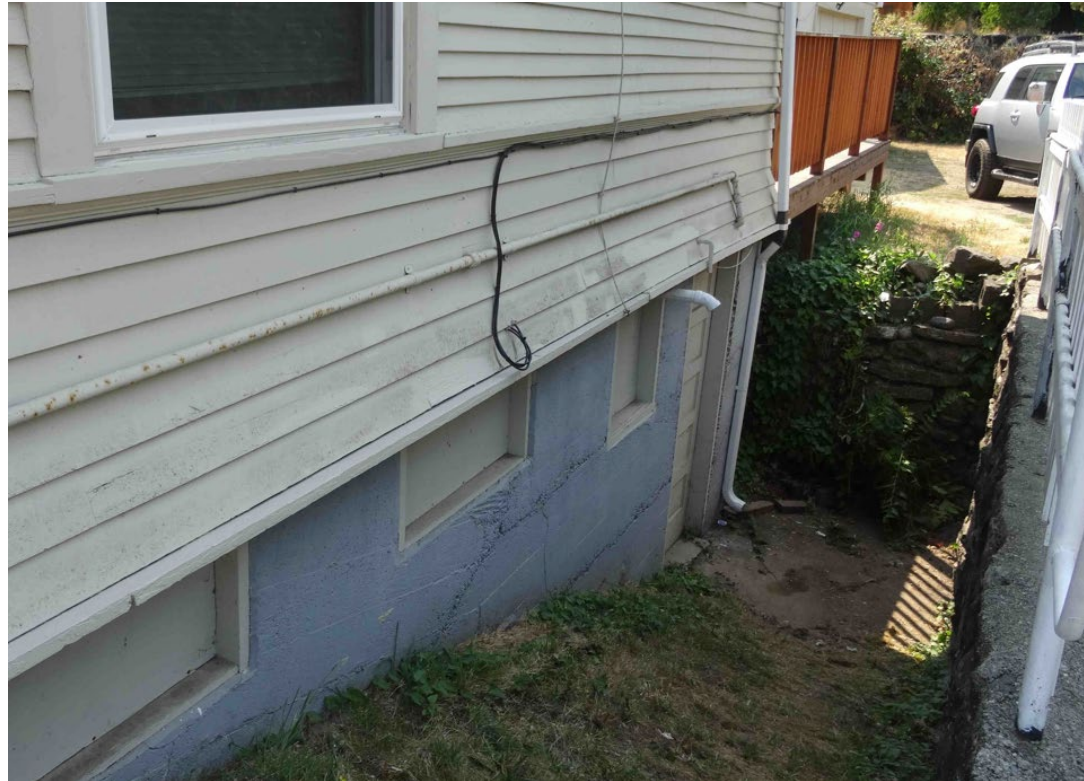
Photo 2: Below-grade 6-foot rock retaining wall and basement entrance. The ladder appeared to be used for climbing between the two levels of ground.

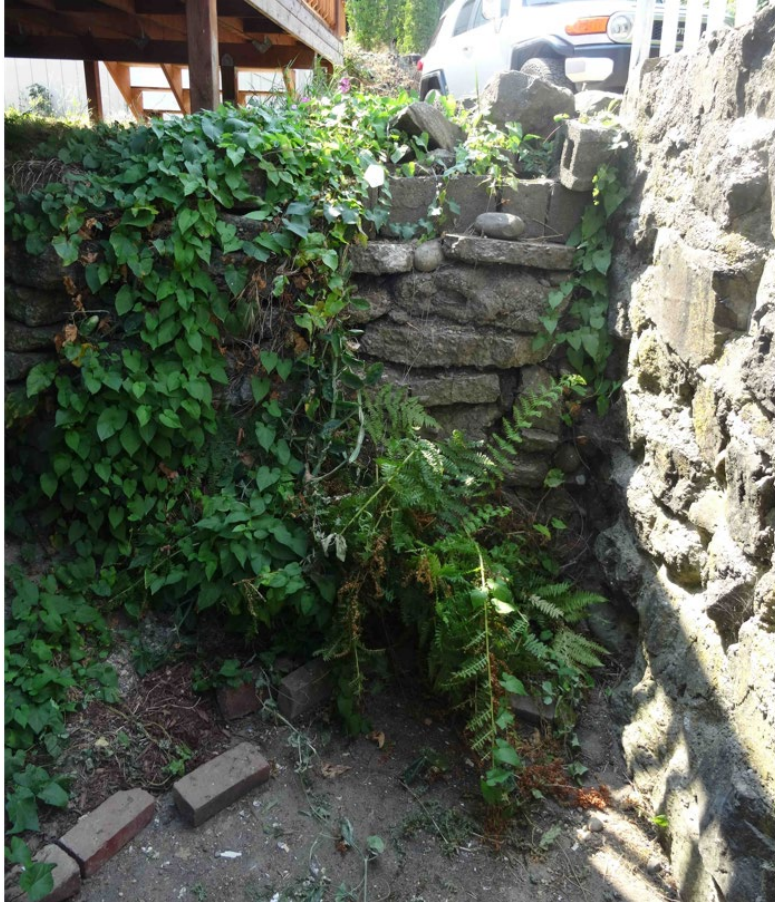
Photo 3: Rock retaining wall the ladder was leaning on.

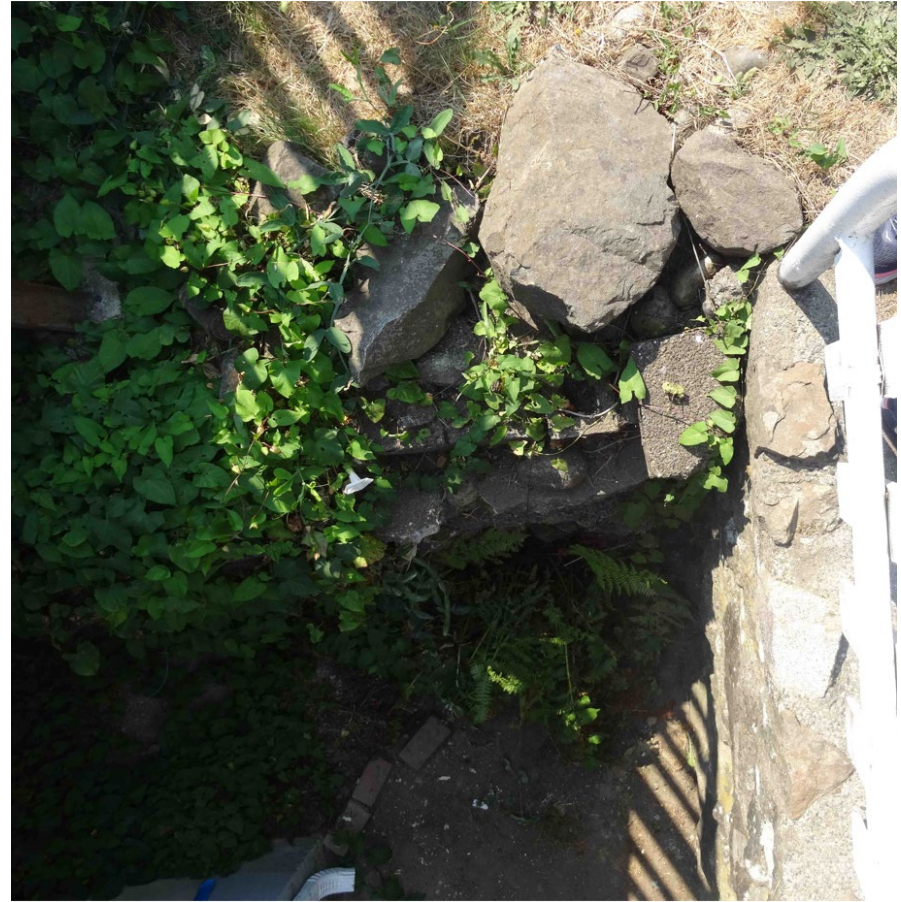
Photo 4: Loose rocks at top of retaining wall.

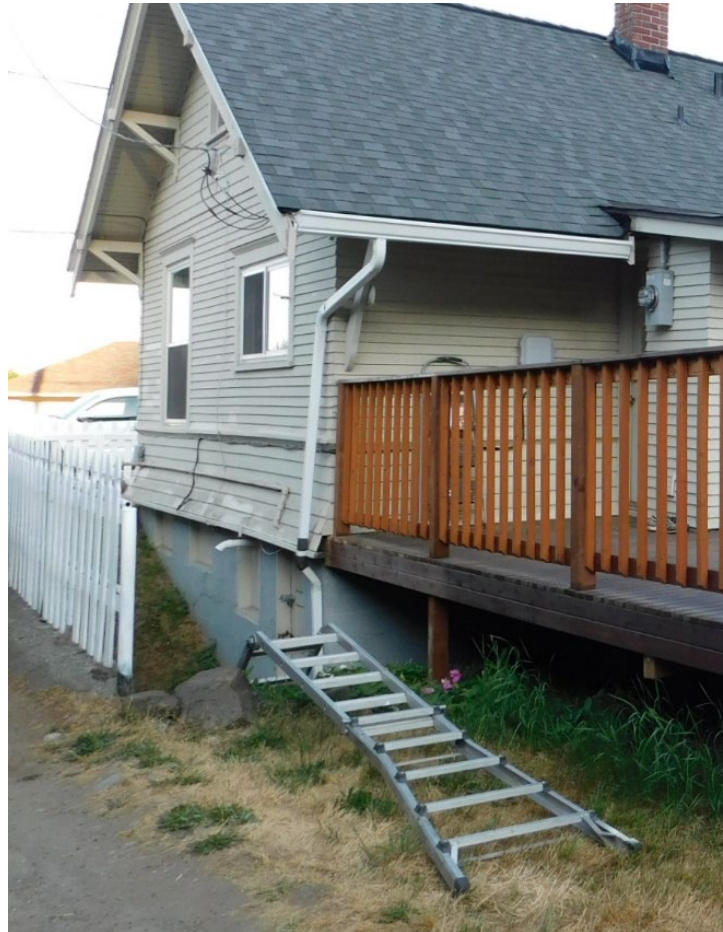
- The employer did not ensure the ladder was secured from accidental displacement.
- The ladder was not in the self-supporting position with hinges locked, which created unstable work conditions that exposed the worker to a fall of around six feet.
- The employer did not provide documented ladder safety training and an on-site safety orientation as part of their accident prevention program (APP).
- The employer stated the ladder did not belong to them.

Photo 5: Unsecured top half of ladder folded over the retaining wall and resting on the grass surface.

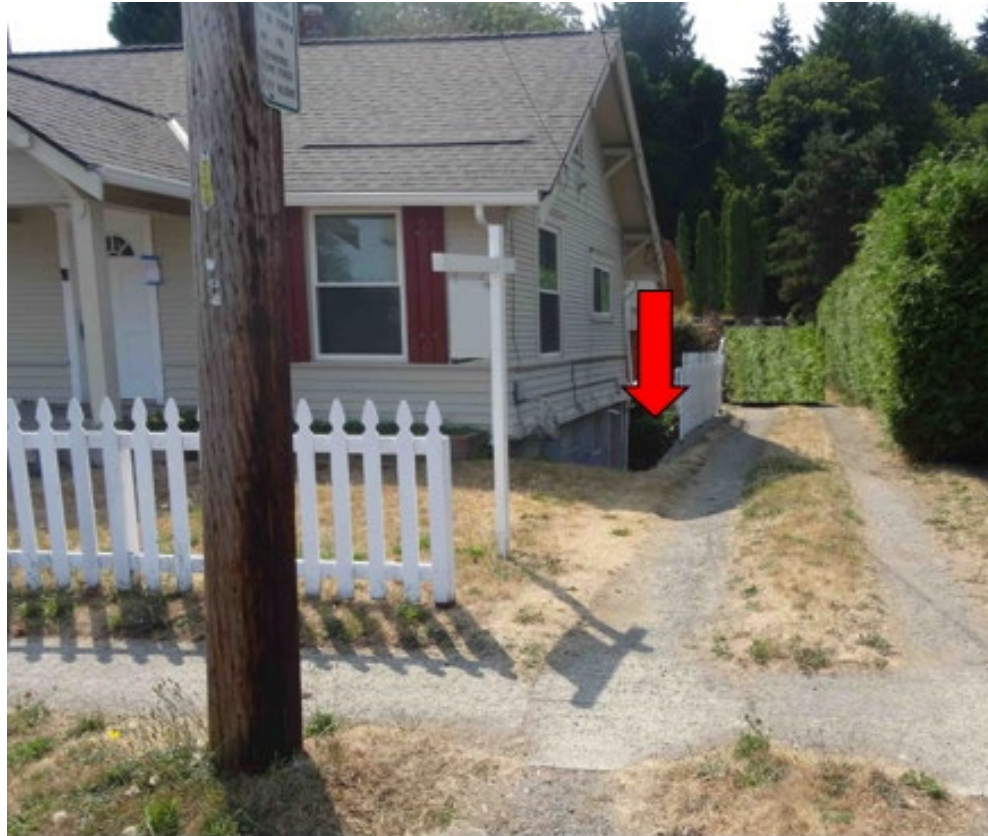
Photo 6: View of incident scene from road. Arrow points to basement entrance area where the lone worker fell from the ladder.
