Foreman Falls 17 Feet from Leading Edge of Roof Deck

REPORT #: 71-244-2023s

EVENT TYPE: Fall from leading edge

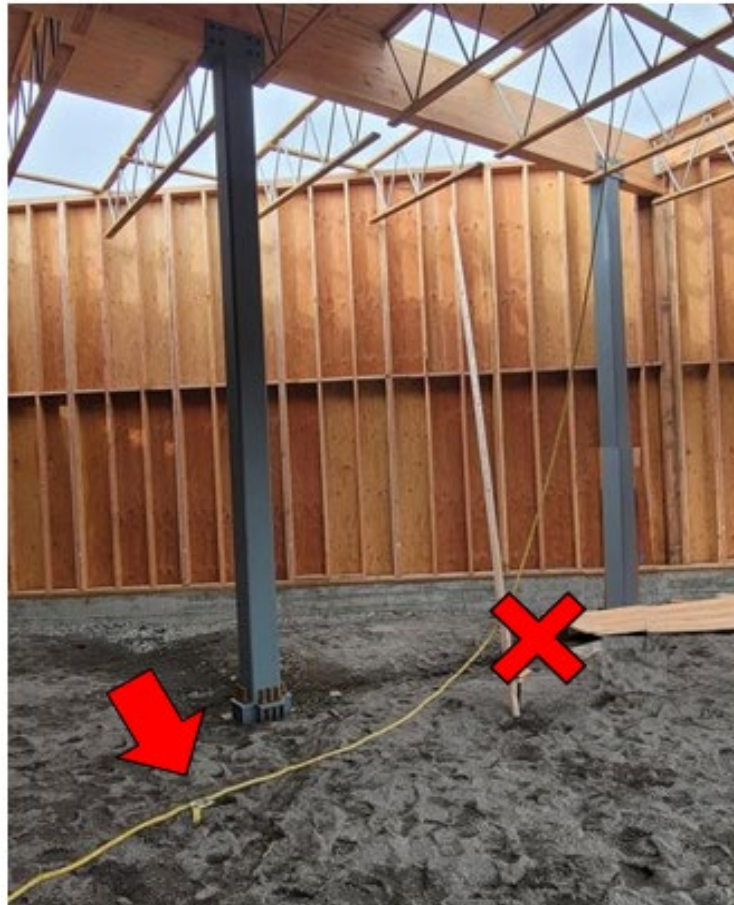
- The worker's PFAS was in excess of 50 feet for a 17-foot fall. An unnecessary second shock-absorbing lanyard was connected to the anchorage. His chest strap was not connected and the leg straps were loose. If the worker had the correct fall distance needed for his PFAS to engage and arrest his fall, it is likely his body still would have slipped out of the harness.

Photo 1. Lifeline with rope grab stretched to show length from where worker fell (X) near plywood sheet.

- Discuss fall protection policies at crew meetings, monthly safety meetings, and annual stand-downs.
- Provide recurring hands-on fall protection training and evaluations of workers' ability to use it correctly.

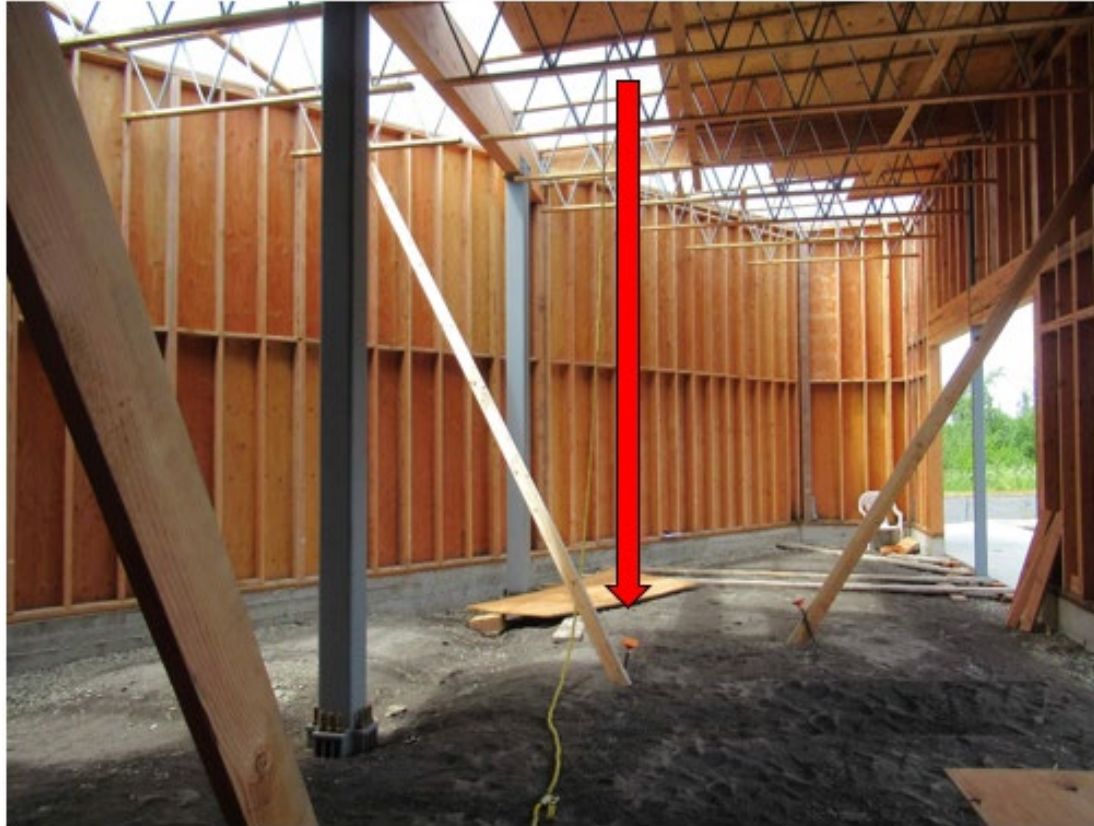
The foreman was laying plywood sheets onto trusses that had brackets on each receiving end where the sheets would be set. He was using his heel to kick the sheets into the brackets. When he tried moving a sheet with his feet, it gave way and dropped under his weight. He fell 17 feet to the ground inside the building with the sheet landing beside him.

Photo 2. Wider view of building interior where worker landed after falling from leading edge of roof deck above. Arrow shows direction of fall.

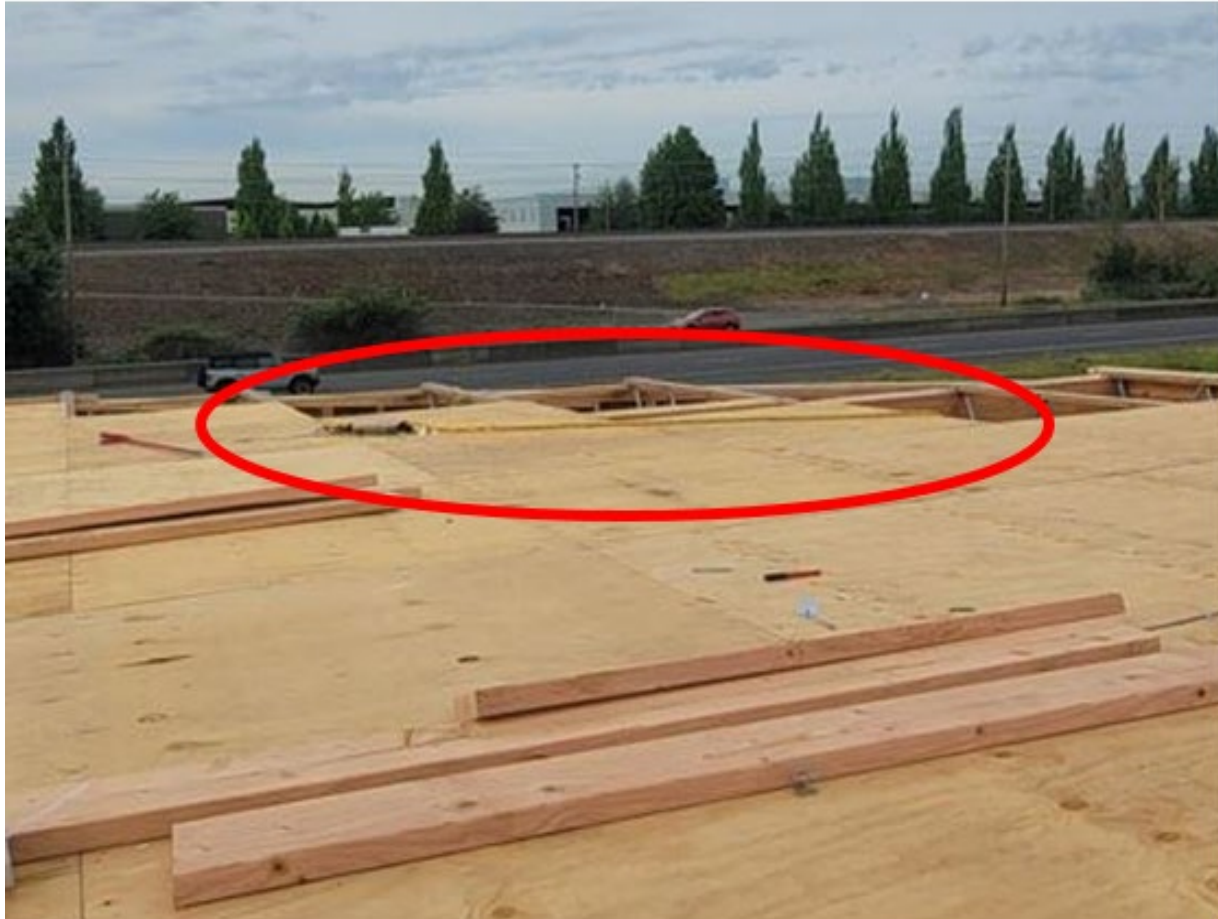
Photo 3. Fall protection anchor, shock-absorbing lanyard, and lifeline near roof deck leading edge where worker fell.
