# FATALITY NARRATIVE

## Pipelayer Dies when Trench Wall Collapses

**Industry:** Site Preparation Contractors  
**Task:** Replacing residential sewer line  
**Occupation:** Pipelayer  
**Type of Incident:** Trench collapse

**Incident Date:** January 26, 2016  
**Release Date:** March 13, 2017  
**SHARP Report No.:** 71-156-2017

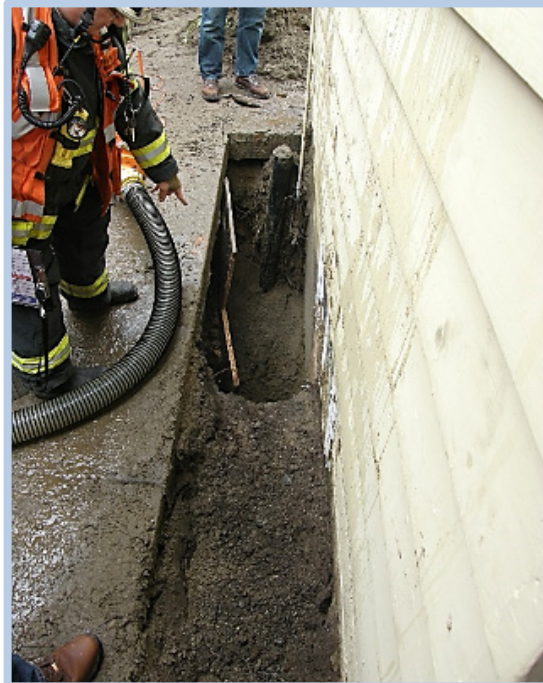
In January 2016, a 36-year-old pipelayer died when the wall of the trench he was working in collapsed and buried him. The incident happened at a residential job site where the employer, the victim, and another worker were replacing a sewer line. The employer runs a small business that does sewer and drainage installation and repair work. The crew had been working at the job site for a week. There had been over three inches of rain during this time. Several trenches were dug in soil to allow workers to remove old pipes and install new pipes. The soil was unstable wet, loamy sand, classified as "Type C" soil. On the day of the incident, the crew was nearly finished with the project. The victim entered a trench to finish work on the sewer line connection to the house. The trench was 21 inches wide by 60 inches long and 7 feet deep. It was alongside a house foundation with a cement walkway on the other side. There was no protective system in the trench (though there was a hydraulic shoring cylinder near the bottom on one side). At 10:30 a.m., a wall of the trench collapsed, burying the victim. The coworker contacted emergency

The collapsed trench after the victim's body was recovered.

services and then attempted to dig out the collapsed trench. Fire department emergency response team personnel arrived on the scene within a few minutes. The rescue attempt soon changed to a recovery effort. The victim was declared dead at the scene. He died of compressional asphyxia.

- Protect each employee from cave-ins by an adequate protective system. See [WAC 296-155-657\(1\)\(a\)](#)
- A competent person must inspect the excavation, adjacent areas, and protective systems each day before the start of work, as needed throughout the shift, and after every rainstorm. See [WAC 296-155-655\(11\)\(a\)](#)
- The competent person must remove workers from the excavation upon any evidence of a situation that could cause a cave-in, such as accumulation of water in the trench or protective system problems. See [WAC 296-155-655\(11\)\(b\)](#)

- Do not enter an unprotected or inadequately protected trench or excavation, even for a short period.
- Before entering a protected trench or excavation, inspect it to ensure that it is safe to enter.
- Exit the trench or excavation and contact the competent person if you see that it unsafe.
