Electrician Falls from Ladder or Awning*

Industry: Plumbing, heating, and air-conditioning contractors
Task: Connecting electrical conduit to install a heat pump
Occupation: Journeyman electrician
Type of Incident: Fall

Release Date: March 6, 2012
Incident Date: October 21, 2009
Case No.: 09WA04901
SHARP Report No.: 71-107-2011

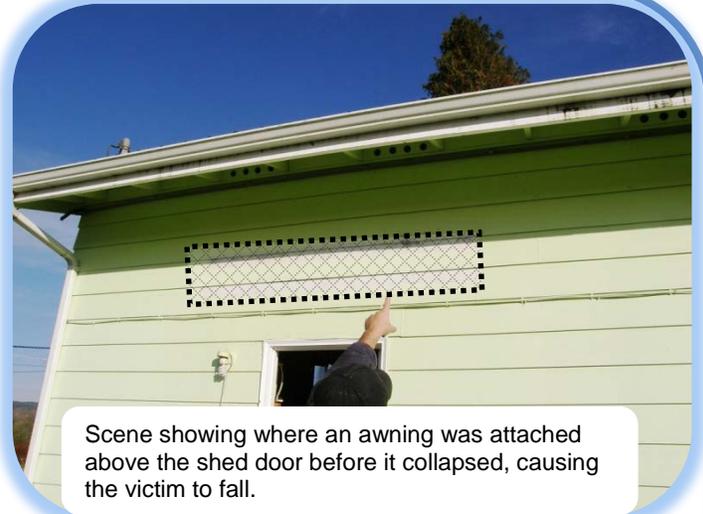
On October 21, 2009, an electrician suffered fatal injuries when he fell while installing electrical conduit. The journeyman electrician, 70, worked for three years for a plumbing, heating, and air-conditioning contractor. The victim and a company foreman were installing a heat pump as part of a heating and air conditioning system for a residence. The victim's task was to make an electrical conduit connection under the eaves of a shed attached to the house. The conduit connection was between the eaves and a small wooden awning attached above the shed door. There were no witnesses, but there are two likely scenarios. The victim may have placed a ladder against the house to the right of the awning and climbed onto the awning to connect the conduit. This may have collapsed the awning, dropping the victim to the ground where he hit his head on the concrete porch below. The second possibility is that the victim placed the ladder directly against the awning. His weight on the ladder may have caused the awning to collapse, again, sending the victim to the ground. A 24-foot extension ladder and an 8-foot folding step ladder were found on the ground; it is not known which was used. The victim was taken to a hospital and died six days later from head injuries.

Scene showing where an awning was attached above the shed door before it collapsed, causing the victim to fall.

- Train employees to recognize ladder hazards and procedures to minimize hazards. See WAC 296-876-15005.
- Ensure that the top support of the ladder is reasonably able to support the weight of the ladder and the person using it. See WAC 296-876-40015.
- Determine whether the surfaces on which an employee will be working will support the employee. See WAC 296-155-505.
- Ensure employees do not work from the top cap or top step of stepladder. See WAC 296-876-40050.

- Employees should be trained to inspect work surfaces and only be allowed to work on surfaces that have the strength and integrity to support them and their equipment safely.
- Employers should consider alternate and safer means of working at height other than a ladder, such as a scaffold or elevating work platform.
