Shepherd Dies When ATV Struck by Motor Vehicle*

Case No.: 13WA002

SHARP Report No.: 71-125-2013

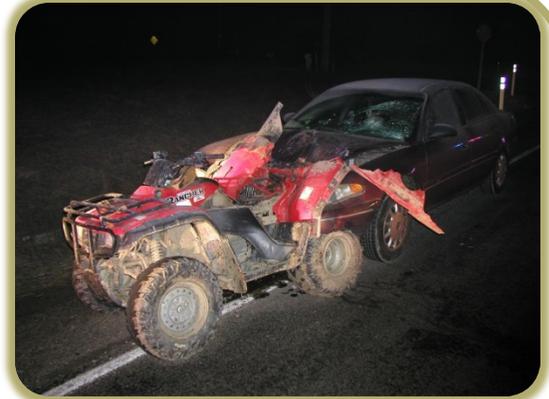
On January 11, 2013, a 32-year-old shepherd was operating an all-terrain vehicle (ATV) on a roadway when he was struck from behind by a motor vehicle. The victim was an experienced shepherd with a work visa allowing him to work temporarily in the U.S. He had been in the U.S. for 10 months and spoke only Spanish. Shortly after 5 pm he was traveling on a rural state highway for about 1½ miles from a sheep grazing site to a temporary camp where he lived. It was dark, the weather was fair, and the road was bare and dry. The speed limit was 55 mph on the straight, two-lane state highway. A passenger motor vehicle approached the ATV from behind and struck it, ejecting the victim. He was not wearing a seat belt or a helmet. The victim was taken to a hospital, where he died a short time later. The driver of the passenger vehicle reported to the State Patrol that he did not see tail or brake lights operating on the ATV. The driver was not cited for any traffic violation. The ATV's operator manual stated "never operate this ATV on any public street, road, or highway." Neither drugs nor alcohol were incident factors.

- Ensure that employees do not operate all-terrain vehicles on public roadways where they are exposed to the hazard of being struck by another vehicle. The victim was operating the ATV on a state highway with the posted speed limit of 55 mph, which is not permitted in Washington.
- Follow manufacturer's instructions and warnings for safe operation of ATVs.
- Employees should report damaged or inoperative vehicle lights so that they can be repaired.
- Always wear a DOT-compliant helmet, goggles, boots, long pants, long-sleeved shirt, and gloves.
