FATALITY NARRATIVE

Carpenter Falls from Ladder

Industry: New Single-Family Housing Construction
Task: Framing a patio rafter
Occupation: Carpenter
Type of Incident: Fall from ladder

Incident Date: August 11, 2014
Release Date: January 7, 2015
SHARP Report No.: 71-134-2015
Case No.: 14WA04201

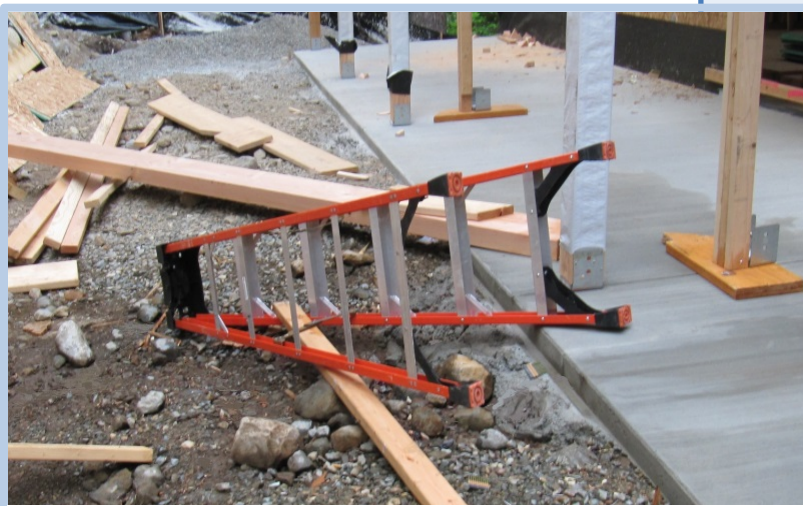
Incident scene showing the stepladder from which a carpenter fell and hit his head on the concrete patio. The ladder had been properly set up and placed on the patio.

determined that it was likely that he fell from the stepladder. When he fell from the ladder he struck his head on the concrete patio. He died at the scene. The investigators found that both ladders were set up properly and that they had no defects.

- Train employees to recognize ladder hazards and the procedures to minimize these hazards.
See WAC 296-876-150.
- Do not stand or step on the top cap and top step of a stepladder.
See WAC 296-876-40050.
- Identify potential hazards by performing a site walk-around safety inspection.
See [WAC 296-155-110\(9\)](http://WAC 296-155-110(9)).

- Consider using safer methods of working at elevation other than standing on a ladder, such as a scaffold or an aerial work platform (scissor or boom lift). Using a scaffold or platform with guardrails greatly reduces the possibility of falls.
- When choosing a ladder for a specific task, make sure it is the correct type of ladder for that task.
