## Carpenter Falls from Ladder

**Industry:** New Single-Family Housing Construction

**Type of Incident:** Fall from Ladder

# ***FATALITY NARRATIVE***

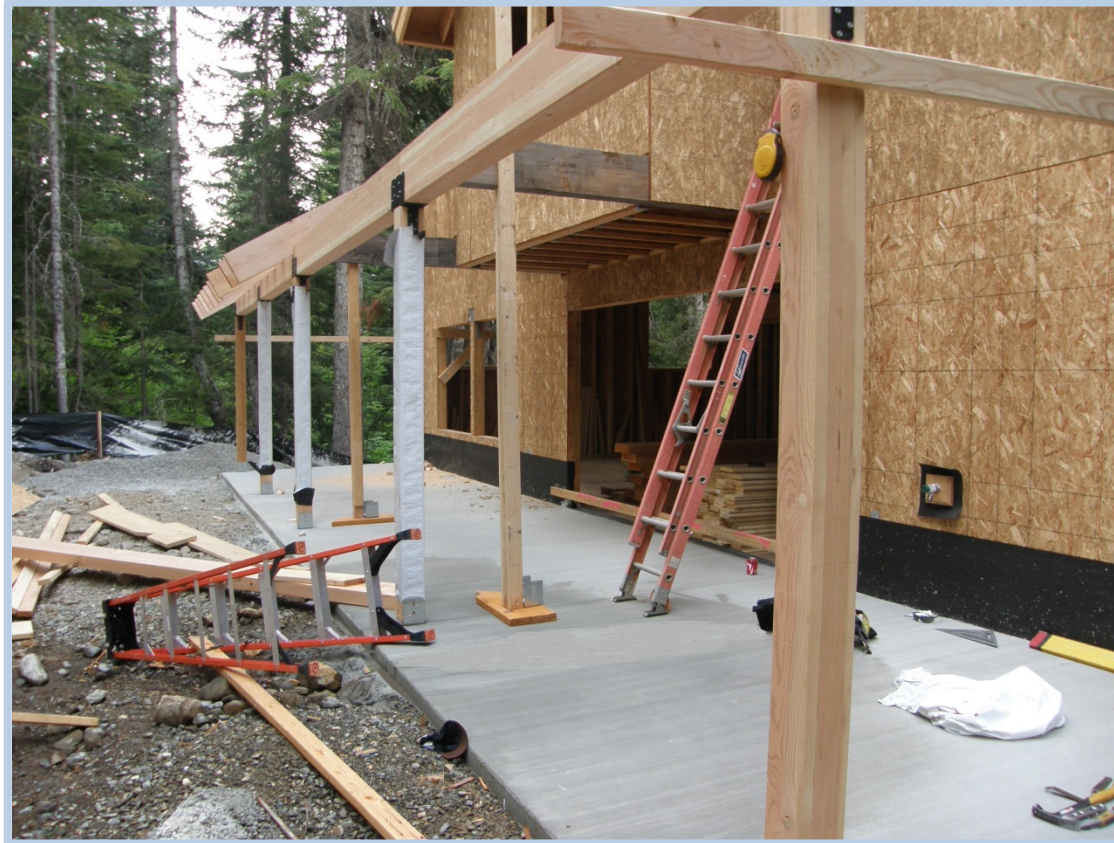
Incident scene showing the stepladder from which the carpenter fell and hit his head on the concrete patio. The stepladder had been properly set up and placed on the patio. He had been taking measurements before making saw cuts in order to install the next set of patio roof rafters.

- Train employees to recognize ladder hazards and the procedures to minimize these hazards.  
See [WAC 296-876-150](#).
- Do not stand or step on the top cap and top step of a stepladder.  
See [WAC 296-876-40050](#).
- Identify potential hazards by performing a site walk-around safety inspection.  
See [WAC 296-155-110\(9\)](#).

- Consider using safer methods of working at elevation other than standing on a ladder, such as a scaffold or an aerial work platform (scissor or boom lift). Using a scaffold or platform with guardrails greatly reduces the possibility of falls.
- When choosing a ladder for a specific task, make sure it is the correct type of ladder for that task.

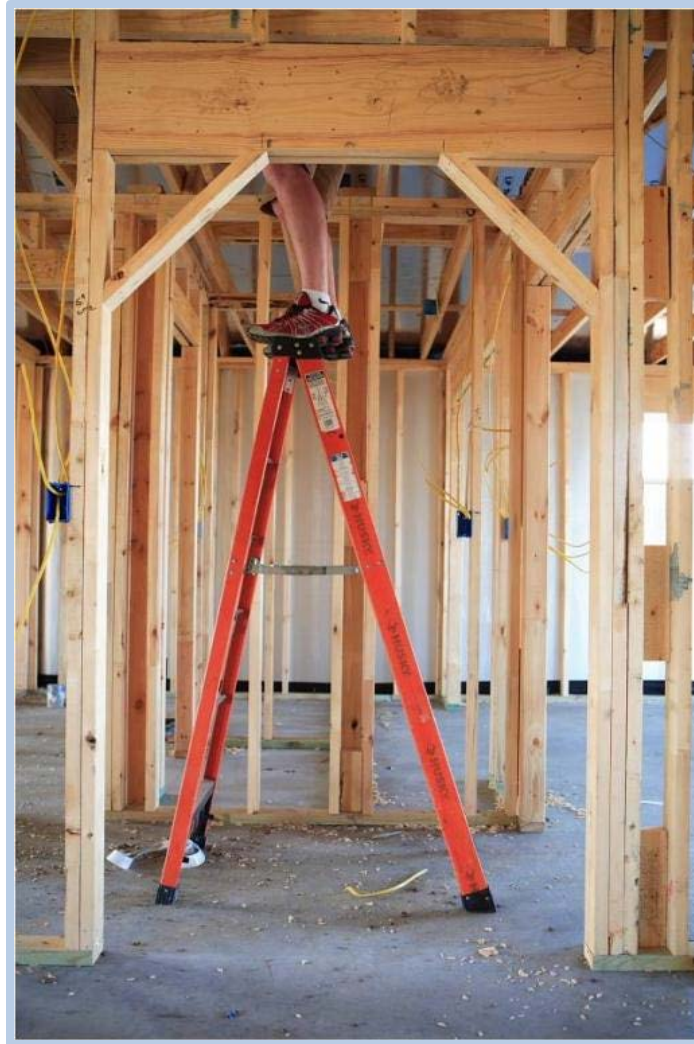
Inappropriate use of a stepladder. Never stand or step on the top cap and top step of a stepladder.
