INJURY NARRATIVE

Dairy Worker Injured When Clothes Are Caught in Straw Spreader

Incident Date: December 13, 2016
Release Date: August 22, 2017
SHARP Report No.: 71-161-2017

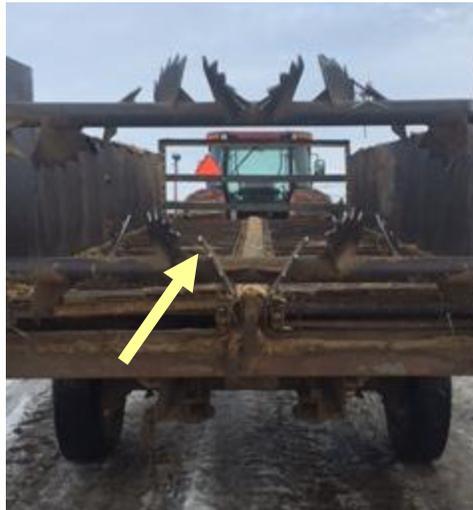
In December 2016, a worker at a dairy farm was severely injured when his clothing was caught in the rotating beater bars of a straw spreader that he was greasing. The worker had been employed at the dairy for 7 months, and had worked in the industry for about 4 years. On the day of the incident, he was working to grease the bearings on a hydraulic straw spreader attached to a tractor. This task was performed by farm employees as needed, up to twice a week. The worker told investigators that the farm mechanic had trained him to grease the straw spreader while it was running so that grease would go into the bearings. The employer's accident prevention program included information about lockout/tagout procedures, but not specifically for the straw spreader. The worker said that he had never received training in lockout/tagout procedures. When the worker had finished greasing the bearings on one part of the spreader, he started to duck under the rotating beater bars to get to the next set of bearings underneath the machine. As he bent down, the metal teeth caught hold of his loose hooded sweatshirt and pulled his head and neck into the beaters. The straw spreader had a mechanism to shut off automatically when jammed, but when the beater bars stopped rotating, he

Photo of straw spreader bars. Arrow indicates where worker's clothing was entangled in rotating beater bar.

remained entangled in the machine and lost consciousness. Another employee found the injured worker caught in the teeth and shut off the power to the straw spreader. The co-worker and a supervisor were able to cut him loose and call emergency services. He underwent surgery for fractures to his neck and skull. After more than six months, he had still not been able to return to work due to the extent of his injuries.

- Employers must develop, document, and use procedures to control potentially hazardous energy. [See WAC 296-307-32013\(1\)](#)
- Employers must provide training to ensure that employees understand the purpose and function of the energy control program. [See WAC 296-307-32019](#)
- Employees must receive training in the recognition of applicable hazardous energy sources, the type and magnitude of the energy available in the workplace, and the methods and means necessary for energy isolation and control. [See WAC 296-307-32019\(1\)](#)

- Always follow lockout/tagout procedures during machine maintenance and repair. Wait until moving parts come to a complete stop before servicing equipment.
- Employers should do spot-checks to ensure that new employees are receiving proper safety training.
- Never wear loose fitting clothing around rotating or moving machine parts.
