Fatality Narrative

Laborer Electrocuted When Truck Mounted Boom Contacts Overhead Power Line^{*}

Case No.: 06WA01801

SHARP Report No.: 71-52-2006

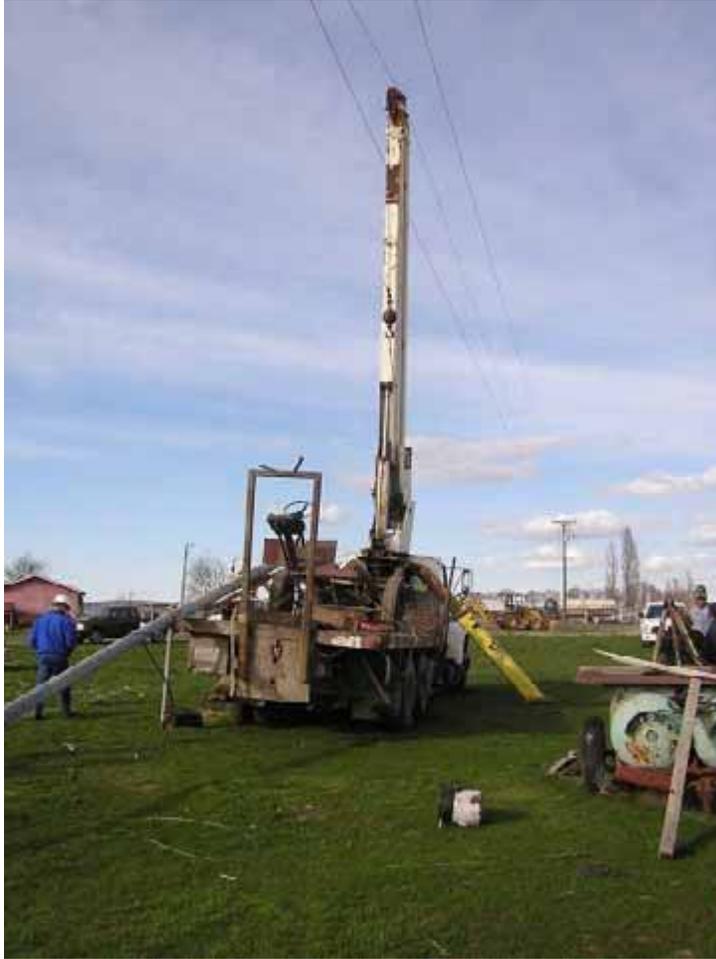
On March 24, 2006, a construction laborer was electrocuted when a truck-mounted boom contacted an overhead power line. The 18-year-old victim had worked with his present employer for two months. Three employees, including the victim, were using a truck-mounted boom to load a 30-foot long section of irrigation pipe on to a truck bed. The pipe was to be used in a pivot irrigation system. The pipe had been lifted by the boom and set on the truck bed, and the boom replaced in the cradle. The victim was standing on the ground near the front of the truck bed strapping down the pipe. The base of the pipe pushed down the boom control located behind the truck cab, causing the boom to raise straight up. The boom contacted the energized outside phase of a three-phase 7620 volt overhead power line. The electric current traveled through the boom to the truck and to the victim, who died at the scene. The two other workers received electric shock injuries.

Photo: The crane and site after the incident, showing the boom arm in contact with the high-voltage line.

- ! When the boom is cradled for transport, make sure that the clutch is disengaged to render the boom controls inoperative.
- ! Evaluate the job site for potential electrical hazards. In this incident the truck was placed directly under an energized overhead power line, exposing workers to an electrocution hazard.
- ! Train employees to recognize overhead electrical hazards.
- ! Maintain a minimum of 10 feet distance from power lines.
- Consider guarding the crane controls to help prevent accidental engagement of the controls or incorporate detent or safety interlock switches onto the levers in order to prevent the unintentional activation of the boom truck controls.
- When loading materials on the bed of a boom truck, make sure the material is positioned so it will not be able to make contact with the boom truck controls.
