Fatality Narrative

Excavator Operator Killed When Excavator Tips Over*

Release Date: March 18, 2009.
Case No.: 08WA00101.
SHARP Report No.: 71-81-2009.

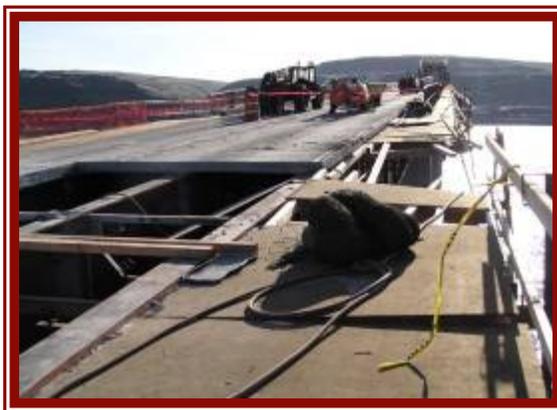
On January 15, 2008, an excavator operator died when the excavator tipped, and fell off a bridge into a river. The 62-year-old journeyman operator with certification to operate cranes was employed with a heavy/highway construction company. He was working on a project requiring the removal of an existing bridge deck and replacing it with a new deck. The current phase of the project involved the demolition of the bridge deck or roadway by cutting the existing concrete deck into slabs that would then be removed by an excavator. The excavator the victim was operating was equipped with a "slab crab" bucket which would grab the slabs and then the excavator would rotate 180 degrees and place the slabs on the deck for removal by a forklift. For this particular lift, due to bridge structural constraints, the excavator was rigged with a two-leg bridle chain sling attached to the slab and bucket in order to lift this 8x10 foot slab estimated to weigh 6,600 lbs. When the operator made the pick of the slab it hung vertically instead of horizontally. The victim extended the boom's arm, raising the load higher so that it could be moved. If the load is raised by the arm, the load is extended outwards. The operator began to swing the load in one direction, but quickly swung it in the opposite direction when he saw someone in his swing radius. When the operator began to swing the load toward the bridge guardrail it appeared that the load might strike the rail. The operator extended the arm, raising the load which cleared the guardrail, but at this point the load capability of the excavator was exceeded and the excavator tipped sideways and fell over the side of the bridge, landing in the river 60 feet below.

Incident scene showing the bridge and the broken walkway and guardrails where the excavator fell through and plunged into the river.

- ! Excavators being used as cranes must have functional load charts posted in the operator's cab.
- ! Train equipment operators in the proper use of equipment they are assigned to operate. Be sure to follow the manufacturer's specifications and recommendations.
- A clear margin of safety regarding the maximum load extension should be established and communicated in writing to the operator before work starts.
- Plan load picks with excavators and cranes so that operators can control equipment and eliminate any instability of the machine.
