Fatality Narrative

Journeyman Carpenter Struck by Falling Wall Section *

Release Date: August 10, 2006
Case No.: 06WA00101
SHARP Report No.: 71-49-2006

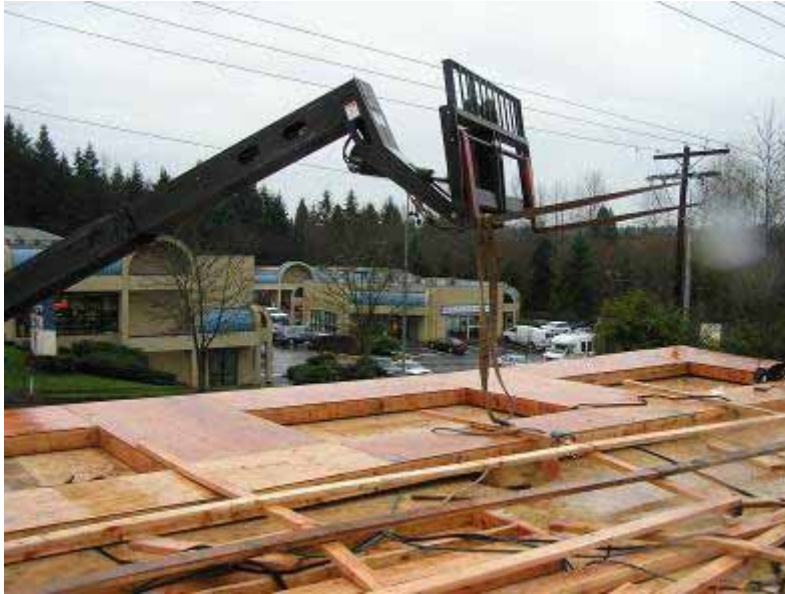
On December 30, 2005, a journeyman carpenter was killed during the raising of a wall section. The 39-year-old victim had 16 years experience as a journeyman carpenter and had worked with his current employer for 5 months. The victim was employed by a framing contractor and was working at a commercial building construction site. Seven workers, including the victim, were to assist in the raising of a sheeted wood frame exterior wall section measuring 38 feet 6 inches by 10 feet 7 inches. The plan was to raise the wall by attaching a nylon sling to a ½-inch by 8-inch eye bolt secured to the wall's top plate as a "pick point." The sling would then be attached to the fork of a forklift. The wall was to be raised and secured in an upright position with seven workers helping to stabilize it. When the wall was raised to about 75% of vertical, the eye bolt failed and the wall fell back toward the raising crew. Five workers escaped to safety and two workers were struck by the wall. One worker hit by the wall suffered a broken leg and the other died as a result of the incident. The failed eye bolt's maximum load capacity, as rated by the manufacturer, was 300 lbs. The wall section was calculated to weigh 1,910 lbs.

Photo: This picture shows the fallen wall and the forklift with the attached nylon strap after the incident.

- ! Conduct "pre-lift" meetings to determine the safest method for raising walls.
- ! Determine the weight of a wall before raising it.
- ! Use a competent person to supervise the lifting operation.
- ! Know and work within the safe working load (SWL) of all rigging components.
- ! Select appropriate rigging and rigging methods to assure a safe lift.
- ! Use raising props, wall jacks, and base plate stops to keep wall sections from falling on workers.
- ! Use cranes or forklifts that are appropriate and are of adequate size and capacity to lift wall sections.
- Only necessary personnel should be exposed while the wall is being raised, in case the wall section falls. Escape routes should be planned before the lift for any workers exposed.
