INCIDENT FACTS

71-174-2018

Operator Struck by Hay Press Guillotine Blade

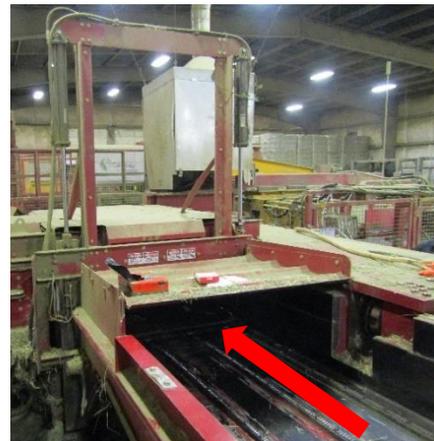
During normal operation, a conveyor moved hay into the covered area of the scale. When the hay reached the correct weight, a guillotine blade would slice off the section of hay before it was moved along by conveyor to be compressed. The victim crawled into the covered area where the scale was located and started to push a bale through to clear the area. His supervisor and coworkers did not notice him get into the machine. As he was lying on the scale, the steel guillotine blade activated and struck him, resulting in near decapitation.

Incident hay press showing the area where the victim was working when he was struck by the guillotine blade.

Always follow the machine manufacturer's operator and safety manual requirements regarding control of hazardous energy before performing cleaning, repairs, adjustments, or any other activity that could put employees at risk of safety hazards.
