INCIDENT FACTS

71-173-2018

Heavy Equipment Operator Run Over by Compactor Roller

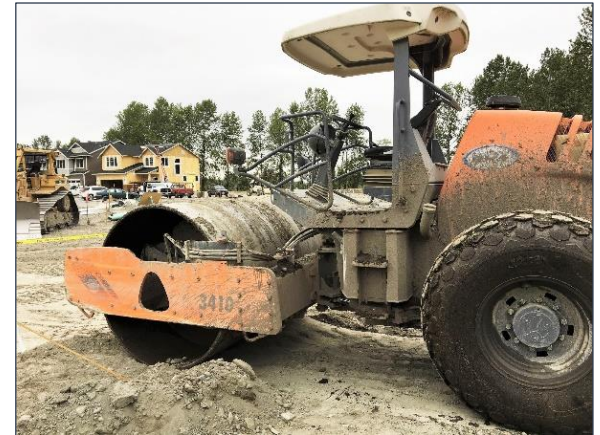
State workplace safety investigators found that he fell from the open cab of the roller as it moved in reverse. The roller was found several hundred yards away resting against a tree. No one saw what happened. Investigators could not determine what caused him to fall, or whether he had been seated or standing prior to his fall.

He possibly stood up to get a better view of the edge of the excavation on his right as he was backing. Evidence at the scene indicates that the side of the roller came in contact with the excavation wall, which may have jolted the roller and caused him to fall.

The roller's seat belt was found to be functional, unclipped, and retracted. The employer required employees to wear seat belts and coworkers told investigators that the victim was known to always wear his seat belt.

Incident compactor roller

- Always use the provided seat belt when operating heavy equipment. Uneven terrain or unexpected movements may cause an operator to be ejected off the equipment.
- Consider purchasing or equipping compactor rollers and other heavy mobile construction equipment with a safety interlock device such as an Operator Presence Sensing System (OPSS) that prevents movement of the equipment when the operator is not seated at the controls.
