INCIDENT FACTS

71-170-2018

Laborer Falls 20 Feet from Scissor Lift in Fruit Cold Storage Warehouse

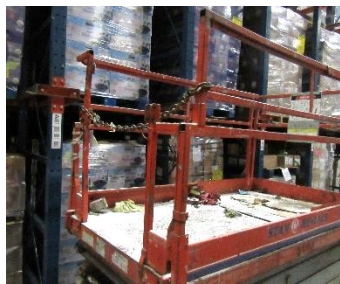
Scissor lift with its swing gate removed with a chain across the entrance to the lift. The lift's platform has frost on it.

The lift's entry swing gate was damaged and had been removed for repair. A metal chain was put in its place. The chain was positioned twenty-five inches above the platform, at around the height of the mid-rail of the platform's guardrail.

Investigators found that the victim had fallen through the gap where the gate had been removed and landed on the floor 20 feet below. The lift did not have lanyard anchorage points.

- Always operate equipment according to the requirements of the manufacturer operator's manual. The operator's manual for the scissor lift specified that platform guardrails and the platform entry gate must be in place, in good working order, and the gate closed before operating the lift.
- Employers should incorporate the requirements of the equipment manufacturer operator's manual into worker training.
- Consider using scissor lifts that, in addition to guardrails, are equipped with manufacturer provided anchor points for personal fall restraint systems. Anchor points may also be installed by qualified persons under the direction of the manufacturer or a professional engineer.

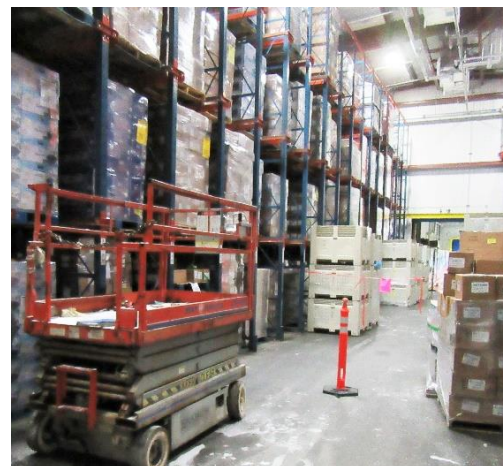
Incident scene showing the scissor lift in the freezer unit of the cold storage warehouse.
