INCIDENT FACTS

REPORT #:
71-167-2018

Laborer Suffers Traumatic Brain Injury when Struck by Load Falling from Forklift

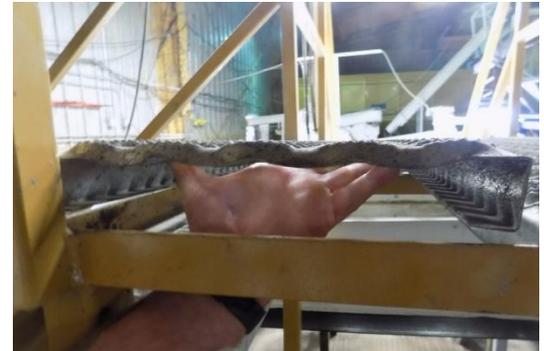
When the staircase platform fell off the forklift forks, a metal decking panel, like this one, came off the platform and struck the victim's head.

- Develop and implement standard safe loading procedures for forklifts, and ensure that workers follow the procedures.
- Workers should never stand on, under, in front of, or near a load being lifted and carried by a forklift.
