Fatality Narrative

Roofer Falls from Extension Ladder When it Collapses*

Release Date: June 30, 2008
Case No.: 07WA4001
SHARP Report No.: 71-72-2008

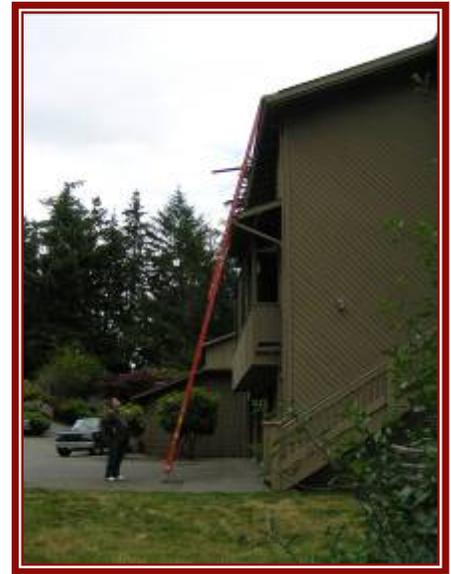
On June 5, 2007, a roofer received fatal injuries after a fall from a ladder. The 20-year-old victim worked for a roofing contractor and had two years experience in this trade. On the incident day, the victim was working with a crew at a condominium complex where they were re-roofing several units. The victim and other crew members completed roofing one condominium unit and moved on to work on the roof of another unit. The victim returned to retrieve tools from the first unit's roof. He accessed the roof by climbing up a 32-foot extension ladder. Before descending the ladder, the victim used his cell phone to ask a coworker to hold the ladder for him. The coworker arrived and held the ladder. The roof line where the ladder was positioned was 25 feet above ground level. The ladder was not extended, so the victim before he began to climb down, pulled the ladder up higher, causing it to extend a bit so that about one rung of the ladder was above the roof line. The victim, holding a drill case in one hand, began to descend the ladder, when at the same moment the ladder telescoped down slightly (the rung locks were not fully engaged) causing the victim to fall about 25 feet to an asphalt surface below. The victim was taken to a hospital, where he died the next day of blunt head and chest trauma.

- ! Employers are responsible for training employees to recognize portable ladder fall hazards and how to minimize or eliminate these hazards.
- ! Position ladders so that side rails extend at least 3 feet above the landing.
- ! Secure ladders at top and bottom to prevent slipping.
- ! Have both hands free to hold on to ladder.
- ! Use a hoist or other means than hand carrying to bring materials and tools up to or down from a roof.
- Always have a 3-point contact (such as, one hand and two feet).
