## Farm Laborer Dies When UTV Struck by Vehicle

**Industry: Wheat Farms**

**Task: Using UTV to check flooded fields**

**Type of Incident: Struck by motor vehicle**

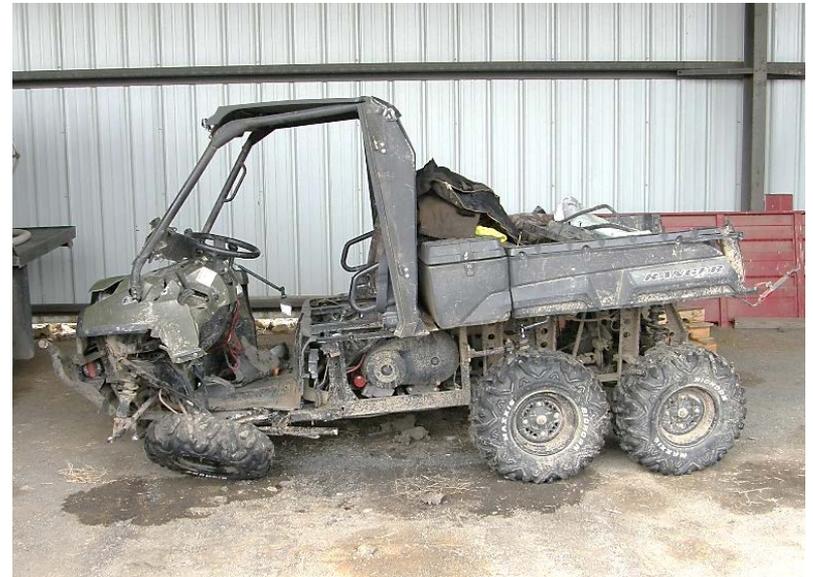
As he began making the turn, a pickup truck approaching from the rear attempted to pass the UTV. The truck struck the UTV's left front corner. The impact caused the UTV to roll over and land on its passenger side, ejecting both occupants. The victim landed in the road and the passenger in a ditch.

UTV after the incident showing the damaged left front that was struck by the pickup truck.

- As part of their accident prevention program, employers should do a job hazard analysis (JHA) of tasks involving farm equipment that may pose risks. Employees should be involved in creating the JHA. In this case, the employer and employees could have come up with a safer way to check the fields.

- **Always** wear a DOT-compliant helmet and seatbelt when operating a UTV.

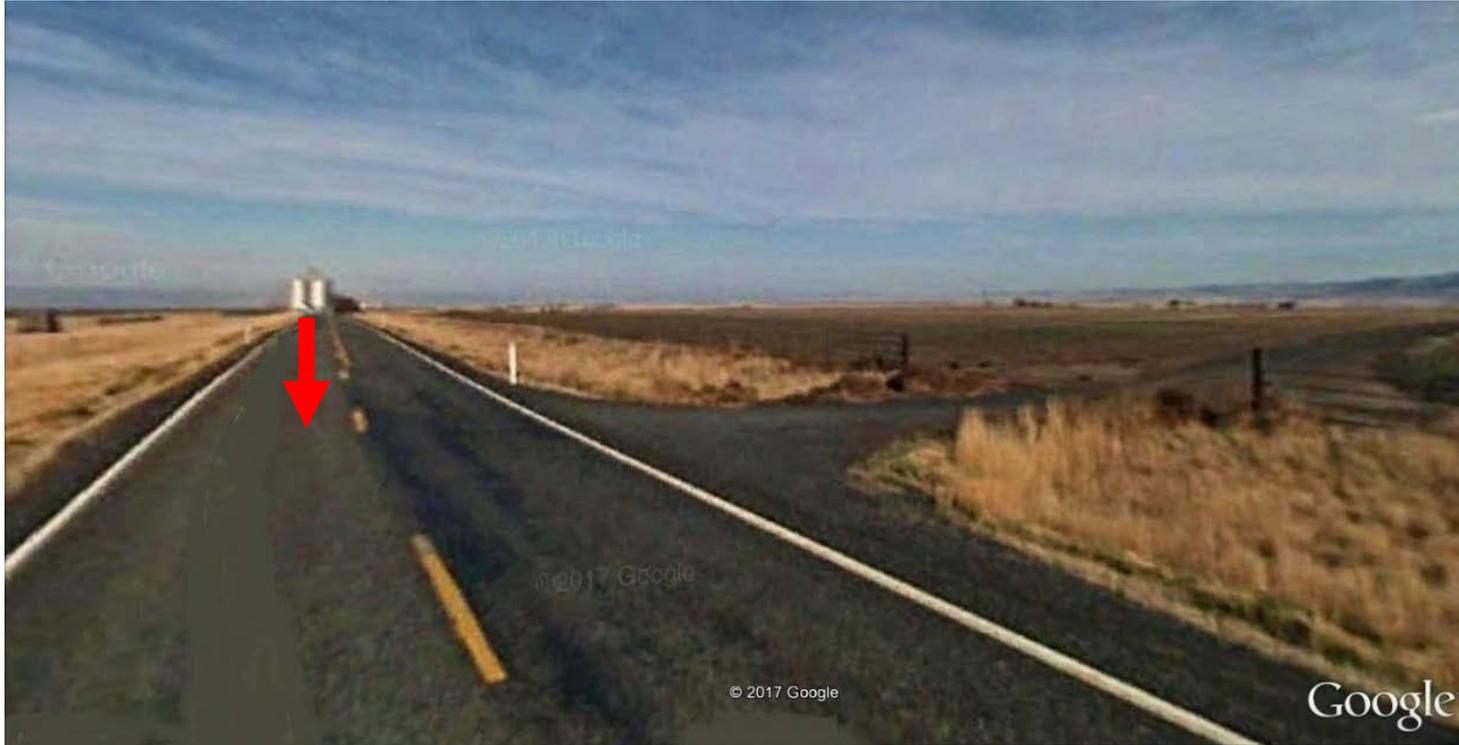
Incident scene showing the state highway along which the UTV was traveling when it was struck by a pickup truck attempting to pass (the arrow indicates the direction of travel of both UTV and pickup truck). The UTV was slowing down and had crossed the center line so as to turn onto a road leading into a field.

Manufacturers have designed and equipped UTVs and ATVs for off road use. Employers should follow the manufacturer's safety guidelines and not let their employees drive these vehicles on public paved roads.

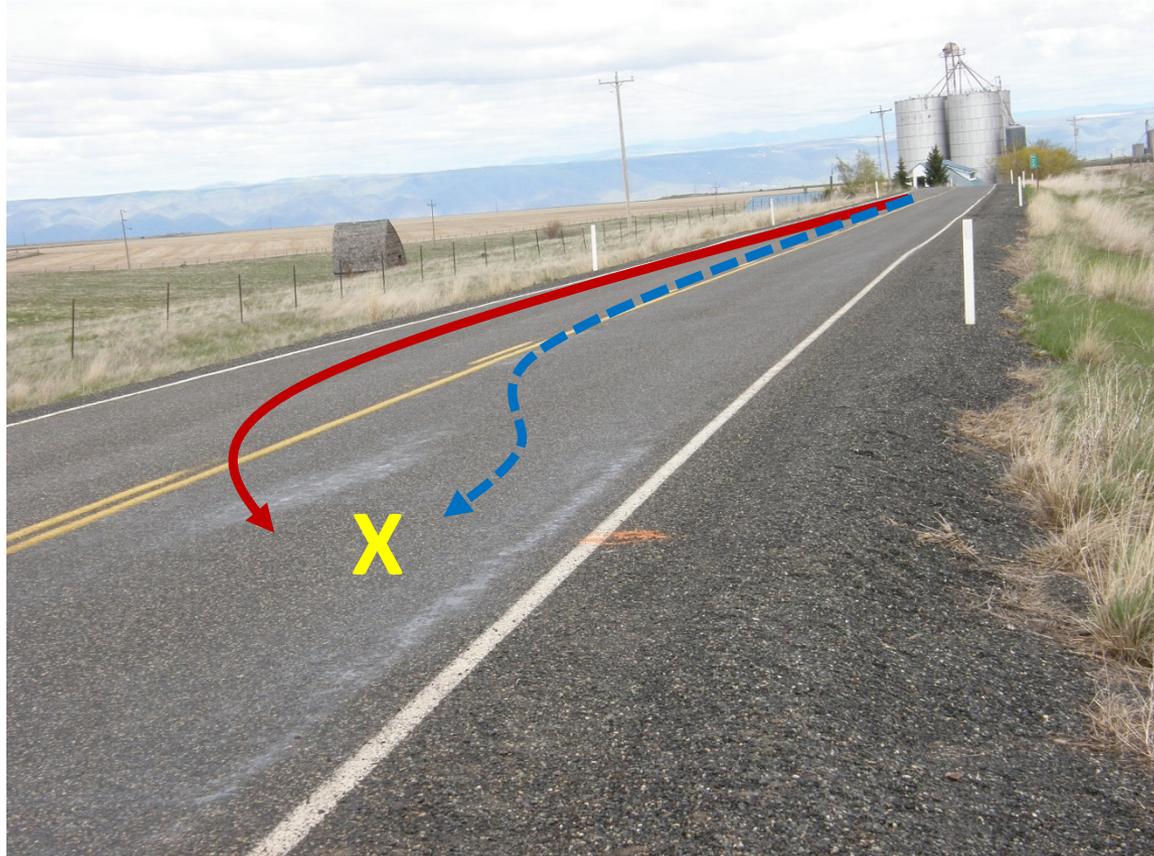
Incident scene showing the direction of travel of the UTV and pickup truck along the state highway. The solid red line indicates where the UTV began to turn left across highway. The dashed blue line indicates where the pickup truck attempted to pass the slow-moving UTV. The “X” indicates where the two vehicles collided.
