## Ironworker Falls 72 Feet from Mast Scaffold

# ***FATALITY NARRATIVE***

On January 6, 2014, a 34-year-old ironworker died when he fell from a mast scaffold.

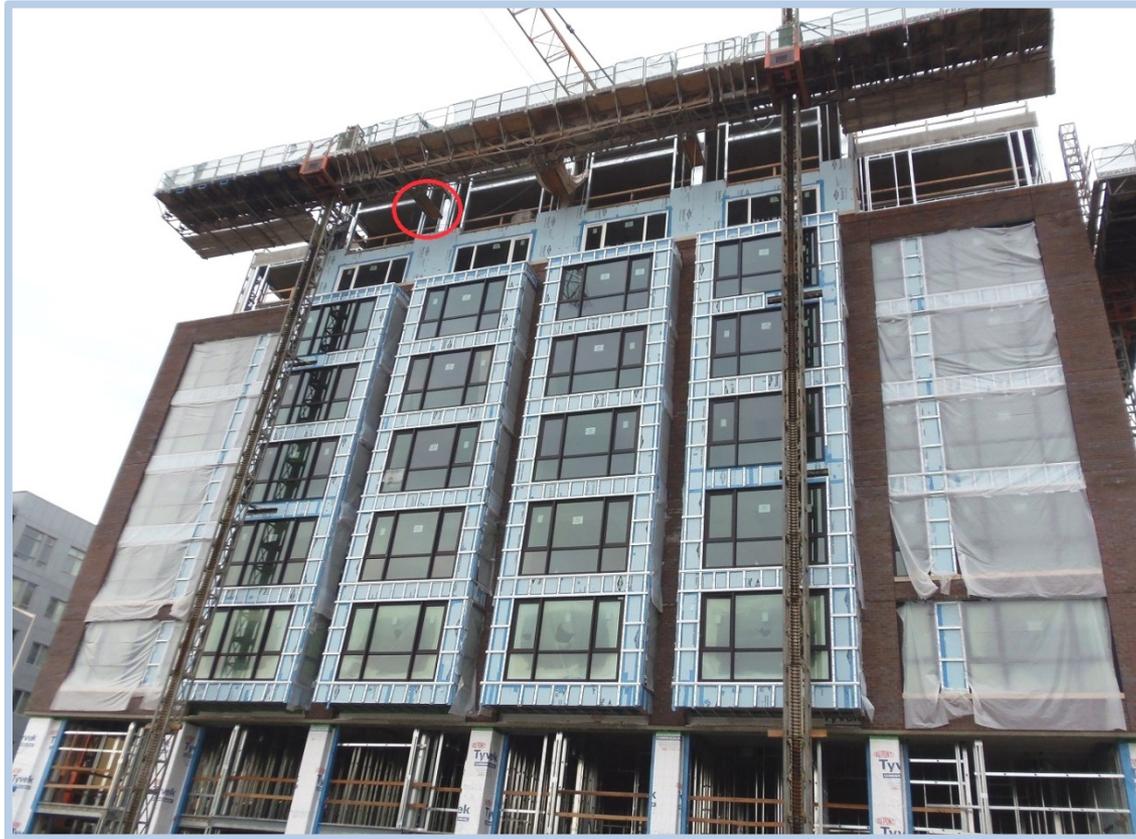
On the day of the incident, three employees were rigging and welding a tube steel eyebrow beam into place between the building's 9<sup>th</sup> and 10<sup>th</sup> floors. That morning the victim and another employee operated the power-driven twin mast scaffold to raise the work platform to the work area. This type of scaffold is also known as a mast climbing work platform or mast climber. Working from the scaffold, the victim and another employee welded half of the beam into place. The third employee was on the roof rigging the beam sections and signaling the crane operator. After receiving and temporarily attaching the second half of the beam, the victim unhooked his lanyard's pelican hook from the scaffold frame and began walking along the scaffold to where he would have to step down onto a 2'x4' platform in order to access the point to be welded. Two employees observed the victim, who was not tied off, trip over a welding cable and fall into an opening between the building and the scaffold. He fell 72 feet from the scaffold to the concrete road below.

Incident scene showing the building exterior and twin mast scaffold. The red circle in the photo shows the area where the ironworker fell through a 55 inch gap between the scaffold and the building.

- **Provide fall protection if a scaffold is too far from the work face.** Provide a guardrail system or have employees use a personal fall arrest system if the distance from the front edge of the scaffold platform to the work face is greater than 18 inches for plastering and lathing work and 14 inches for all other work.

See [WAC 296-874-20054](#).

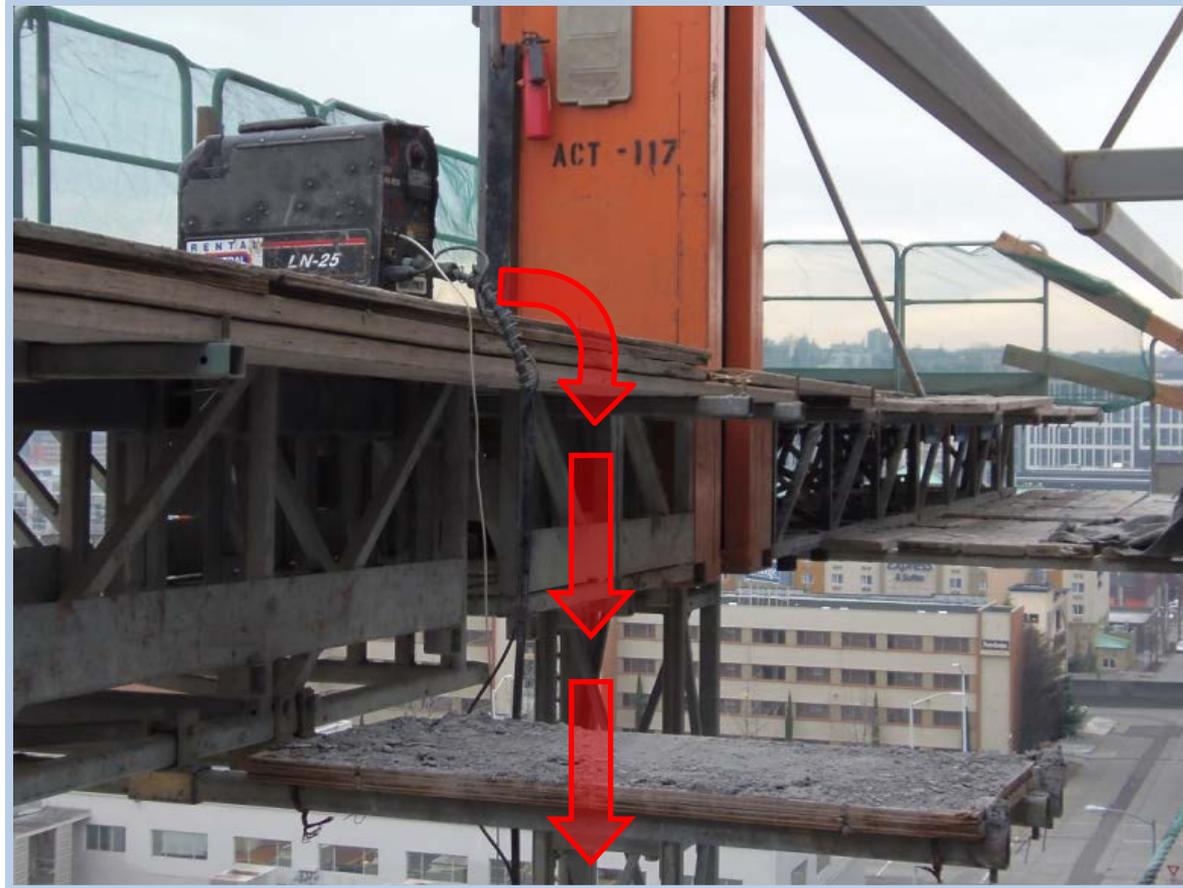
Incident scene showing the mast scaffold platform where an ironworker who had disconnected his fall protection was walking and tripped over a welding cable and fell 72 feet to his death.

- the unprotected opening between the scaffold platform and the building was 55 inches;
- neither vertical nor catenary lifelines were available on the section of the scaffold where the victim fell;
- employees were not properly trained in fall protection measures or in the operation and use of the mast scaffold; and
- the scaffold and its components were not inspected by a competent person.

- **Train employees who work on a scaffold.** Have a qualified person train each employee to: 1) recognize the hazards associated with the type of scaffold they are using, 2) understand the procedures to control or minimize the hazards.

- **Inspect scaffolds and scaffold components.** A competent person must inspect for visible defects before each work shift and after anything occurs that could affect the scaffold's structural integrity.  
See [WAC 296-874-20034](#).
- **Fall protection work plan.** Develop and implement a written plan for each area of the work place where employees are assigned and where fall hazards of ten feet or more exist.  
See [WAC 296-155-24611\(2\)](#).
