Log Truck Driver Dies When Struck by Logs Being Loaded Onto Trailer

Investigation: # 11WA03301
Release Date: May 15, 2015
SHARP Report: # 52-33-2015

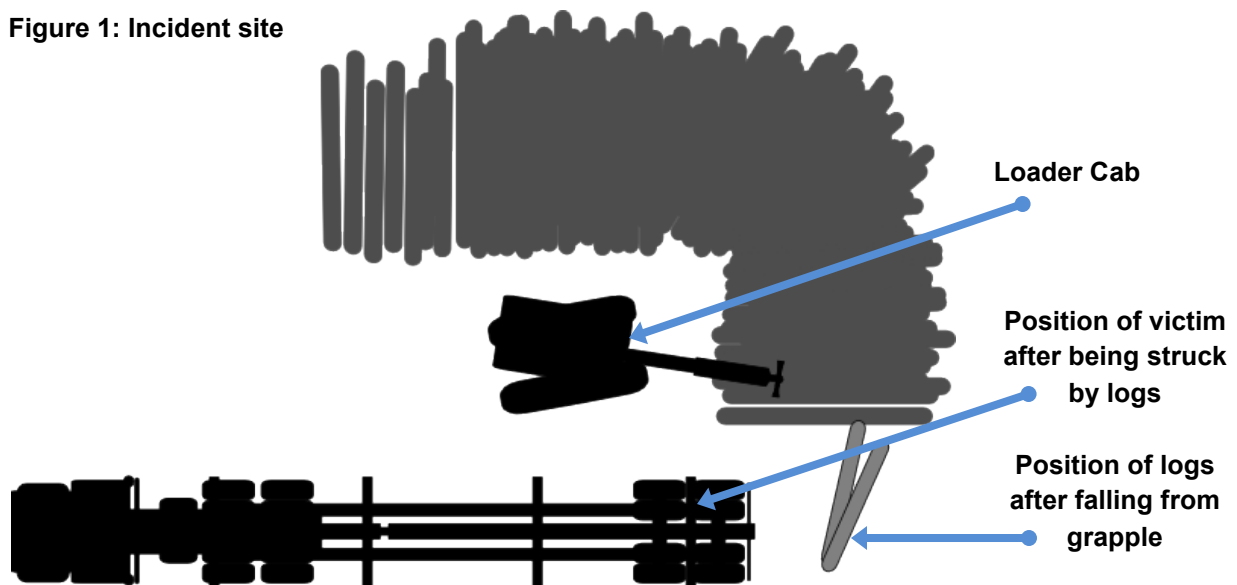
Figure 1: Incident site

The victim was in the cab of the truck at approximately 5:15 a.m. when the loader operator placed the first load of logs in the bunks at the front of the trailer. The loader operator then turned the cab and boom arm away from the trailer and picked up the next two logs to place in the rear bunks. As the loader operator was bringing the second pair of logs around toward the rear of the trailer, he suddenly caught sight of the victim's orange safety vest and realized that he was standing on the back of the trailer. The loader operator immediately reversed direction of the load, and both logs fell from the grapple and landed on the ground behind the trailer. The loader operator left the cab and found the victim lying unconscious over the bar of the rear bunk. He had been struck by the logs either as they were being swung toward the bunk or as they fell.

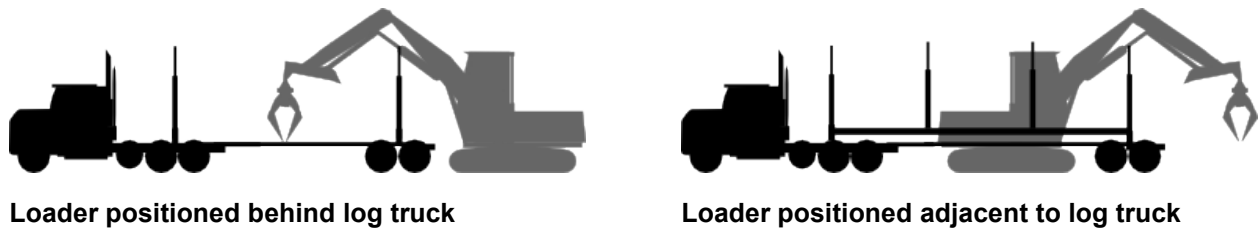
Figure 2: Loader positions

Discussion: Often during loading, the loader will be positioned behind the trailer facing the truck cab; the employer indicated that this was the typical arrangement in his experience. In this position, the operator has a relatively unobstructed view of the trailer and cab in most positions when rotating the loader, and would be more likely to see if the driver exits the cab. On the morning of the incident, the landing was configured in such a way that the loader was located adjacent to the trailer facing away from the cab of the truck (Figure 2).

Had the loader operator been able to better see the trailer during the movement of the second load, he might have seen that the victim had left the cab and climbed onto the trailer, but the position of the loader allowed for blind spots. In situations such as this, where visibility of the truck cab or trailer is obstructed or reduced, employers should instruct loader operators to take the extra step of verifying the driver's position prior to loading.

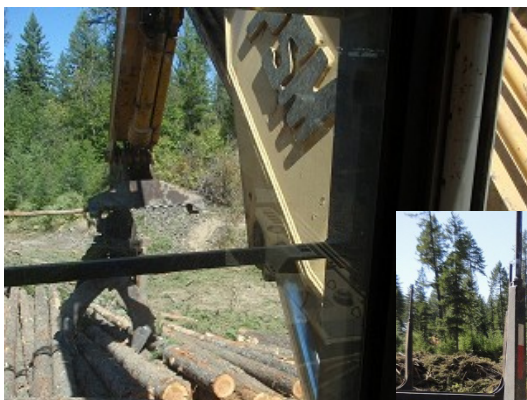
Photo 3: View from forward facing window of loader cab

In this location, boom arm movement occurred between the loader cab and the trailer. It is likely that as the loader operator was lifting the second load of logs off the deck and swinging them toward the rear bunks, his view of the trailer was partially obscured by the arm of the boom (Photos 3 & 4), and he would not have been able to see the victim on the trailer near the rear passenger side bunk stake until he had almost fully rotated back toward the trailer (Photo 5).
