INCIDENT FACTS

71-180-2019

April 10, 2019

Orchard Manager Dies When ATV Crashes into Apple Bin

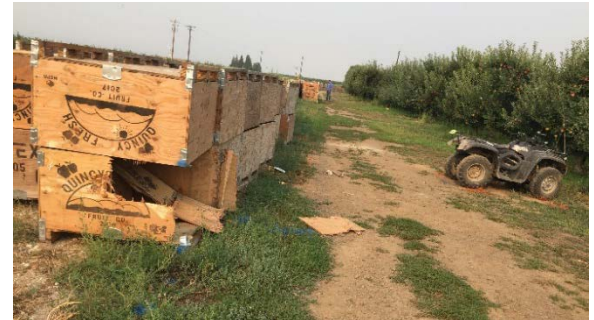
State investigators and the county Sheriff's office investigated the incident scene. They found that the manager was operating the ATV along an orchard gravel and dirt road at a high rate of speed when the ATV went into a 58-foot straight skid and struck an apple bin. The ATV then rolled over and came to rest 20 feet from the point of impact. The manager was found on the road 12 feet from the ATV. He was not wearing a helmet. He died of massive head injuries. The employer did not ensure that his employees wore DOT approved helmets while operating ATVs. Investigators noted the operation of the ATV at an excessive speed as a primary cause of this incident.

Location where the manager was ejected from the ATV when it struck an apple bin at a high rate of speed.

- Operate ATVs at speeds safe for conditions and terrain.
- Employers should create and enforce a policy to ensure that employees use helmets when operating ATVs.
- Employers should consider providing and requiring employees to use company ATVs.
- Employers should consider installing governors on ATVs to prevent high-speed operation.
- Always wear a DOT approved helmet while operating ATVs.
- Take a hands-on ATV safety training course.
- Follow manufacturer's instructions and warnings for safe operation of ATVs.
