INCIDENT FACTS

71-185-2019

Roofing Foreman Falls 19 Feet from Extension Ladder

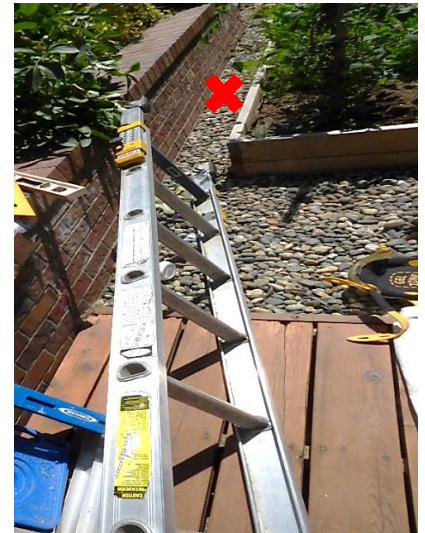
Fascia board (circled) that the foreman was installing when his unsecured ladder slid sideways and he fell.

The roofer used a 24-foot extension ladder to access the roof at the rear of the house. The foreman then moved the ladder to the side of the house. He planned to place a fascia board on the upper part of the chase while standing on the ladder, with the roofer's help. To do this he placed the base of the ladder between two raised garden beds and leaned the ladder against the chimney chase. This created a 65-degree angle, lower than a safe 75-degree angle. The ladder would have been nearly vertical if he had placed it on the other side of the garden bed.

He did not secure the ladder from movement at the bottom, or secure it at the top once he climbed up it. The roofer questioned him about the safety of the ladder setup, but the foreman replied it would be okay because the job would not take long.

From the roof, the roofer helped the foreman hold the board in place. The board was about 25 feet above the ground. Standing either on the second or third rung from the top of the ladder, the foreman used a drill to put a screw into the board. As he leaned to his right to put in another screw, the ladder slid sideways and he fell with it, landing 19 feet below on a concrete walkway. He died from multiple blunt force injuries.

Base section of ladder and location it was set up (X) and leaned against the chimney chase at a 65-degree angle.

- Secure the ladder at the top and bottom when working from it. See [WAC 296-876-40040\(2\)](#)
- Set up non-self-supporting ladders at a safe angle. The ladder is set at the proper angle when the horizontal distance from the top support to the foot of the ladder is approximately one-quarter the working length of the ladder. See [WAC 296-876-40020\(1\)](#)

- Keep your body centered between the ladder's side rails. Do not overreach.
- Determine whether you can do a task safely using a ladder. If not, then use a safer alternative. Remember, even if it "will just take a minute," using a ladder unsafely is always dangerous!
- Set ladders at a 75-degree angle to ensure the bottom of the ladder does not slide out, and so that the user is able to maintain their balance.
- Never work from the top three rungs of a straight, single, or extension ladder.
