**INCIDENT FACTS**

71-182-2019

## Truck Driver Crushed Between Two Trailers

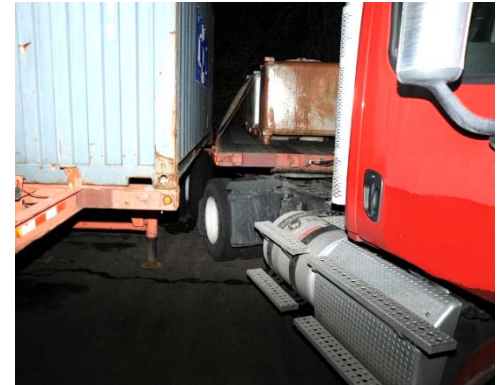
Close up of pinch point between the two trailers where the driver was crushed.

He got out and hooked up the trailer to his truck. He did not set the parking brake. He also did not chock the wheels of his truck or the trailer. Then he walked around to the passenger side where the trailer's landing gear was located. He stood between the two trailers and began cranking up the landing gear. When he raised the landing gear, the truck and trailer rolled backward, crushing him between the two trailers.

Pinch point between the two trailers where the truck driver was crushed when his semi-truck and trailer rolled backward.

- Drivers should always set the truck's parking brake before exiting the cab. Even if there does not appear to be a slope where a vehicle is parked, a small slope can be sufficient to allow a vehicle to roll if no braking systems or wheel chocks are used.
- As part of your Accident Prevention Program (APP), establish and enforce safety policies and train drivers to recognize the hazard of a vehicle rollaway and to use safe work practices to prevent unintended vehicle movement.
- Make sure that the tractor and trailer are lined up before coupling.
- Make sure trailer wheels are chocked or spring brakes are on.
- Consider installing commercially available warning alarms designed to alert drivers that the truck's parking brake has not been set when they leave the driver's seat or open the cab door.
