Laborer Partially Buried When Trench Wall Collapses

REPORT #: 71-196-2020s

EVENT TYPE: Trench collapse/Struck by

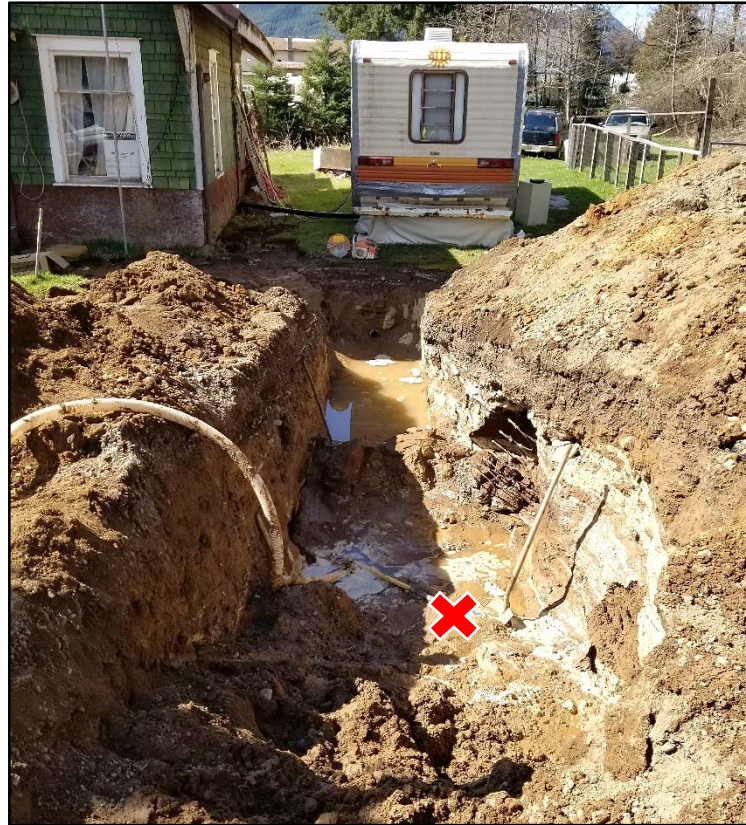
Photo 1. Unprotected trench after a part of its sidewall collapsed, partially burying the laborer. The “x” indicates the laborer’s location.

- Trenches must have adequate cave-in protective systems.
See [WAC 296-155-657\(1\)\(a\)](#).
- Keep excavated or other materials away from the edge of the trench.
See [WAC 296-155-655\(10\)\(b\)](#).
- Ensure that there is a safe way to enter and exit a trench that is four feet or more in depth.
See [WAC 296-155-655\(3\)\(b\)](#).

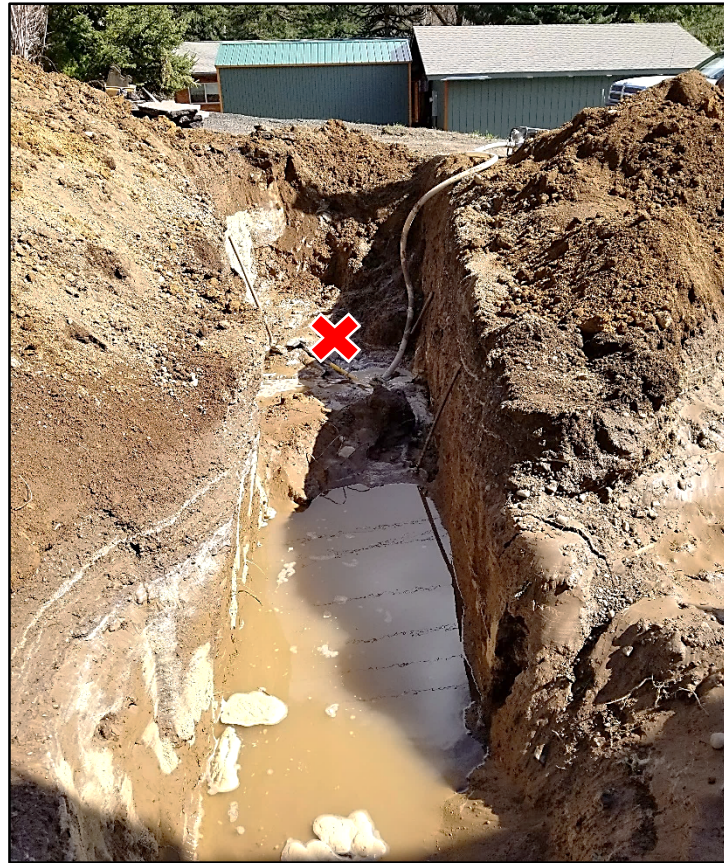
The excavator's bucket struck and ruptured a water main, causing the trench to start filling. As the trench rapidly filled with water, bystanders responded. From the side of the trench, they held the laborer's head above the rising water while the coworker used the excavator to dig a side trench to drain the water.

Photo 2. The “x” indicates the laborer’s location. The water in the trench came from the water main that was ruptured by the excavator the laborer’s coworker was using in an attempt to dig him out after the trench wall sluffed onto him.

- Ensure prompt and safe removal of injured employees from trenches and excavations prior to commencement of work. See [WAC 296-155-035\(9\)](#)

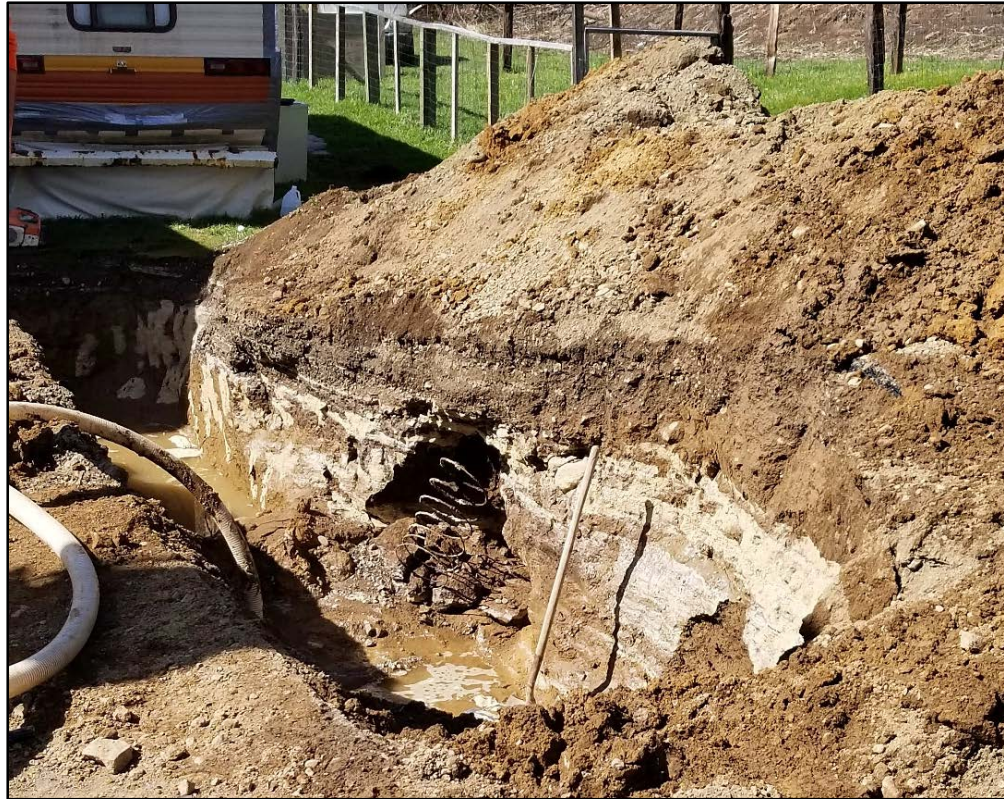
1. The trench was not protected from cave-ins by an adequate protective system.
2. Spoil piles three feet high of type C soil were placed within two feet of the trench edge.
3. Spoil piles were positioned on the uphill side of the trench creating a surcharge towards the trench opening.
4. It is possible that the excavators created vibration in the ground and caused the trench side to sluff.

Photo 3. The area where the laborer was using a shovel to uncover a water main when the trench sidewall sluffed into the trench, partially burying him. The spoils piles were not set back the required two feet from the trench edge.

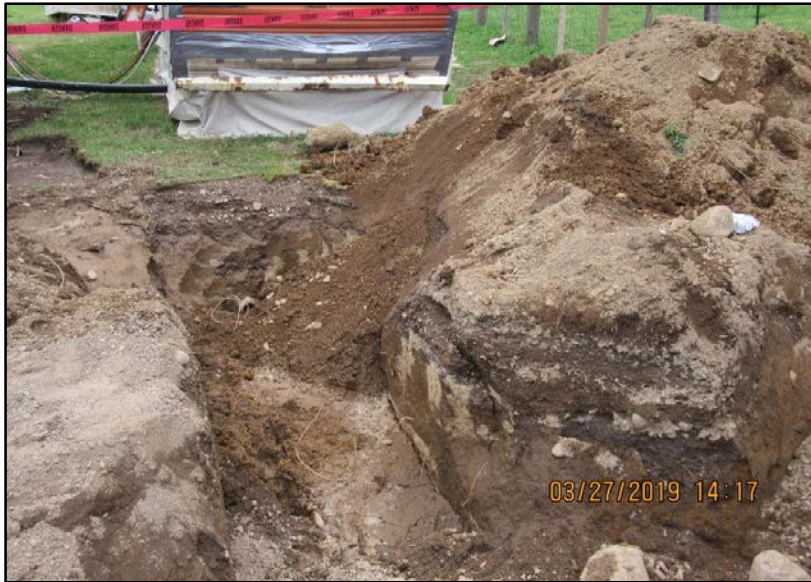
Photo 4. Spoils piles sloughing into the trench.

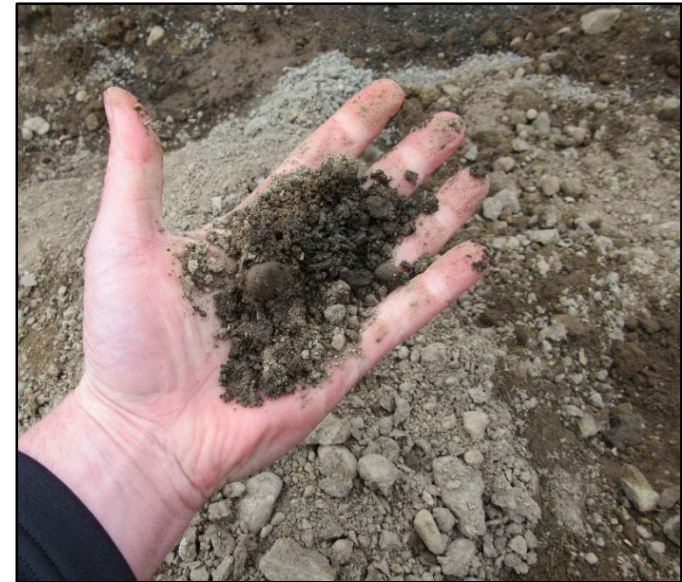
Photo 5. Type C soil material taken from the sidewall of the excavated trench.

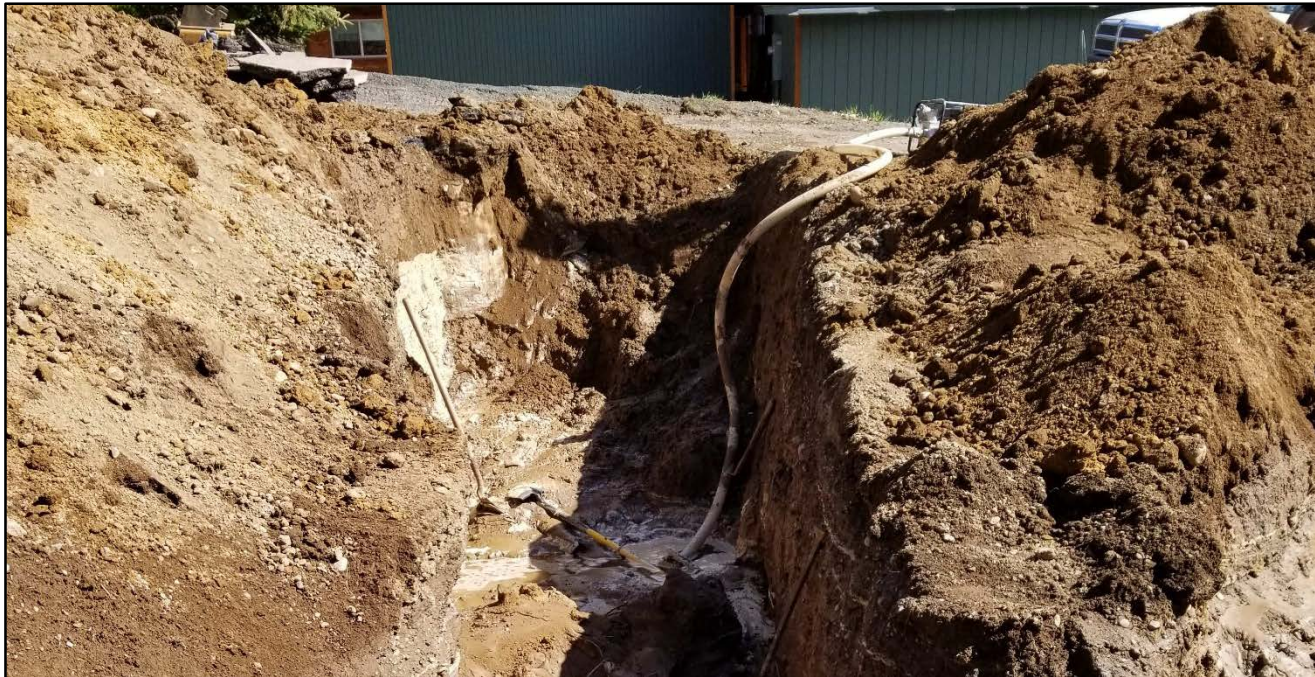
Photo 6. The workers did not use a safe means of entering and exiting the trench which was more than four feet in depth. The workers got in and out in this area at the far end of the trench.
