Roofer Falls 20 Feet through Rotten Roof

REPORT #: 71-190-2020s

SCENE: Storage building at manufacturing plant

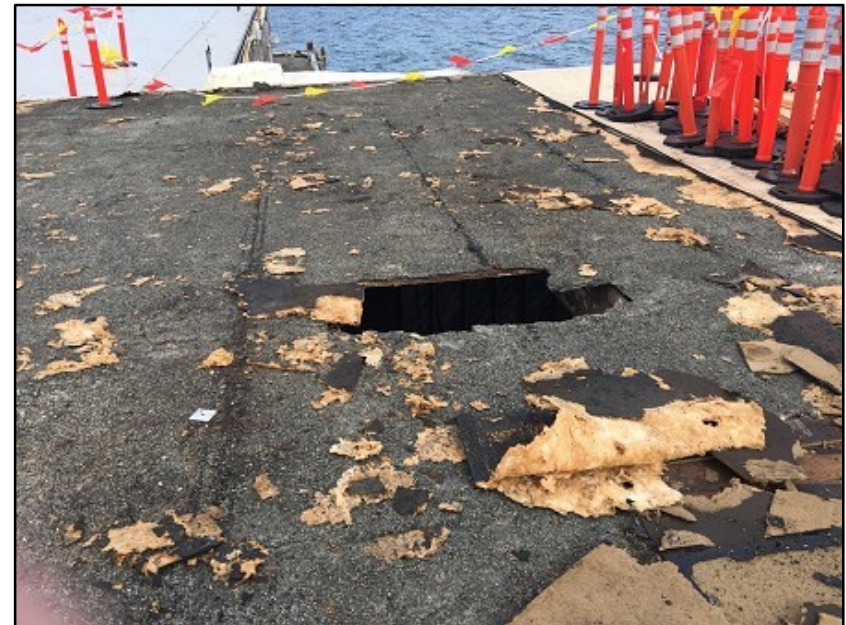
The roofer was inside the warning lines near the roof ridge using a shovel to scrape off shingles and insulation. As he stepped backward, a patch of rotten roof gave way and he fell through, landing 20 feet below on wood flooring. He was severely injured and suffered numerous fractures and internal injuries.

Investigators found that a worker had previously placed an orange cone to mark a rotten spot near where the roofer broke through the roof.

- Erect guardrails around rotten roof areas to prevent access.
- Place a cover of standard strength and construction over localized rotten roof areas. (A sheet of plywood would have covered the rotted deck area in this case.)
- Use scaffolds and/or elevating work platforms to access the underside of a roof to remove rotted deck when site conditions allow their use.

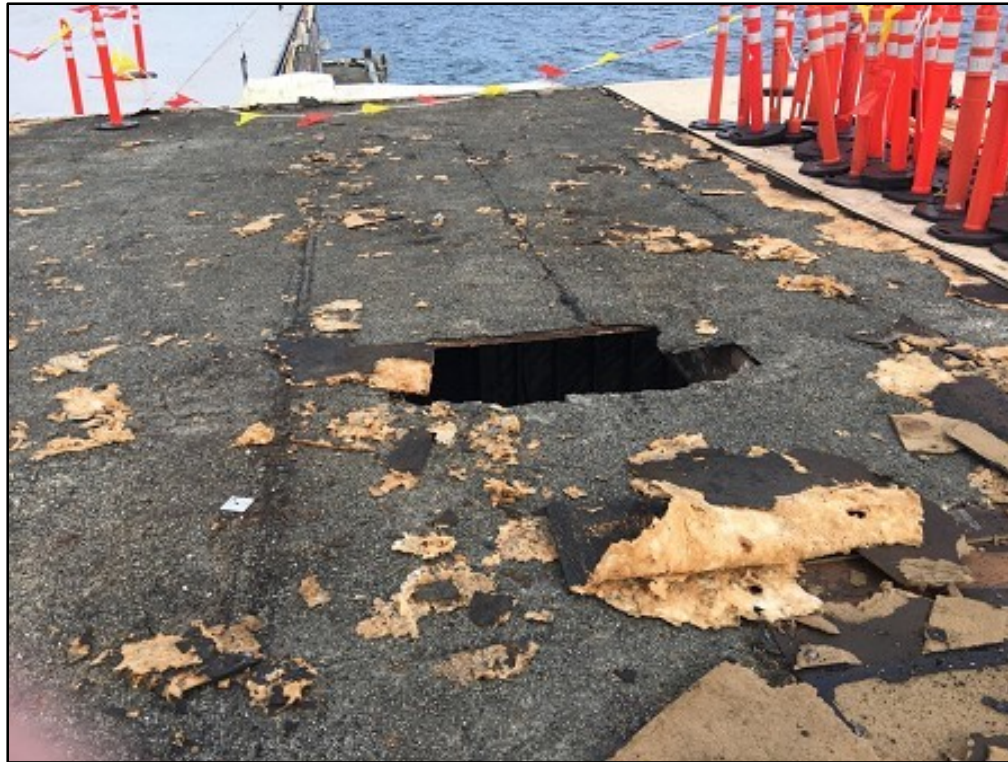
Photo 1. The rotten patch of roof that gave way when the roofer stepped on it.

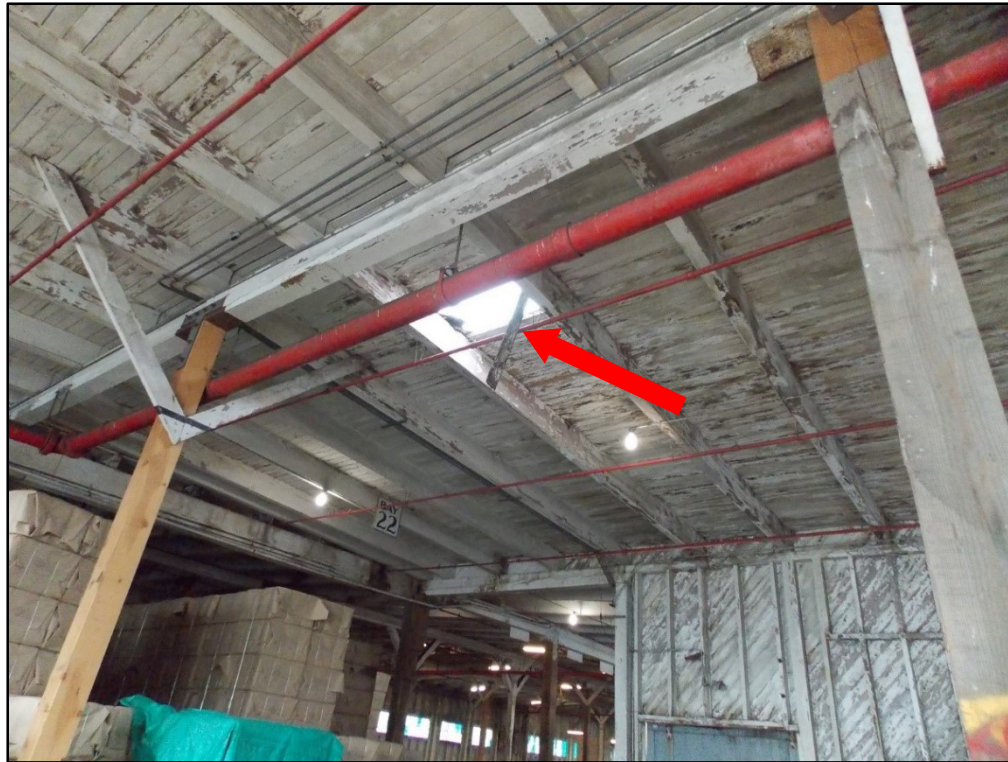
Photo 2. Hole created when the roofer fell through the roof. He landed on the floor 20 feet below.

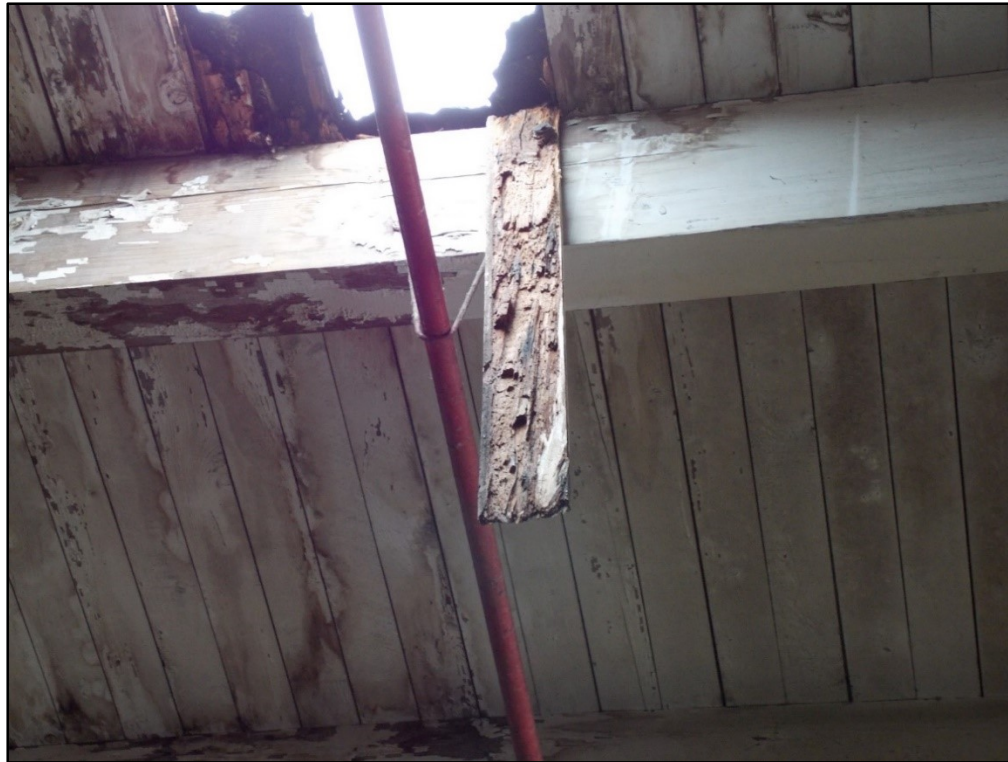
The spot he fell through was three feet away from the cone and under three layers of roofing material so he was not able to recognize it was rotten.

Photo 3. Close up of the roof hole that the roofer fell through showing the rotten wood.

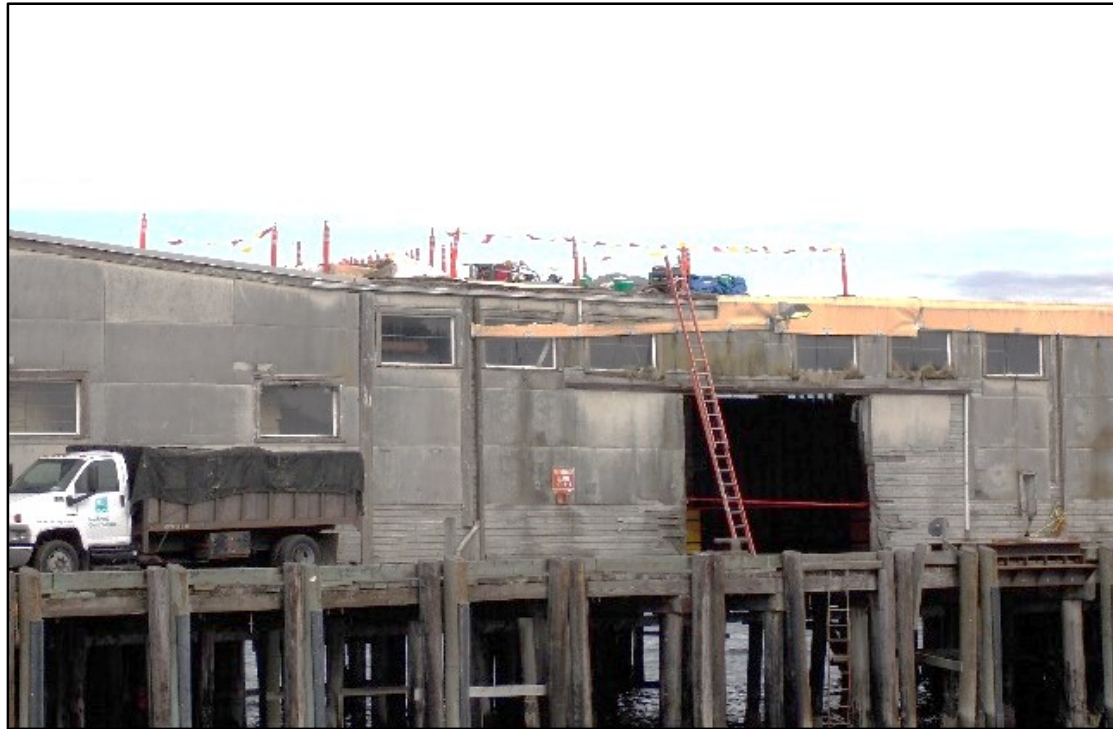
Photo 4. Building area where the roofer fell through the roof.

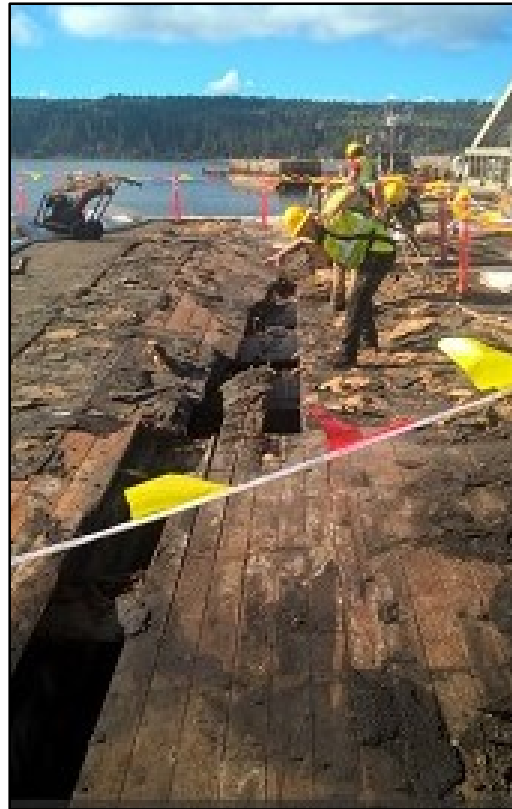
Photo 5. Employees using personal fall arrest systems while working near rotten roof area.

After the incident, the employer required workers to use a personal fall arrest system at all times.
