Compost Plant Operator Caught in Rotating Conveyor Belt

SUMMARY

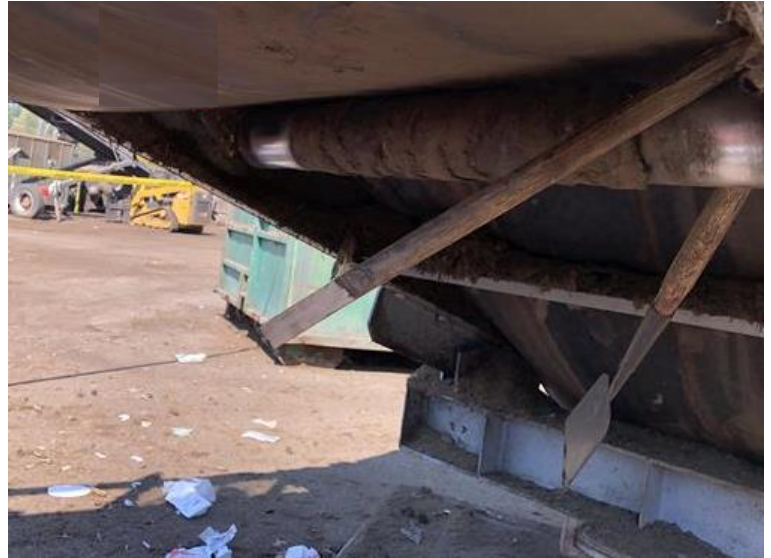
Conveyor belt and unguarded steel return idler roller with metal spade scraper tool that was pressed against the lead operator's throat. Responding workers cut the belt and broke the tool's wooden handle to release the operator. Photo taken after incident.

- Ensure that equipment safety guards are not removed, displaced, or carried off.
- Identify lockout/tagout (LOTO) procedure steps and how to properly use and test LOTO devices' effectiveness for specific equipment.
- Conduct and document periodic reviews at least annually to make sure workers know and can apply LOTO procedures, including how to provide notification before LOTO application and removal on affected equipment.
- Document that LOTO training had been done and kept up to date for all authorized and affected workers.
