FACE IT: Report Slides

Logging processor lost traction and rolled down hillside fatally injuring operator – Idaho (FACE 2020-01)

REPORT#: 2020-01 **REPORT DATE: March 31, 2022**

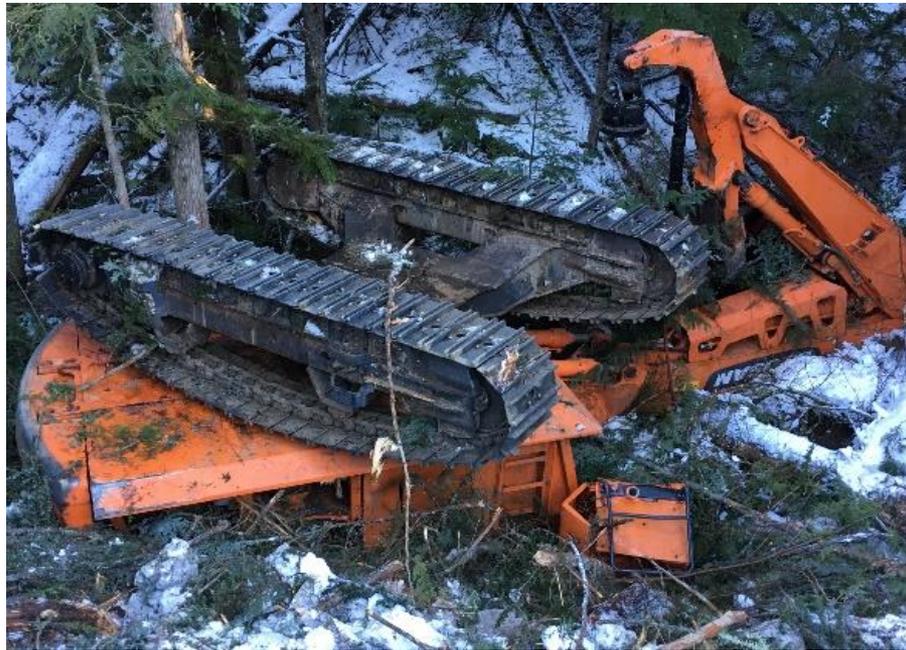
Processor Equipment, photo courtesy of USDOL

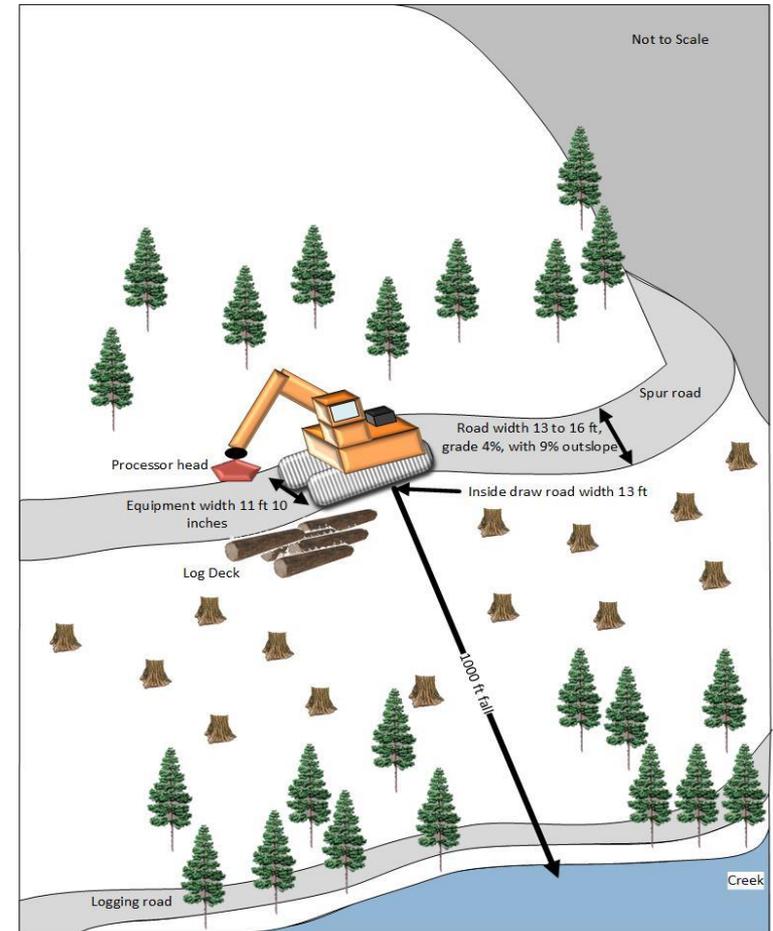
Diagram of clear-cut logging site

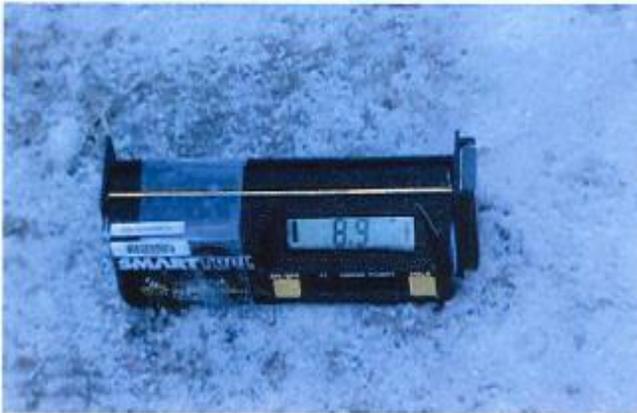
- The road was a single lane logging road that varied between 13 to 16 ft in width.
- The road grade varied but was approximately 4 percent with an approximate 9 percent outward slope at the site of the rollover incident.
- The surrounding hillside terrain had an approximate 20 percent slope.
- At the time of the incident, the logging road was covered with 2 inches of ice and lined with snow on both sides.

Road percent grade measured with an inclinometer, photo courtesy of USDOL

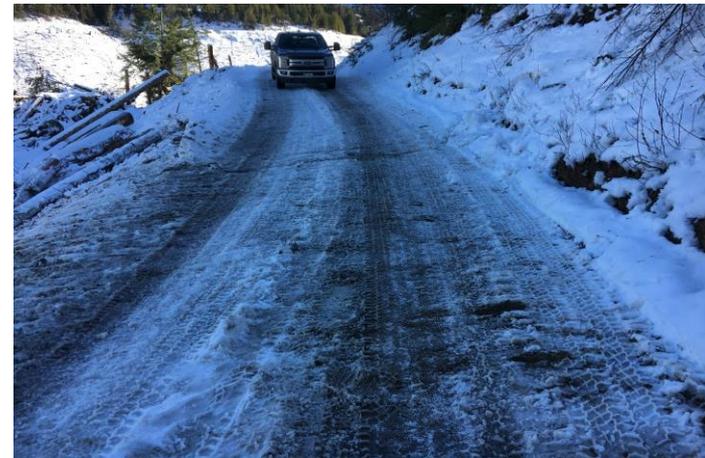
Road draw and grouser groves, photo courtesy of USDOL

- There were six employees onsite at a cable logging operation.
- The processor operator was driving the equipment from a spur road to a main logging road to harvest some fringe trees on the lower section of road, then the equipment was to be loaded on a lowboy and transported to a new timber harvesting location.
- As the processor operator approached a narrow inside corner in the road near a log deck (a stack of logs near a roadway), the tracks on the equipment slipped laterally on the outsloped road.

- Manufacturers should design stowing or sway control features for forestry attachments such as dangle head processors.
- Manufacturers should provide engineer designed ice bits for forestry equipment operating during winter snow and ice conditions to reduce lateral slipping.

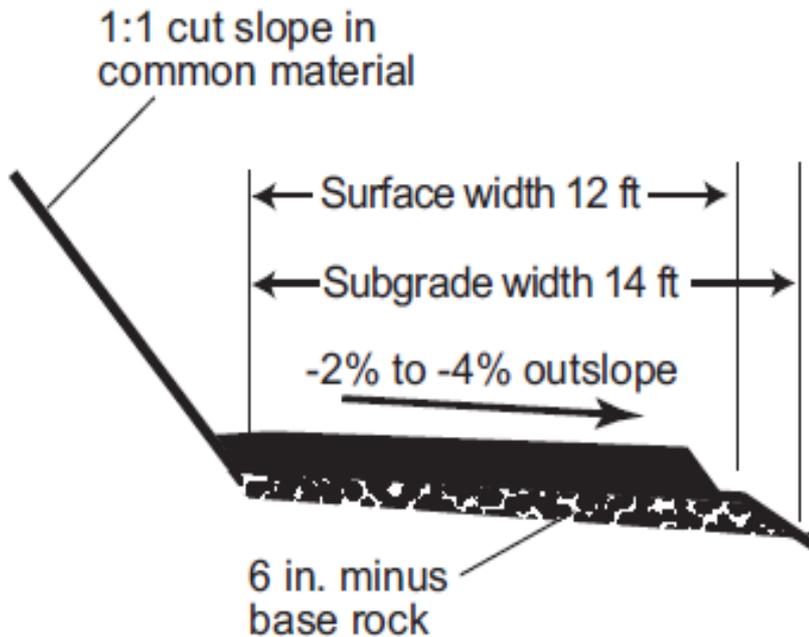
Outsloped forest road, figure courtesy of Oregon State University

- Road designers should limit outsloping on forest roads with potential winter travel.
- Employers should conduct a hazard assessment when working with forestry equipment in areas of steep terrain and provide worker training on hazard recognition as part of a comprehensive and site-specific safety plan.
- Employers should develop, implement, and train operators on strategies for traveling forestry equipment over forest roads.

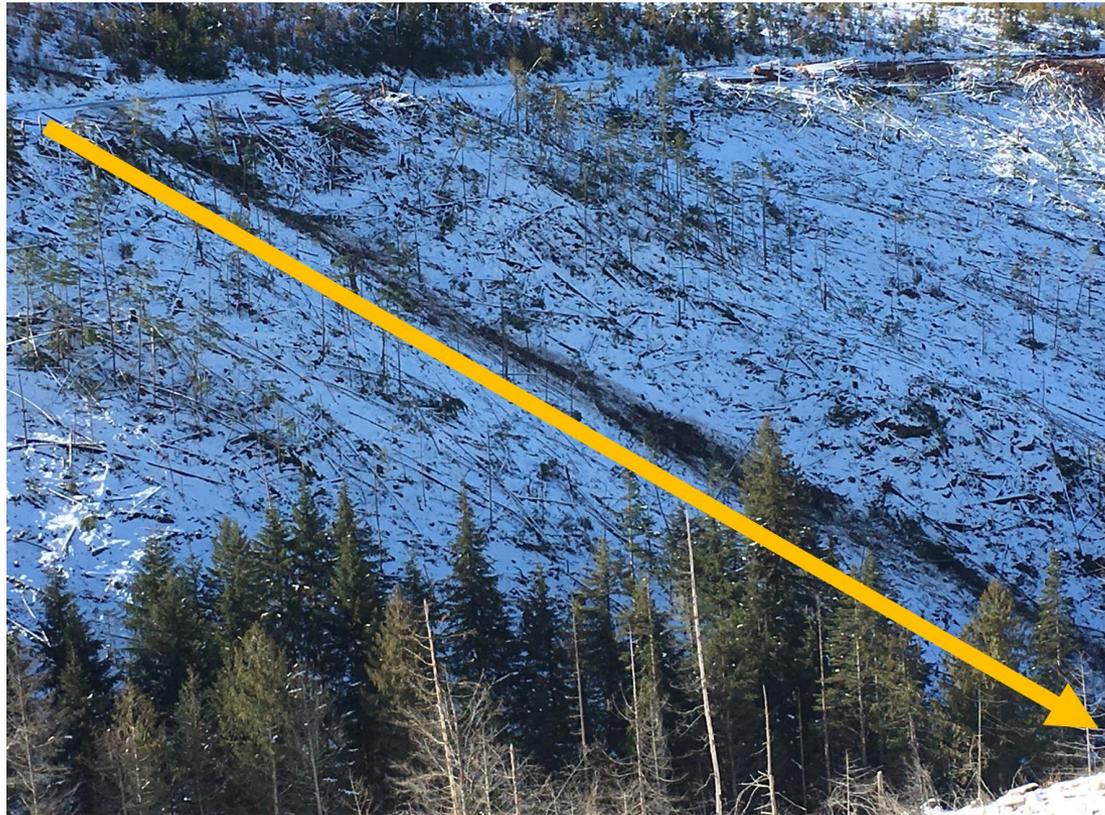
- The equipment slid off the road and temporarily stopped on logs that had been decked.
- The processor operator swung the boom and placed the processor head on the uphill side of the road attempting to transfer the center of gravity.
- The yarder operator saw the equipment slipping down the slope, communicated over the radio for the processor operator to “get the boom down and get out of there!”
- While the processor operator was attempting to exit the cab, the equipment tumbled down the hillside, shearing the operator cab off the equipment and fatally crushing the processor operator before coming to a rest in the creek near the road below.
- EMS arrived on scene and declared the processor operator deceased.

Clear-cut hillside showing dirt pathway from rolling equipment, *photo courtesy of USDOL*
