A Commercial Cleaning Company Worker Dies of Carbon Monoxide (CO) Poisoning at a Warehouse in Washington State

Investigation: # 06WA021
Release Date: February 22, 2011
SHARP Report: # 52-21-2011

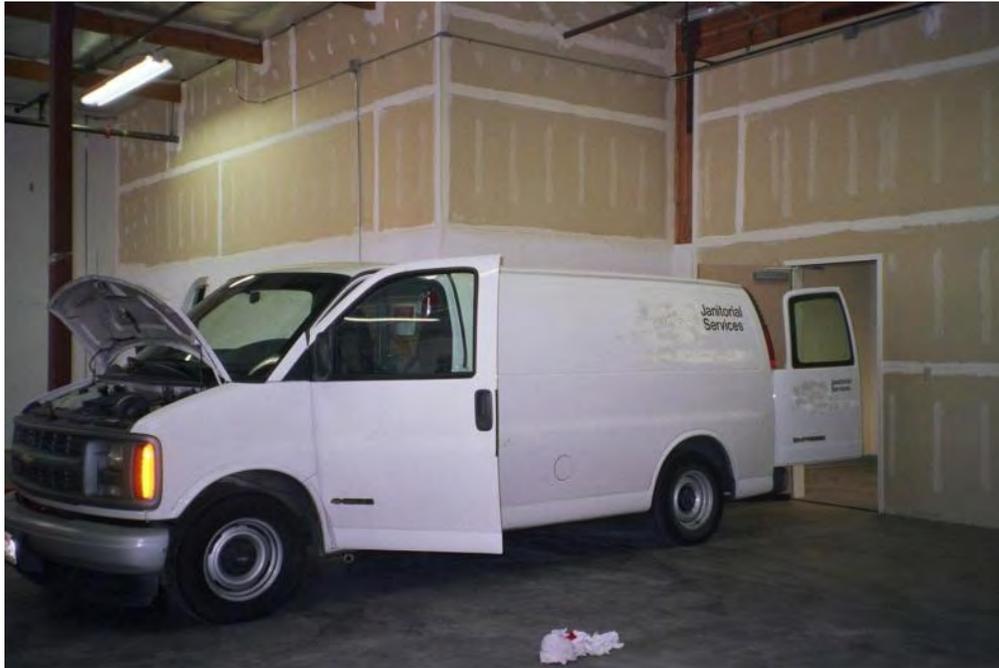
Photo 1. Carpet cleaning van parked in warehouse at incident scene. The open door to the rear of the van was where the victim accessed the office space in order to clean its carpets.

The victim ran the truck-mounted gasoline-powered carpet cleaner inside a warehouse with the building's doors closed, no open windows, and the HVAC system turned off (see [Photo 1](#) and [Photo 2](#)). These conditions contributed to a decreasing level of oxygen as it was consumed in the combustion process and a resulting change in the exhaust gas composition from carbon dioxide to carbon monoxide.

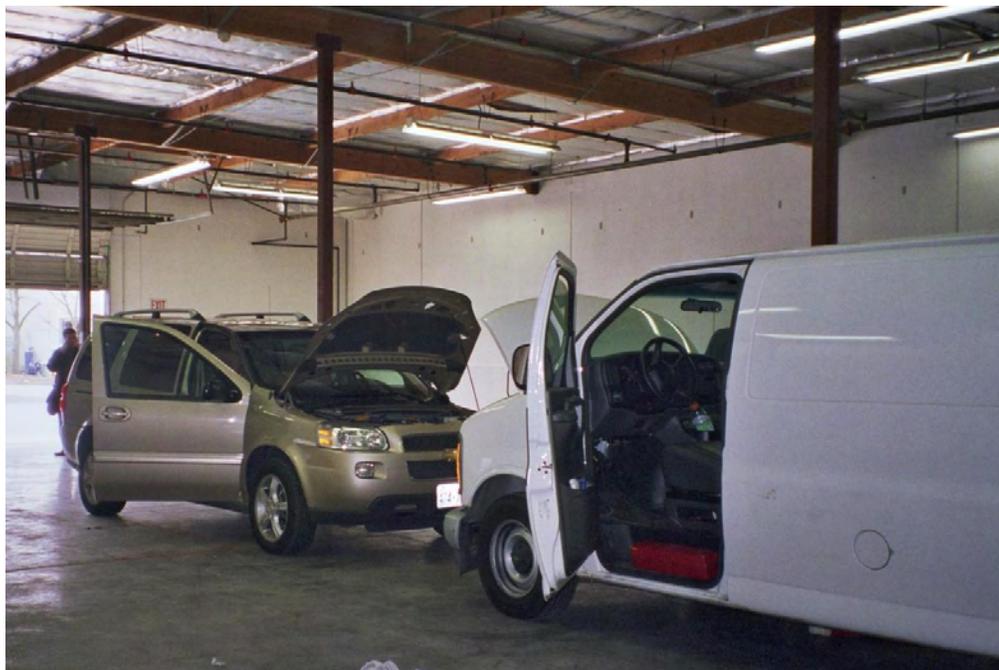
Photo 2. Carpet cleaning van (vehicle on the right) in warehouse at incident scene. The overhead sliding door was closed when the victim was found in the van.

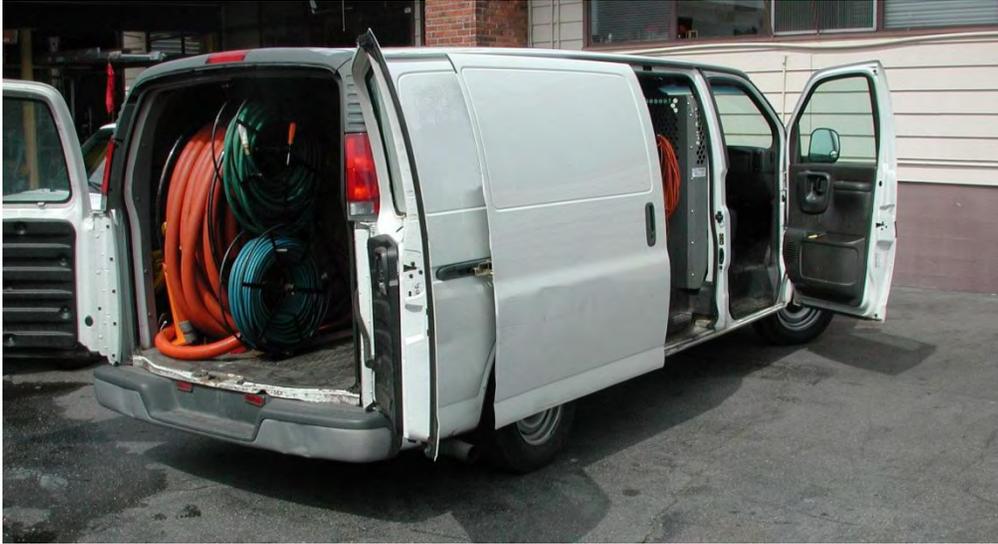
Photo 3. Van equipped with carpet cleaning equipment that was used by the victim.

At about 5:30 the victim left the branch office location driving one of the company vans equipped with a truck-mounted carpet cleaner and the tools and chemicals needed for the job (see [Photo 3](#)). The specific equipment involved in this incident was a truck-mounted carpet cleaner (see [Photo 4](#) and [Photo 5](#)) that had been purchased from and installed into a Chevrolet Astro Van by a local equipment dealer in 2004.

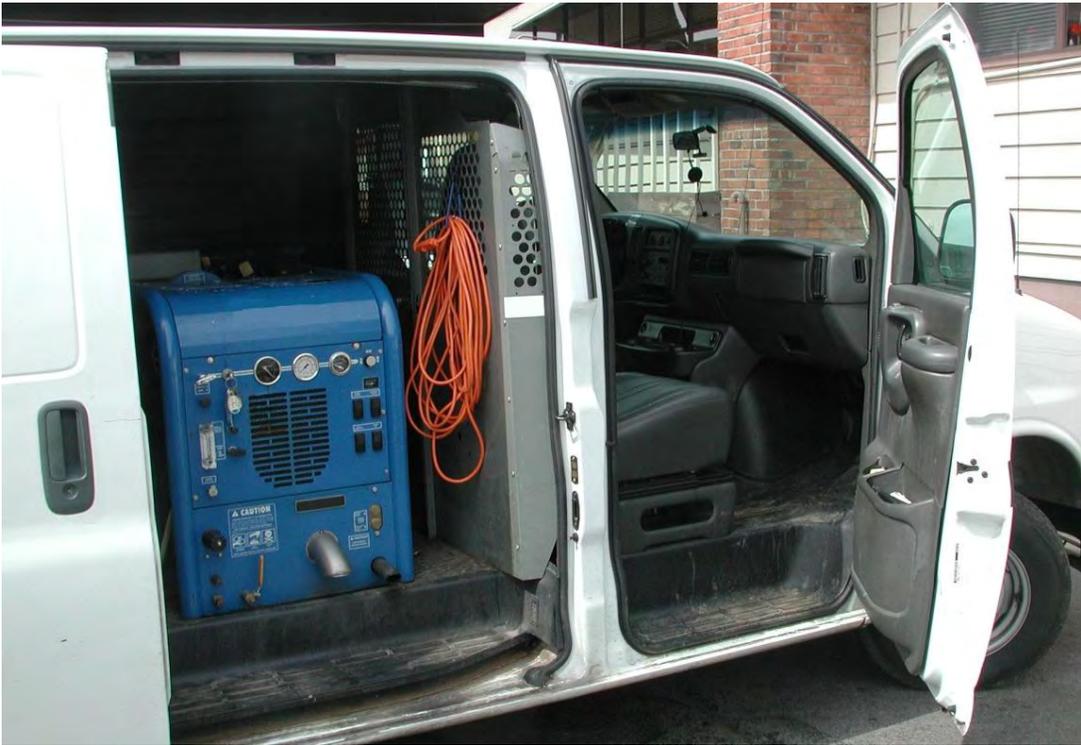
Photo 4. Incident van showing the truck-mounted gasoline powered carpet cleaner.

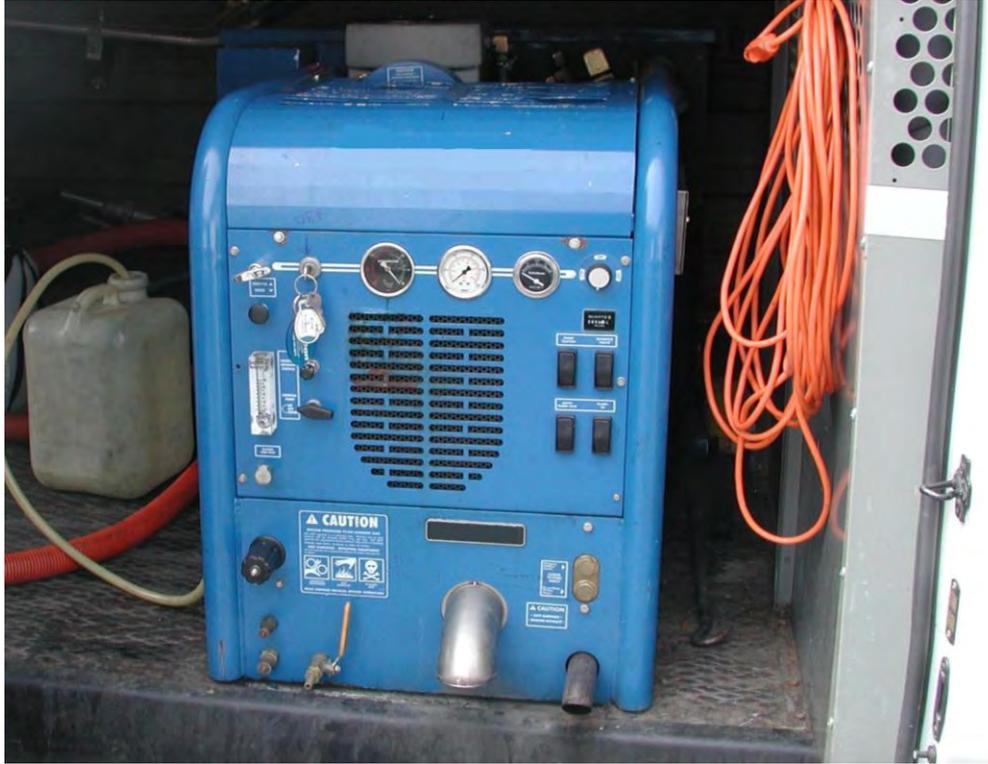
The carpet cleaning equipment used by the victim was a truck-mounted, slide in, gasoline-powered unit (see [Photo 5](#)). The employer purchased the carpet cleaner from a supply company which installed it. This equipment is powered by a small, spark ignition 21 horsepower Briggs and Stratton engine that is fueled by gasoline pumped directly from the van's gas tank. This engine is not equipped with an emission control device. The engine throttle for the carpet cleaning unit was found pulled out to "high"

Exhaust from the Briggs and Stratton engine is partially diverted into the water tank's heat exchanger. During divert mode, cooler exhaust is emitted through the larger pipe and hot exhaust is emitted through the smaller pipe at the front of the cleaner. Once water in the tank reaches the set temperature, the unit switches to muffler mode and all engine exhaust is emitted via the smaller exhaust pipe at the front of the cleaner. To the left of the exhaust pipe on the front of the cleaner, there is a caution label (see [Photo 6](#)) stating "engine produces toxic exhaust gas."

Photo5. Truck-mounted carpet cleaner in incident van.

Recommendation #2: Work with manufacturers to re-design the truck-mounted carpet cleaner so that the unit more effectively reduces or eliminates carbon monoxide in the exhaust gases or prohibits exhausting into the van and work area.

Truck-mounted cleaning systems should also be designed and maintained to prevent exhaust gases from entering the vehicle and the work environment by diverting exhaust gases. This can be achieved using a leak proof exhaust hose that will screw or clamp-on to the engine or existing exhaust and be long and flexible enough to route exhaust gases away from the van and work space. Similar hoses are used in auto repair facilities to route exhaust gases outdoors.

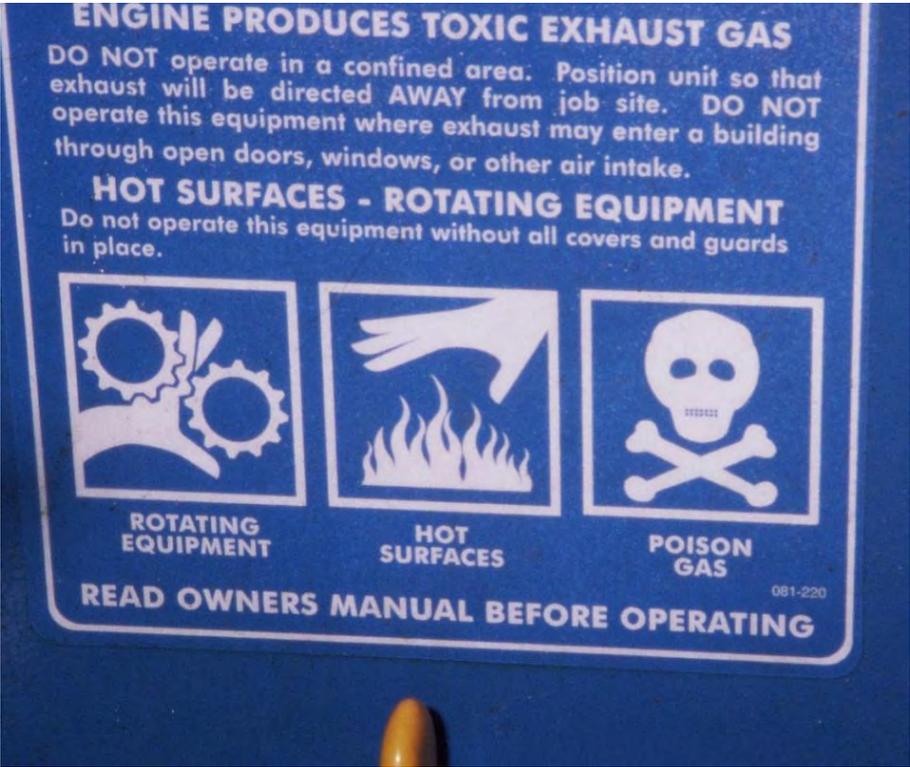
Photo 6. Warning on carpet cleaning machine.

Employers should use the results of the risk and job hazard assessment to educate their employees regarding CO and how to prevent exposures while doing their job. Employers should contact the equipment manufacturer for safety guidelines and operating procedures. This information should be used to provide employees with equipment specific applicable safety instruction. The manufacturer's operating manual for this equipment contains a section of precautions with warnings for CO, toxic fumes, and engine exhaust, among others. In the manual, warnings are defined as conditions that can cause possible injury or death. The CO warning explicitly instructs users to "Position vehicle so that fumes will be directed away from the job site. Do not Park where exhaust fumes can enter a building through open doors, windows, air conditioning units, or kitchen fans". These warnings should also instruct users how to recognize the symptoms of CO poisoning. Employers should also advocate that the manufacturer emphasize the warnings in the operating manual by changing the section

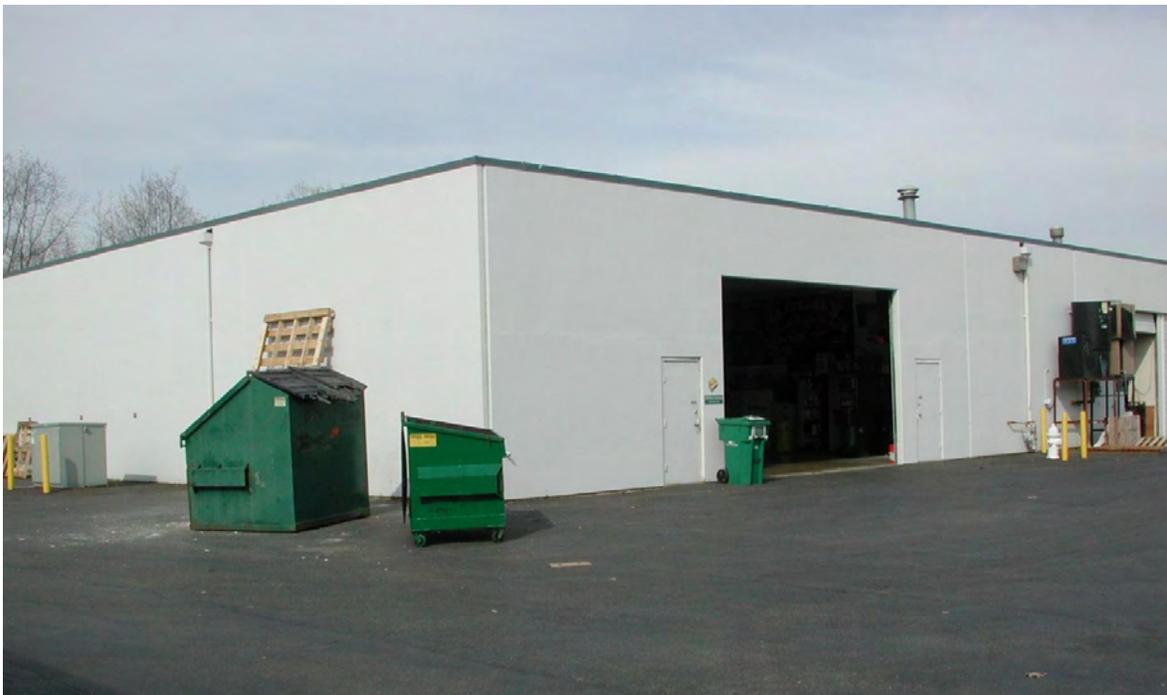
The victim unlocked one of the warehouse bay doors and drove the van into the 4,000 square foot warehouse (see [Photo 8](#)) and parked it close to the office spaces where the carpets were to be cleaned (see [Photo 1](#)). Most nearby businesses were closed. It is possible that the victim closed the doors because he was concerned about working alone on a Sunday night in an isolated area. The company and its employees had experienced work place violence incidents and equipment theft in the past, so it was an issue for workers in the field.

Photo 8. Incident location warehouse (victim accessed the warehouse and its office space through this door).

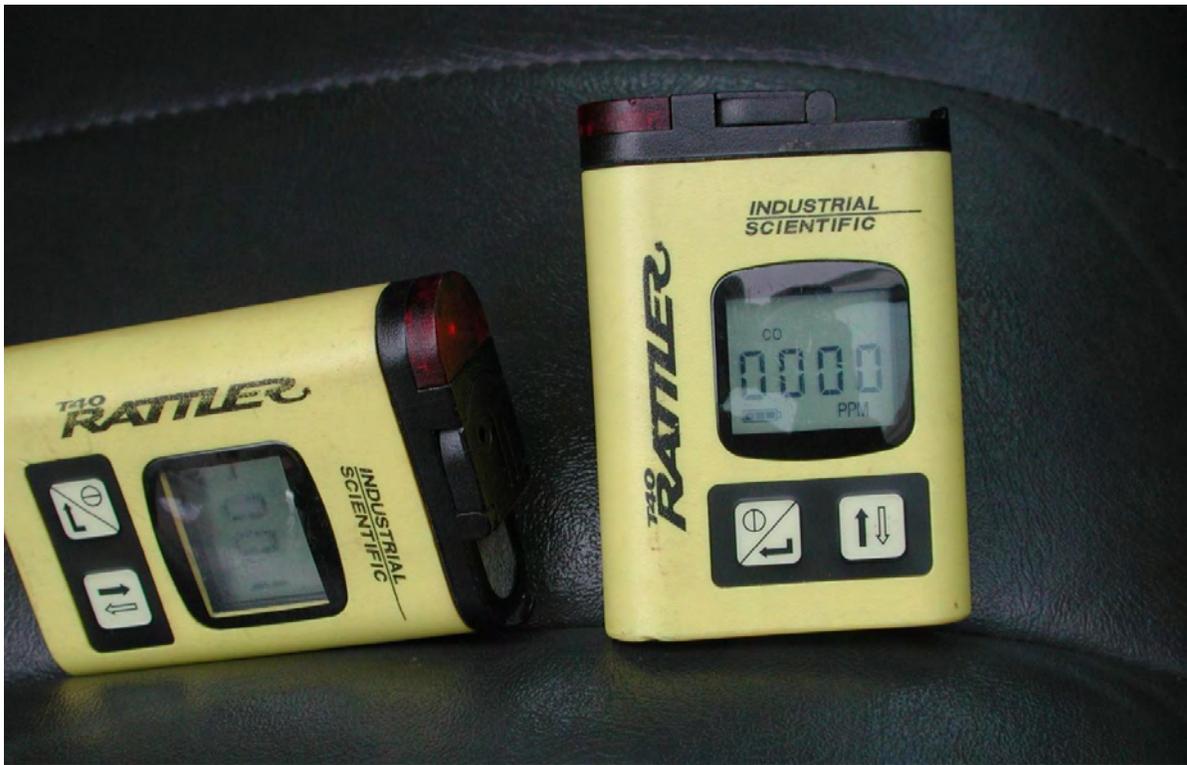
Photo 9. Example of personal portable carbon monoxide monitor.

Personal CO monitors should be used whenever a fuel-burning generator is used as an energy source and there is potential for CO to accumulate. Personal CO monitors should provide a means of direct reading of CO exposure concentrations with preset alarm warnings for hazardous concentrations (see [Photo 9](#)) and should have both visual and audible alarm and warning functions. Fixed site ambient CO monitors should also be used near the CO source. ⁽⁶⁾ CO monitors should be capable of recording and responding to peak CO concentrations and average CO exposures over time.

WA FACE recommends that CO monitors be set to activate the alarm or warning at an exposure concentration of 35 ppm (0.0035%) which is the level generally accepted to have no adverse health effects in healthy humans. Any CO alarm or warning should initiate evacuation of the workplace, shutting down the generator and immediate contact with a supervisor. The employer should then work with the employee to establish procedures to diminish and prevent further exposure before resuming work.
