# Truck Driver Dies after being Run Over by Propane Transport Rolling Backward at Bulk Plant

Investigation: # 11WA013  
Release Date: May 21, 2013  
SHARP Report: # 52-28-2013

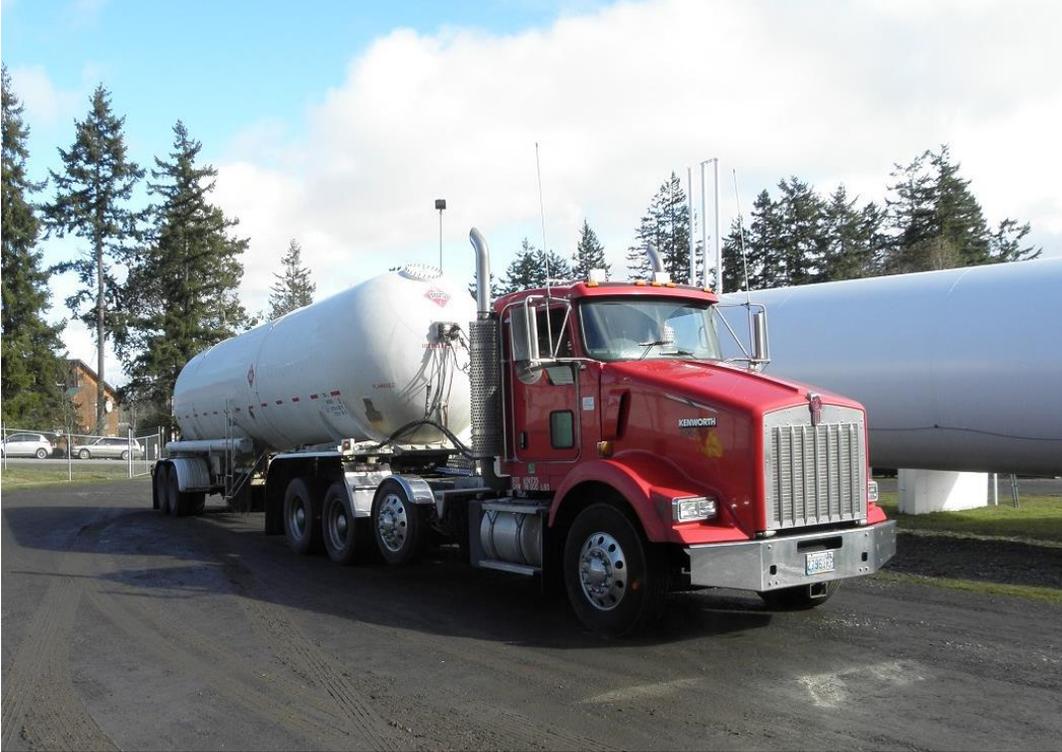
**Photo 1. Propane transport at bulk plant incident scene.**

The vehicle involved in the incident was a 2006 four-axle Kenworth truck-tractor in combination with a 1965 double-axle Lubbock MC330 cargo tank transport semitrailer (see photo 1). The MC 330 cargo tank is the U.S. Department of Transportation designation for a high pressure cargo tank built before December 1, 1967 for the transport of compressed gasses. In the propane industry, a vehicle with a tractor and cargo tank trailer combination, is known as a propane transport.<sup>4,5</sup> The U.S. Department of Transportation designates this type of vehicle a cargo tank motor vehicle.<sup>6</sup> The cargo tank, with a 10,600 gallon capacity, was laden with 8,940 gallons of liquefied petroleum gas (LPG), also known as propane. The total loaded weight of the transport vehicle was 79,900 lbs.

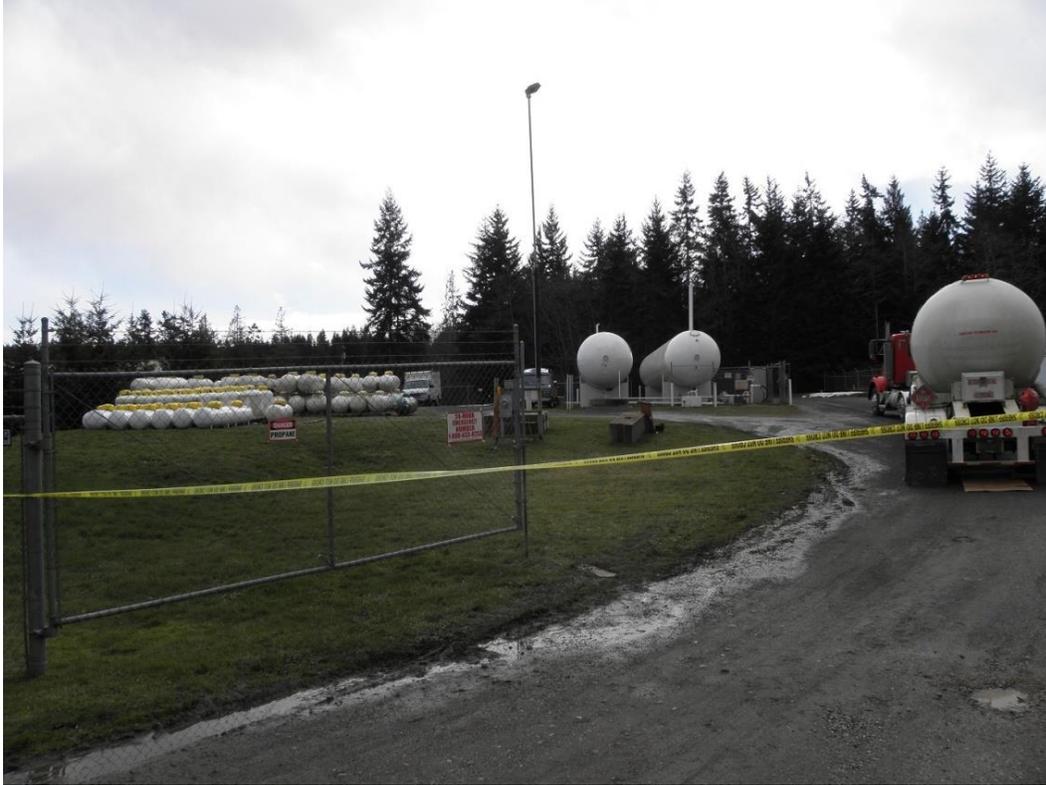
**Photo 2. Propane bulk plant facility. Incident propane transport on far right.**

The location of the incident was a bulk plant facility consisting of propane storage tanks in a yard in Western Washington (see photos 1 and 2). The owner of the facility is a retail seller of propane. The surface of the yard and its driveway were composed of soft, wet dirt and gravel. The surface area where the victim parked his transport to deliver the fuel had a down-slope of 1 to 2 degrees with the driveway area behind the transport sloping down a further 2 to 3 degrees. There was no one other than the driver present at the time of the incident.

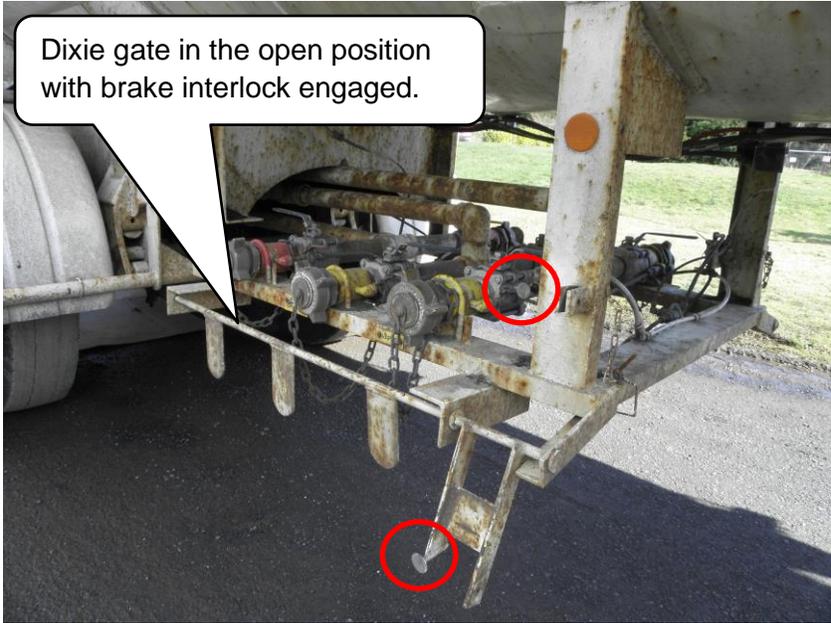
**Photo 3. Fuel loading/unloading valve connections with trailer brake interlock or Dixie gate on the trailer undercarriage. The gate is in the open or “down” position which sets the trailer brakes. The interlock operating air valve connection is the metal button circled in the right center of the photo; located beneath it and circled is the piece of metal that when the gate is up will depress the air valve.**

He would have then walked around to the right side of the trailer to open a metal hinged gate. This gate, which is in front of a set of loading and unloading valve connections in the trailer's undercarriage, is variously known as a loading, safety, safety interlock, brake interlock, or Dixie gate (see photos 3 and 4). In order to dispense fuel this gate must be opened to the "down" position. To open the gate a pin must be removed. When the gate is opened an air interlock valve is activated, which sets the trailer's parking brakes. This gate which activates the interlock operating air valve is located on the right side of the trailer only.

The driver cannot drive the vehicle as long as the brake interlock gate is open and the interlock operating air valve is activated. This safety air brake interlock system is an optional feature on propane transport trailers. The purpose of the safety air brake interlock system is to prevent the truck driver from driving away while hoses are not properly stored for travel or are connected to a fuel loading or unloading bulkhead, or the vehicle's power take off (PTO), which provides power to the fuel transfer pump's main shaft, is engaged. When this gate is in the closed or "up" position the trailer's parking brakes are released and the truck may be driven.

The safety air brake interlock system when activated locks the transport trailer brakes. The vehicle cannot be driven unless the safety gate is closed, thereby releasing the trailer brakes.

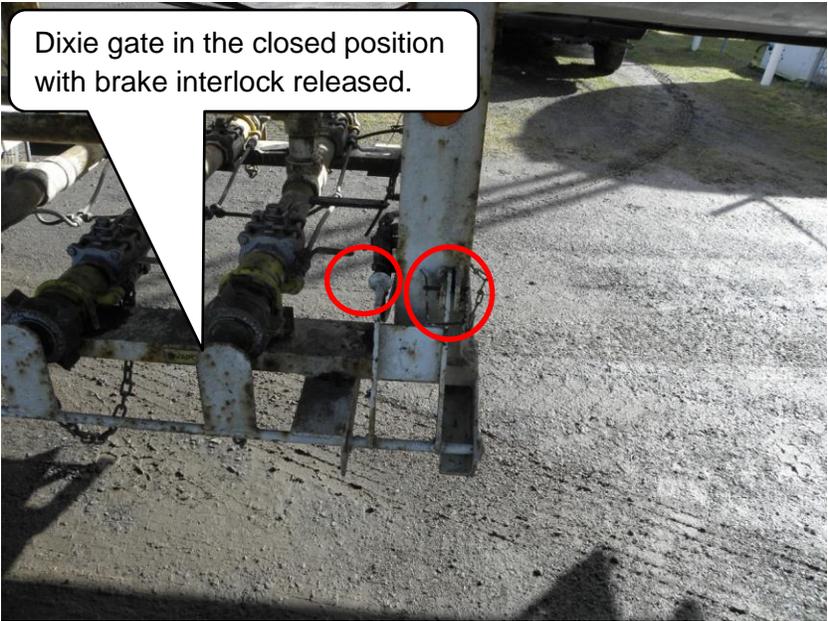
**Photo 4. The trailer brake interlock or Dixie gate in the closed or “up” position which releases the trailer brakes and allows the vehicle to be driven. The metal pin circled in the right of the photo keeps the gate in place; to the left of the pin is the piece of metal attached to the gate and is depressing the air valve.**

Upon getting into the truck's cab he releases the parking brake, and attempts to drive away, but could not do so as the trailer's brakes were still engaged by the brake interlock because the brake interlock gate was open. Stepping out of the cab without setting the tractor's parking brake he leaves the engine running, does not use wheel chocks, and walks around to the right side of the cargo tank semi-trailer where the brake interlock gate is located and closes the gate by swinging it up. He inserts a metal pin to keep it in place so that it will not open during transport. The closing of the brake interlock gate depresses a button which releases the trailer's brakes.

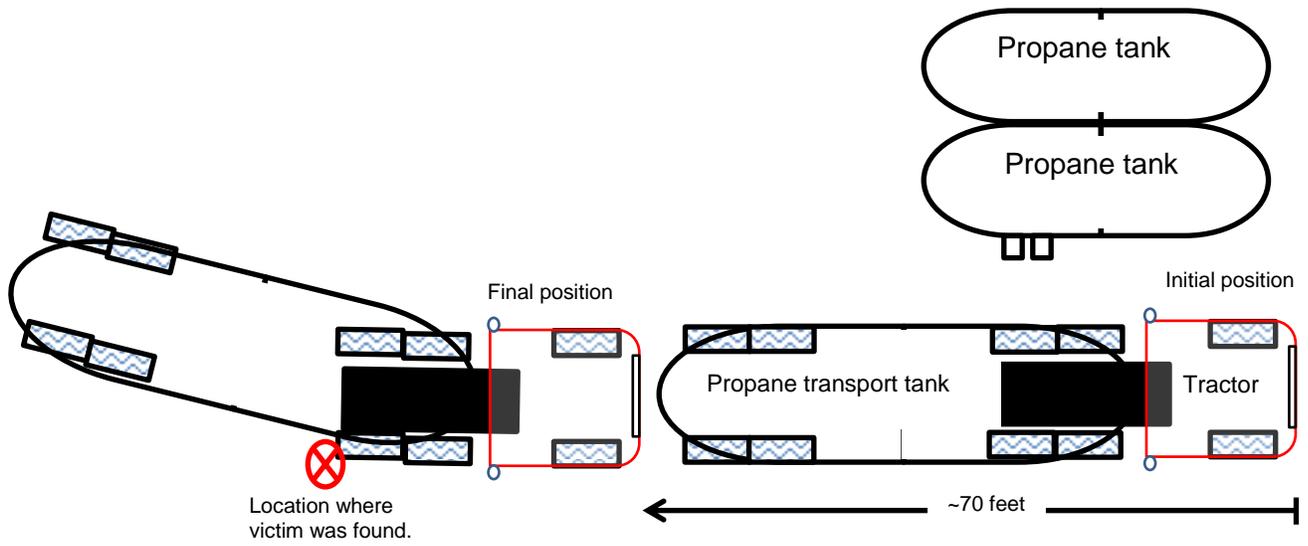
The propane transport had rolled backward down the 3 to 5 degree downgrade dirt driveway before stopping approximately 70 feet from where it had been parked (see figure 1 and photo 6).

**Figure 1. Illustration of incident scene showing initial and final position of the propane transport relative to the location of the stationary propane tanks and the location where the victim was found.**

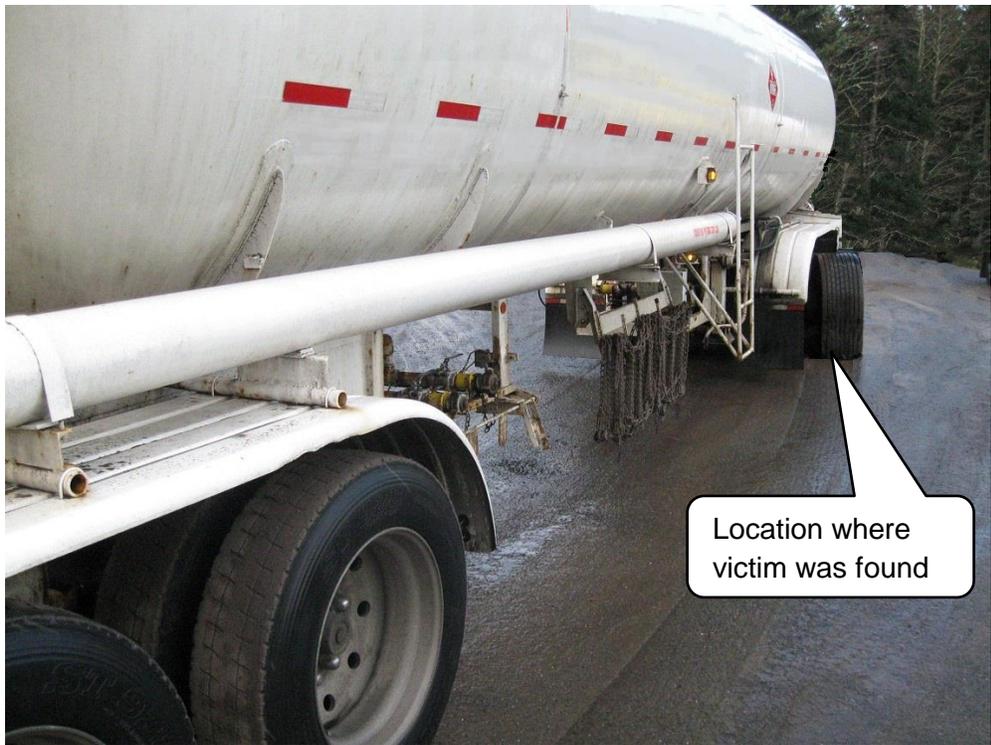
With no brakes engaged the transport starts to roll backward. He runs after the rolling vehicle, reaches under the cargo tank, gets the brake interlock gate pin out and opens the gate in order to activate the trailer brake and stop the vehicle. The momentum of the loaded vehicle rolling downhill and the fact that the air brake takes between 1½ to 3 seconds to engage prevents it from stopping immediately. As the vehicle rolls, he is struck by the cargo tank ladder or a structural member of the tank or semi-trailer and is knocked to the ground, or slips/trips and falls on wet dirt. The right rear wheel of the semi-tractor rolls onto his right leg and lower abdomen/pelvic area, and traps him beneath the wheel as the vehicle comes to rest (see photo 5).

**Photo 5. Incident scene with propane transport trailer. Victim was found under the semi-tractor wheel in the upper right.**

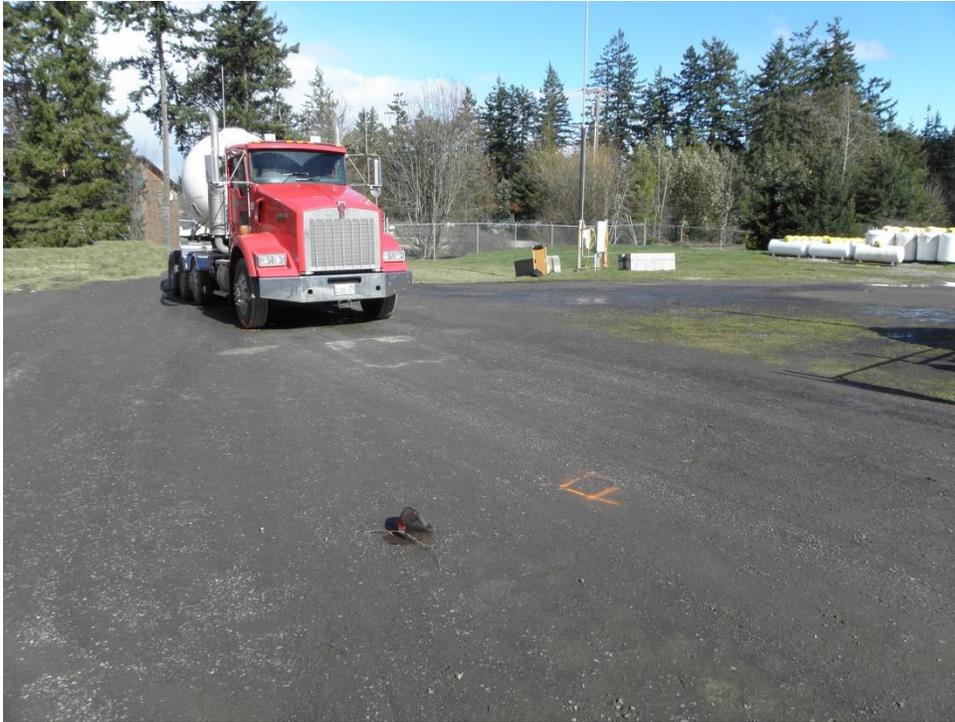
**Photo 6. Incident scene showing where the transport came to rest after rolling approximately 70 feet backward. In the foreground is the victim's cap where first responders found it.**
