## Roofing Contractor Falls 25 Feet from Church Roof

**Industry: Roofing Contractors**

**Type of Incident: Fall from roof**

# ***FATALITY NARRATIVE***

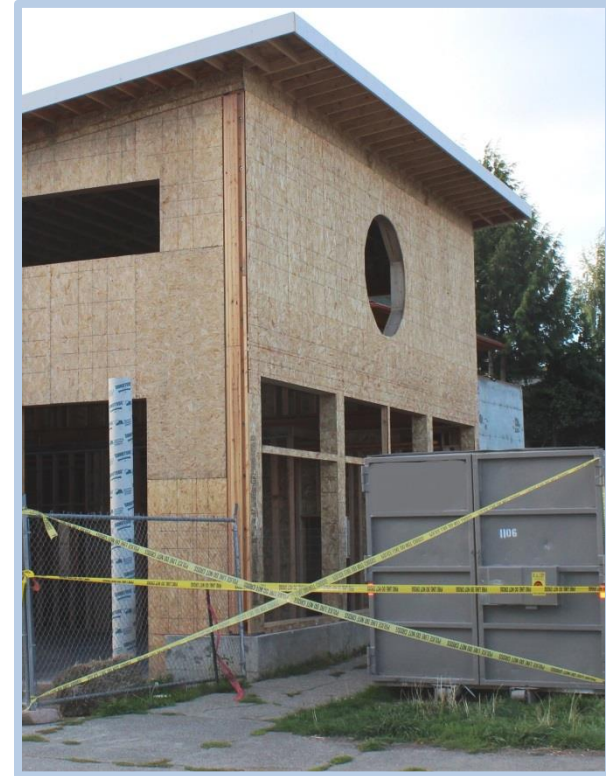
On the day of the incident, the weather was sunny and warm. They were the only workers at the site, and both were working on the roof. It was a low pitch roof with a 1 in 12 slope. The victim was working on the edge of the roof nailing down roofing materials. Neither of the roofers was using fall protection, nor was there any in place on the roof or on site. The father looked up from his work and did not see his son on the roof. He went to the side of the roof where his son had been and looked down. His son was lying on the sidewalk below, bleeding. He had fallen 25 feet from the roof edge.

Develop and implement a written fall protection work plan that includes each area of the work place where employees are assigned and where hazards of ten feet or more exist.

Ensure that the appropriate fall protection system is provided, installed, and implemented when employees are exposed to fall hazards of 10 feet or more to the ground or lower level while engaged in roofing work on a low pitched roof. A low pitched roof has a slope equal to or less than 4 in 12.

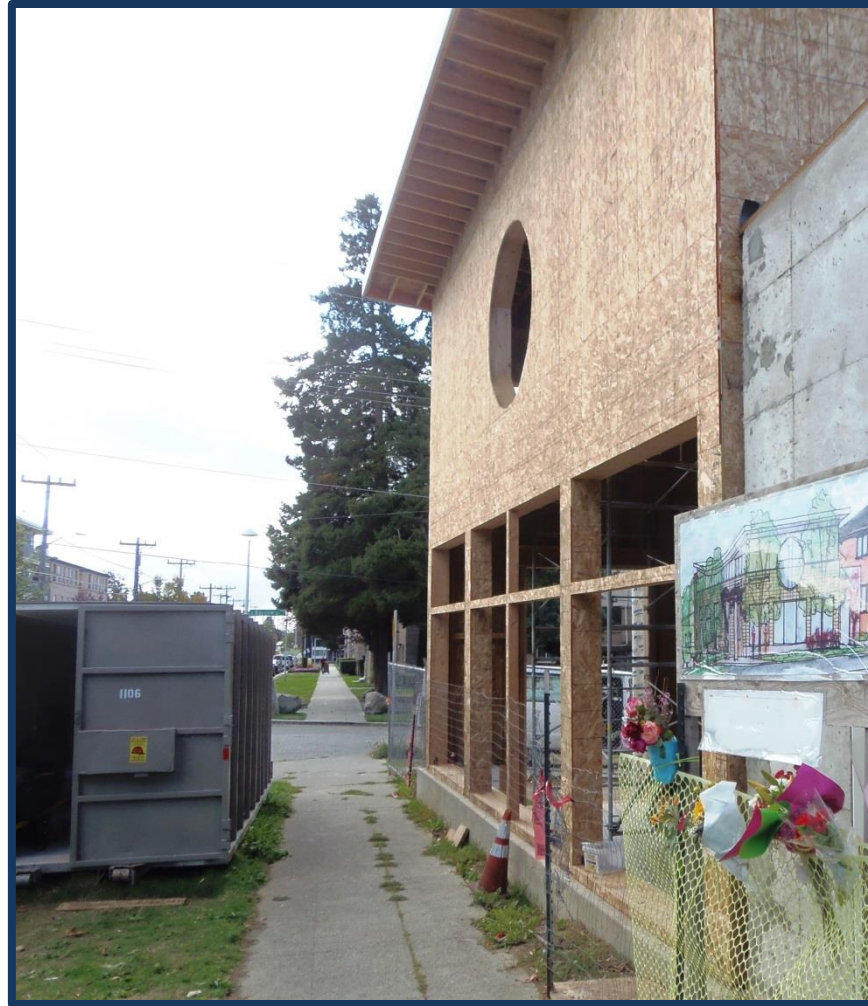
Incident scene showing the church roof edge from which the victim fell 25 feet to the sidewalk.

Prior to permitting employees into areas where fall hazards exist you must ensure employees are trained and instructed in the items described in the fall protection work plan.
